A case history of a major fault slip rockburst

David Landry ^{a,*}, Justin Roy ^a, Navita Ramdass ^a, Ana Leite ^a, Scott Shears ^a

^a Vale Base Metals, Canada

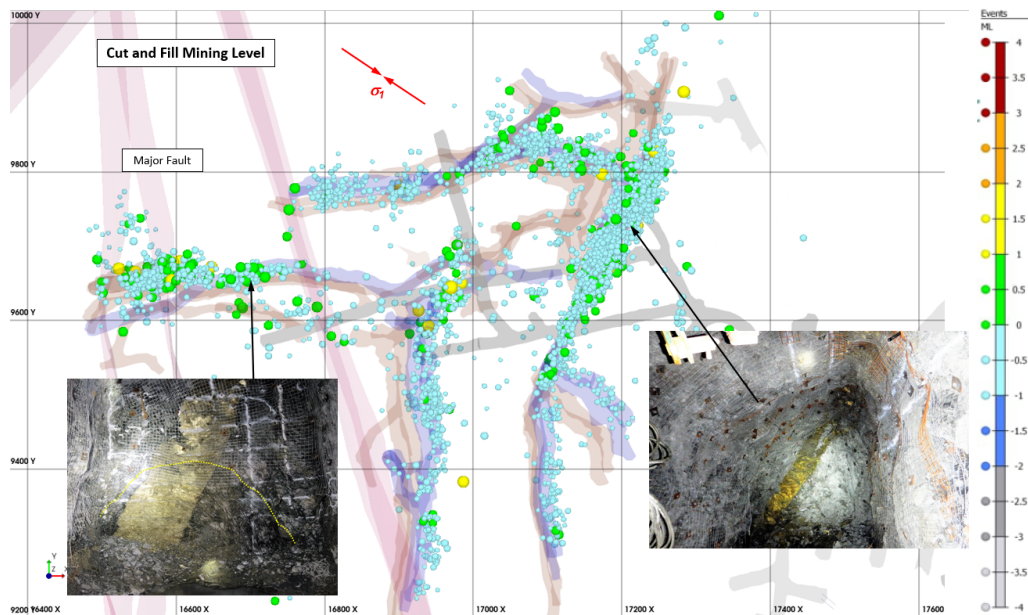
Figure 2 Plan view of a narrow vein cut-and-fill mining level at Coleman Mine (1,700 m depth). Seismic events for the life of the cut are coloured by magnitude ($MN > -1$). Typical field observations shown in the photo as high stress spalling conditions
