Lessons learnt from a pillarburst at a development heading in one of Vale's deep mines: a case study

Mike Yao ^{a,*}, Alex Hossack ^a, Chris Groccia ^a

^a Vale Base Metals, Canada

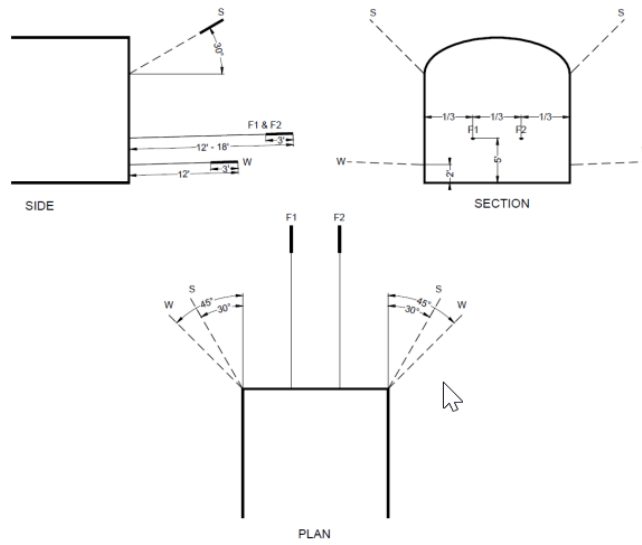
Figure 5 Garson's development de-stress layout

- de-stress development blasting – Garson Mine procedure (Figure 5) was followed for the 5220 Ramp (Yao & Moreau-Verlaan 2010)
- de-stress relief holes in the pillar – at 15 m to breakthrough, de-stress relief holes were drilled as follows (Figure 6):

The purpose of the de-stress relief holes in the pillar was to precondition the rock mass by allowing the holes to squeeze and thus providing pressure relief points. Though the effectiveness of these ‘pressure-relief’ de-stress holes have not been categorically demonstrated, underground observations indicate they have provided some form of de-stressing in previous applications. However, this strategy proved inadequate in the 5220 Ramp breakthrough pillar.

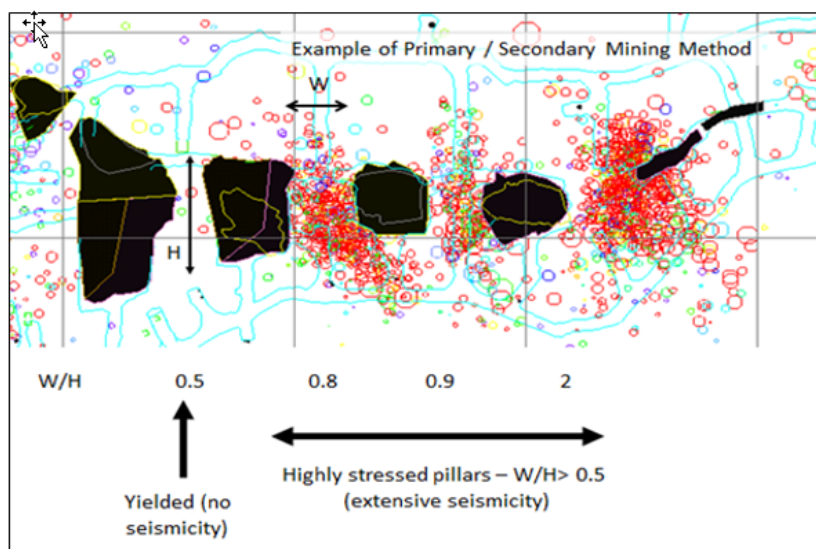
Figure 11 Example of seismicity for various weight:height (W:H) ratios (Brad Simser, pers. comm., 2020)

Pillar width:height (W:H) ratio has also been found to correlate well with seismic hazard in the mining industry. Pillars with a W:H ratio between 0.5 and 2.0 are relatively squat and have historically demonstrated greater seismic activity as compared to slender pillars. Figure 10 shows a plan view of secondary stopes (pillars) bounded by previously mined primary stopes and measured seismicity (Brad Simser, pers. comm., 2020). Because the main driving stress is horizontal and roughly perpendicular to the orebody, the relevant W:H ratio is the ratio of the stope strike length to the orebody thickness. As can be seen in Figure 11, there is significant seismicity in the squat pillars ($2.0 > W:H > 0.5$) and there is very little seismicity in the slender pillars. It is noted that the Garson breakthrough pillar had a W:H ratio of 5.5:5.8 m or 0.95.

- The effectiveness of 'pressure-relief' de-stress holes proved inadequate in mitigating the 5220 Ramp rockburst.
- This breakthrough pillar had a W:H ratio of 5.5 m:5.8 m or 0.95 being in the range between 0.5 and 2.0, which is relatively squat and has historically demonstrated greater seismic activity as compared to slender pillars.

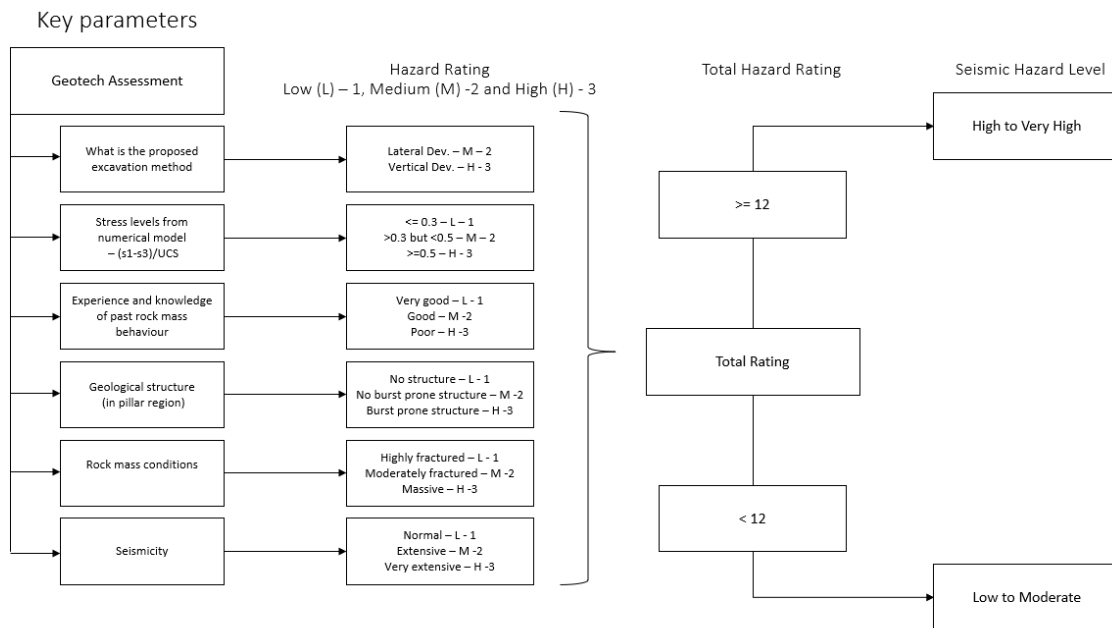
Figure 12 A rating system to assess seismic hazard for breakthrough pillars

Based on internal knowledge and experience, many factors must be considered when assessing seismic hazard in a development breakthrough pillar. As shown in Figure 12, these factors include, but are not necessarily limited to: excavation method, anticipated stress level, previous knowledge and experience on rock mass behaviour in the area, local geology and geological structure, rock mass conditions and seismicity trends. For each factor, a rating of 1, 2 or 3 is assigned for Low, Medium, or High hazard respectively. In order to define the seismic hazard level, a simplistic approach was used and a numerical value of 12 (cumulative total if all parameters were rated as moderate) was selected to differentiate between a low to moderate

seismic hazard and a high to very high seismic hazard. It is important to note that had this methodology been in place prior, the breakthrough pillar at the location of the 5220 Ramp, the pillarburst would have been classified as a ‘high to very high’ seismic hazard. This methodology will be further reviewed to identify opportunities for improvement in the future.

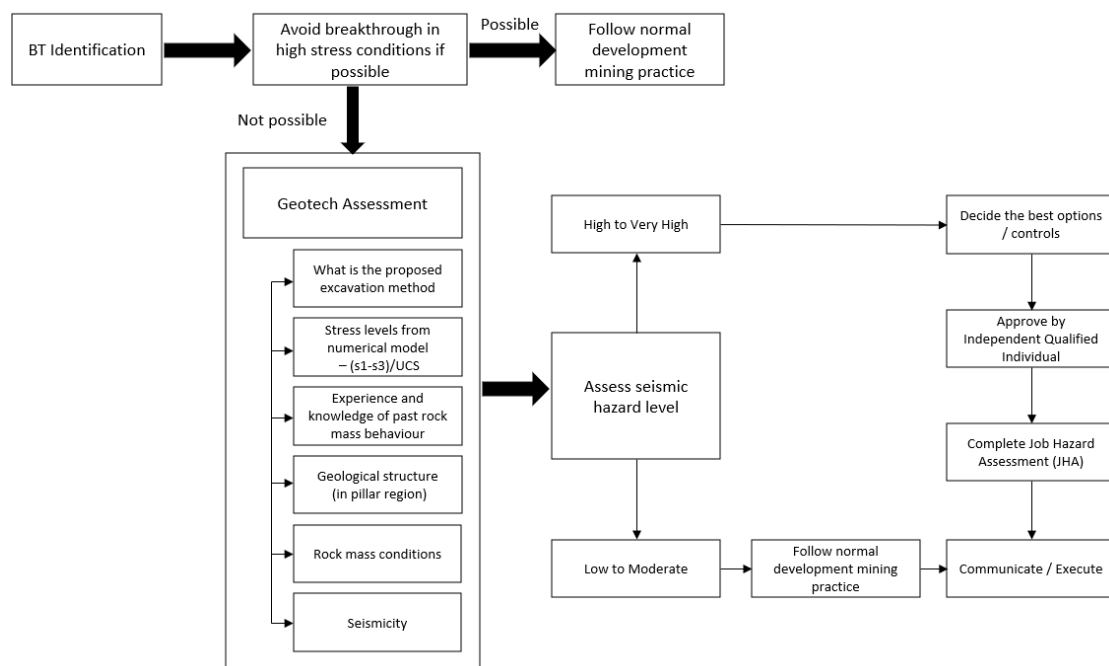
Figure 13 Design review process flow chart

As shown in Figure 13, all development breakthroughs with ‘high to very high’ seismic hazard automatically trigger a formal risk assessment, including review and approval by an independent qualified individual is required and the development of a job hazard assessment with all key stakeholders, while all breakthroughs with ‘low to moderate’ seismic hazard follow normal development mining practice.

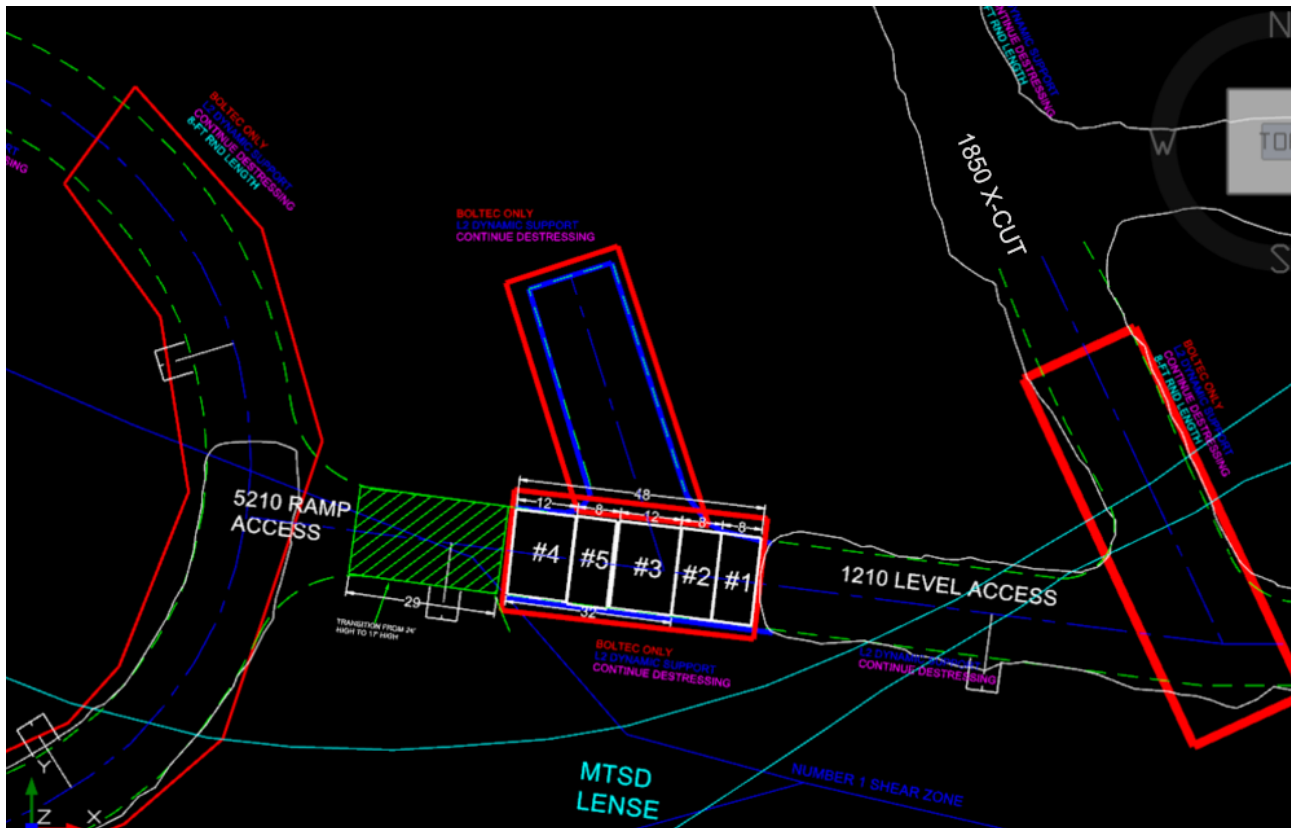
Figure 16 Plan view of the breakthrough in the 1210 Level access on 5300 Level

Since the pillarburst in the 5220 Ramp occurred, Garson Mine has designed more than 20 development breakthroughs using the new design methodology. To date, only two have been classified as 'high to very high' seismic hazard, both of which have been successfully developed without incident. The more recent of the two was the 1210 Level access on 5300 Level which connects the west side of 5300 Level to the west ramp (referred to as the 5210 Ramp at this location) as shown in Figure 16.

The 1210 Level access breakthrough was considered more hazardous than many other breakthroughs because it was planned to be developed in one of the more challenging areas of the mine. The west ramp to the west, and the 1850 Crosscut and connected infrastructure to the east; both experienced a number of strain bursts while being developed. This area of the mine is situated primarily in MTBS interlaced with east–west trending, steeply dipping metasedimentary lenses. As previously mentioned, the MTBS is very stiff and relatively strong and can be moderately jointed in some locations. The metasedimentary lenses are less stiff, and this stiffness contrast may explain why the mine has noticed that strainbursts often occur near the contact between these two lithologies.

The first step in designing a development breakthrough is to select a location. In some cases, practical and operational constraints may dictate the location; however, whenever this isn't the case, careful consideration is given to selecting a location. In the case of the 1210 Level access breakthrough the location was chosen to be as far from the nearby metasedimentary lens as possible (albeit not very far), to be in a length of drift that is not larger than usual either in height or span, and to be in a drift that is approximately aligned with the major principal stress ($075^{\circ}/00^{\circ}$ at Garson Mine).

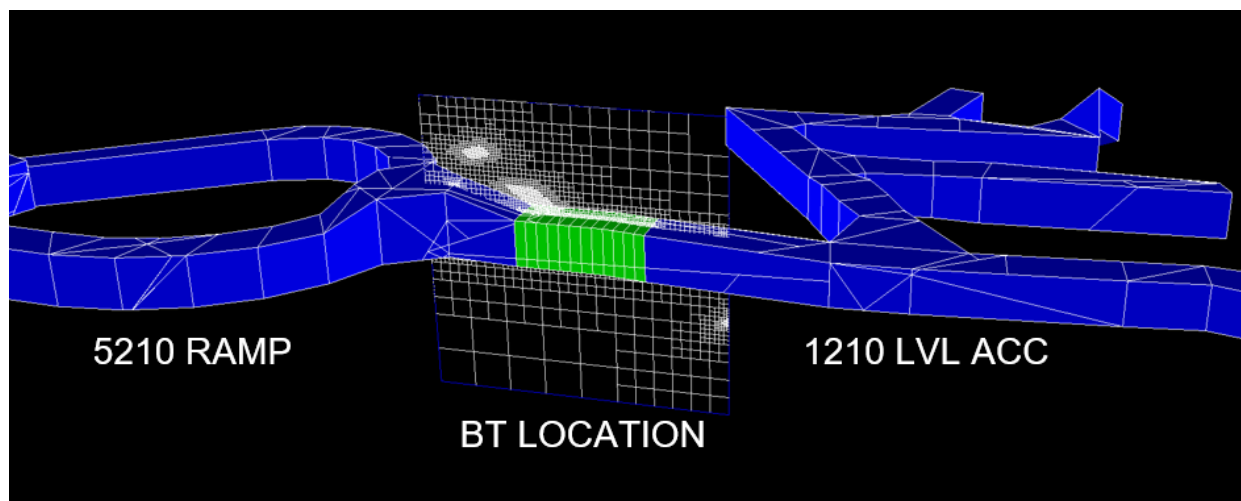
Figure 17 Isometric view looking approximately north showing the geometry of the 5300 Level 1210 Level access that was modelled and the vertical grid plane that was used for viewing results

Next the anticipated stress conditions associated with various development strategies were assessed. Map3D's Fault Slip package (Wiles n.d.), which is a boundary element method tool that models the rock mass as being linearly elastic was used for the assessment. Figure 17 shows the development that was modelled, and the vertical grid plane that was used to view results. Mined out areas and the metasedimentary lens were included in the model but are omitted from Figure 17 for clarity. The breakthrough location was divided into 1.2 m lengths of drift advance, that were sequenced such that they were excavated sequentially so that the stress conditions in the pillar could be assessed in increments to determine when it was anticipated to transition from a stable pillar with an undamaged core to a yielded pillar.

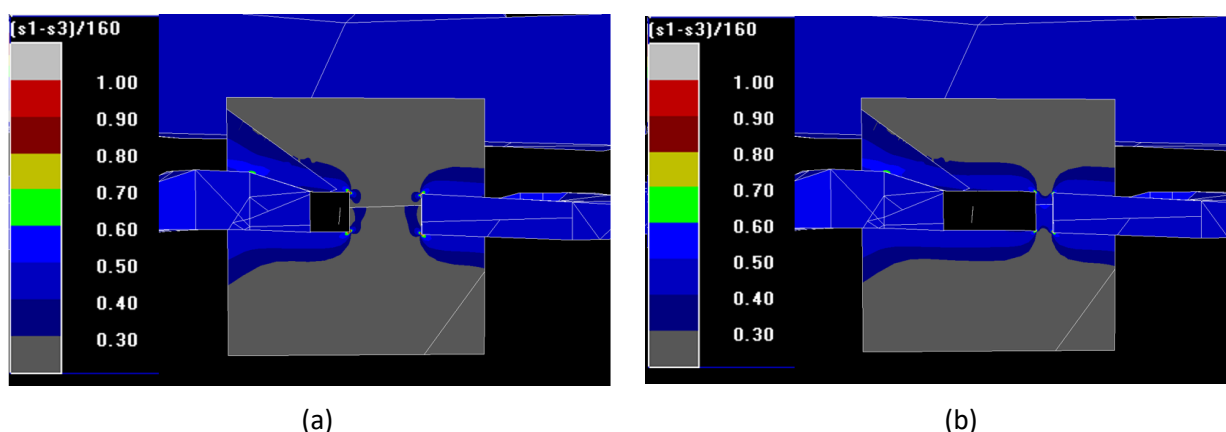
Figure 18 Isometric view facing north showing deviatoric stress ratio displayed on a vertical grid plane when the 1210 Level access breakthrough pillar is (a) 9.75 m and (b) 2.43 m

Figure 18 presents the modelling results in terms of DSR for when the 1210 Level access is 9.75 m from breaking through (left) and when it is 2.4 m from breaking through (right). It should be mentioned that due to additional data collected, a UCS of 160MPa was used in this model compared to 180MPa being utilised in the previous model. The solids that make up the breakthrough pillar are not shown in Figure 18 to allow for an unobstructed view of the modelling results on the grid plane. The modelling results suggested that at 9.75 m there may be some stress induced damage in the face, which is common for all development in this area; however, the core of the pillar was anticipated to be intact. At approximately 7.30 m the pillar core was anticipated to begin to experience stress induced damage, and by 4.88 m the pillar was anticipated to begin to yield. These results suggested that it would be relatively conservative to develop the pillar to a thickness of 9.75 m, and to then blast a 3.66 m round from either side, leaving a 2.43 m yielded pillar that could be safely excavated. Figure 16 shows how this plan was executed, by numbering the rounds in the plan view. Rounds #1 and #2 were developed sequentially as 2.44 m rounds, then rounds #3 and #4 were excavated simultaneously as 3.66 m rounds, then round #5 was excavated as the final 2.44 m round.
