# Experiences of seismic monitoring at the Kittilä mine

Antti Pyy <sup>a,\*</sup>, Stephen Meyer <sup>b</sup>, Véronique Falmagne <sup>c</sup>

<sup>a</sup> Kittilä mine, Agnico Eagle Mines, Finland

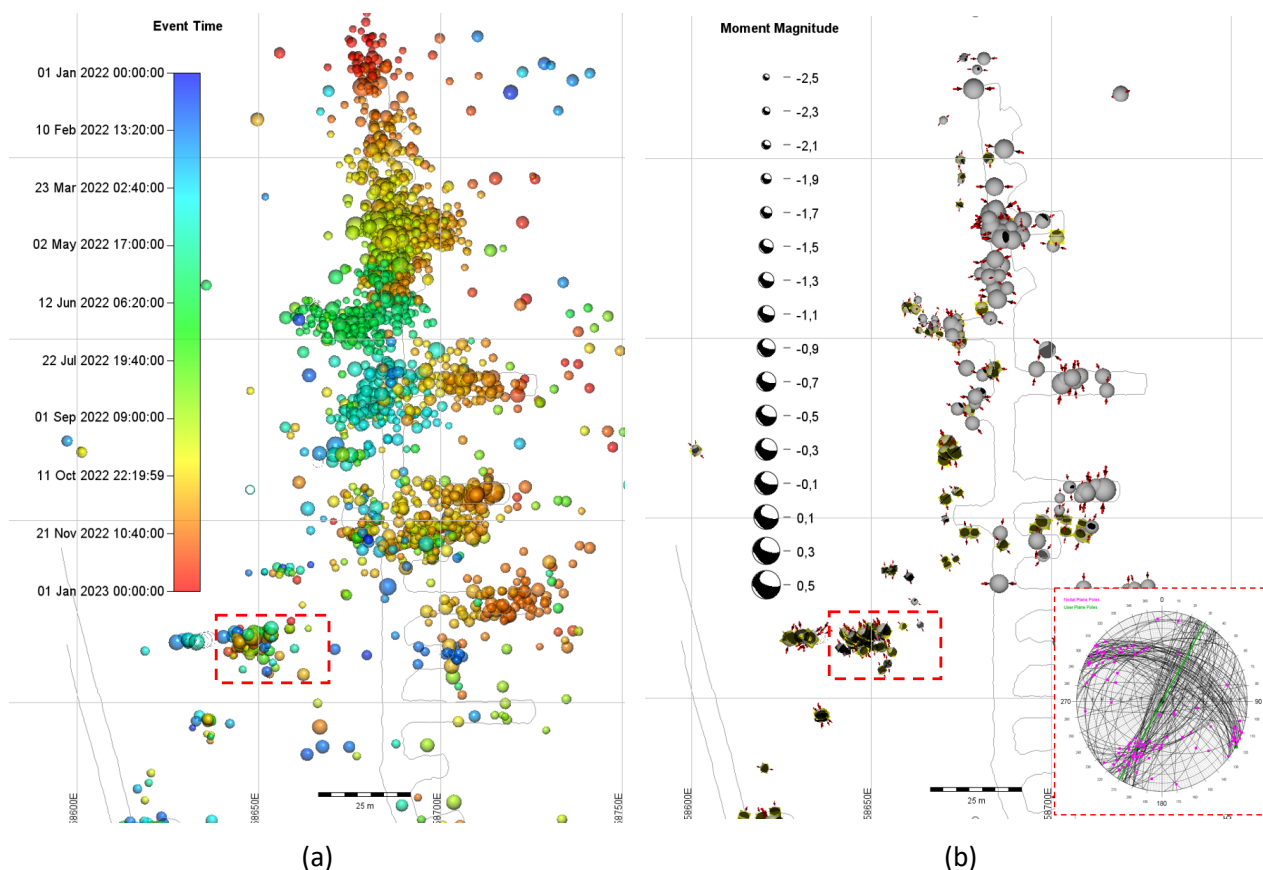
With the development progressing in the lower pyramid, planar clusters of small events ( $MW < -1$ ) were recorded at X925 level. Events around the development in the northern part show mostly crush-type sources. Events 20 m west of the haulage drift are mostly slip-type events related to structures (Figure 7). Source mechanism calculations to events of  $MW > -2.3$  enable verification of earlier structural interpretation of the area. Monitoring the behaviour of a distinct structure in response to stoping highlights areas requiring increased ground support where activated structures intersect the footwall development.

**Figure 7 X925 level: (a) Spatial-temporal evolution; (b) Calculated source mechanisms of the same event set. Pressure axis at red arrows. Stereonet of the highlighted events' nodal planes are presented in the lower corner**

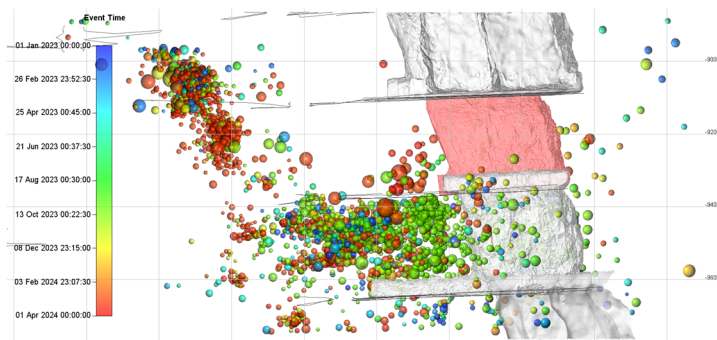
Observed seismicity after the extraction of the sill pillar stope X925L331 (Figure 9) was located on the footwall structures. This, combined with observed stress fracturing at the X925 development, suggests the sill had already yielded and that observed seismicity is due to change in the stress orientation.

**Figure 9** Section view of the X925-X900 sill pillar stope X925L331 (in red) blasted in March 2024. 20 m-thick spatial filter towards the view of the image (north). Colour scale of the events is the same as in Figure 8

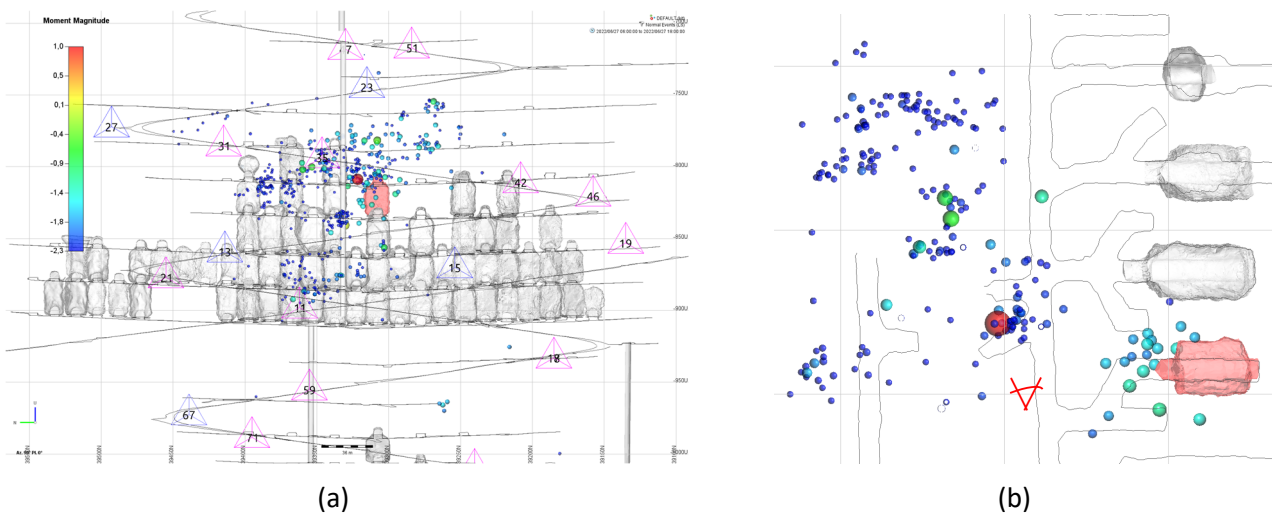
In June 2022, a MW1.0 pillarburst took place after a nearby primary stope blast. The event happened during the post-blast exclusion protocol and damage was limited due to proactively increased ground support. The event was, however, of a larger magnitude than previously recorded in the area. A complete record of the seismicity was available from the surrounding area for forensic analysis. Ground support loading was also observed in the area, with cracked FRS and bent rockbolt faceplates prior to the event. Figure 12a presents immediate seismicity after the stope blast. The MW1.0 event location matches the observed damage in the local pillar between the sump and exhaust air raise access. (Figure 12b). On a larger scale, the event is located in between the two mining pyramids.

**Figure 12 Seismicity 12 hours after X800 footwall pillarburst: (a) Longitudinal image of the location; (b) Level layout of the event location. The blasted stope is in red with a red viewpoint marker for Figures 13 and 14a**

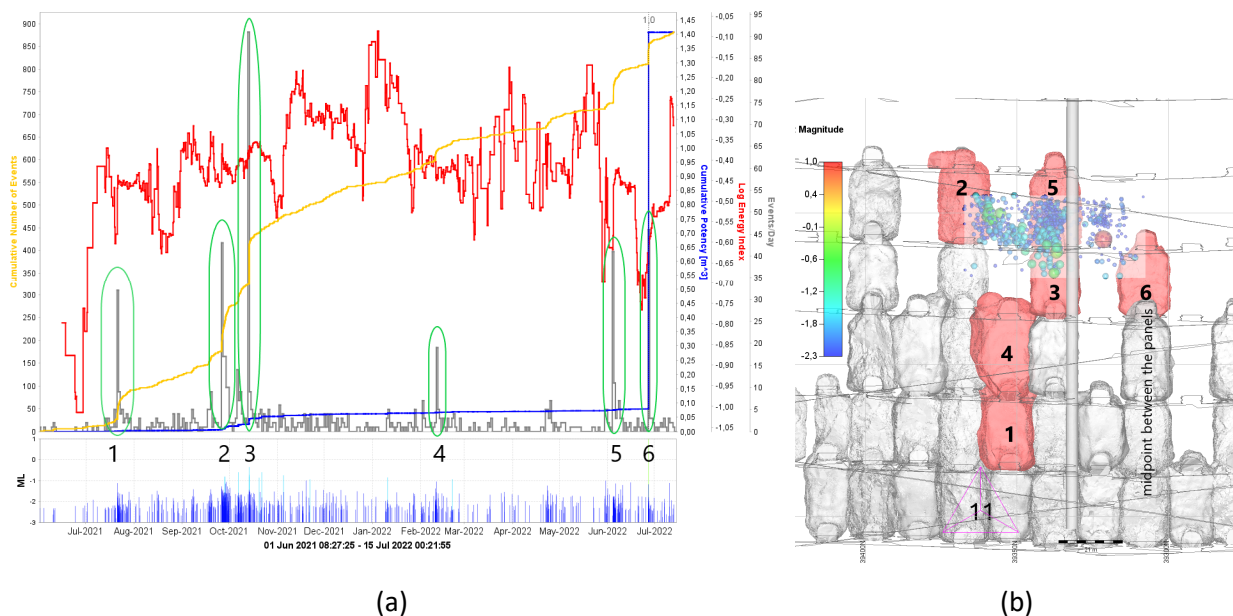
Time history of the immediate surrounding area (Figure 15) shows several increases in the event activity rate. The energy index shows a decrease before the event, indicating progressive weakening of the pillar. The location accuracy of the events in this area is < 10 m with an updated adaptive apparent velocity model (Nordström et al. 2017). The filtered event set in Figure 15 contains 882 events, 437 of which have a source mechanism calculated.

**Figure 15 (a) Time history of the area one year before the MW1.0 event. Increases in seismicity are marked with green ellipses, with numbering linked to mining of the stopes in (b); (b) Stopes that activated seismicity in the filtered area, with the dimension of filtering polygon l:58 m, w:34 m and h:27 m**

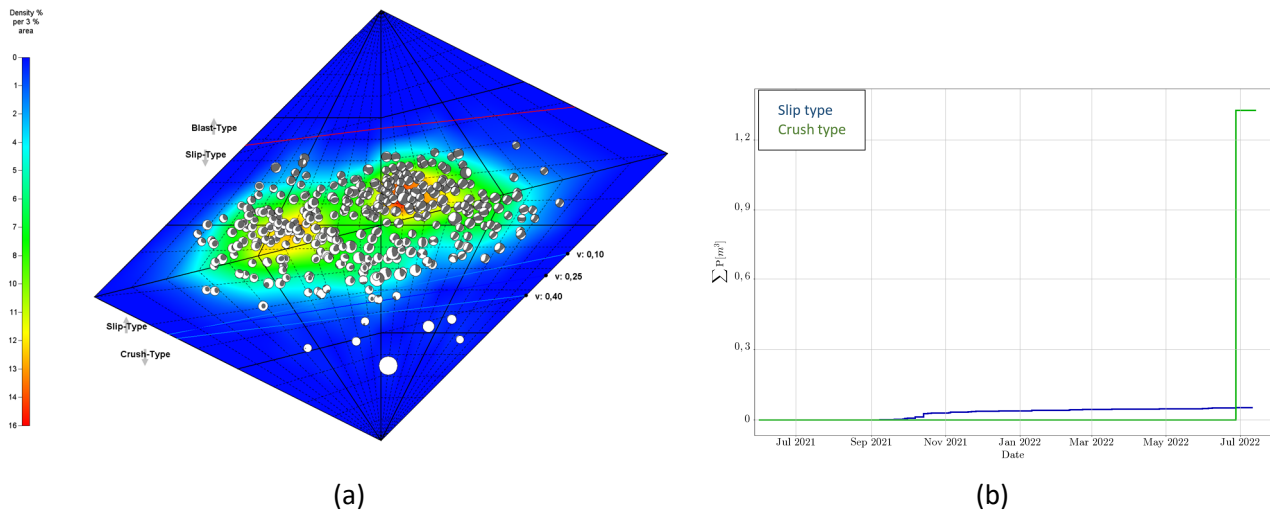
Most of the events are small slip-type events (Figures 16a and 17) along a structure set on the west wall of the footwall drive. Most of the damage was caused by the MW1.0 burst event with higher potency in comparison to slip events with a total cumulative potency of ~0.05 m<sup>3</sup> (Figure 16b).

**Figure 16 (a) Hudson plot of the filtered event set,  $MW > -2.3$ ; (b) Cumulative potency graph of the slip-type (blue) and crush-type (green) type events**

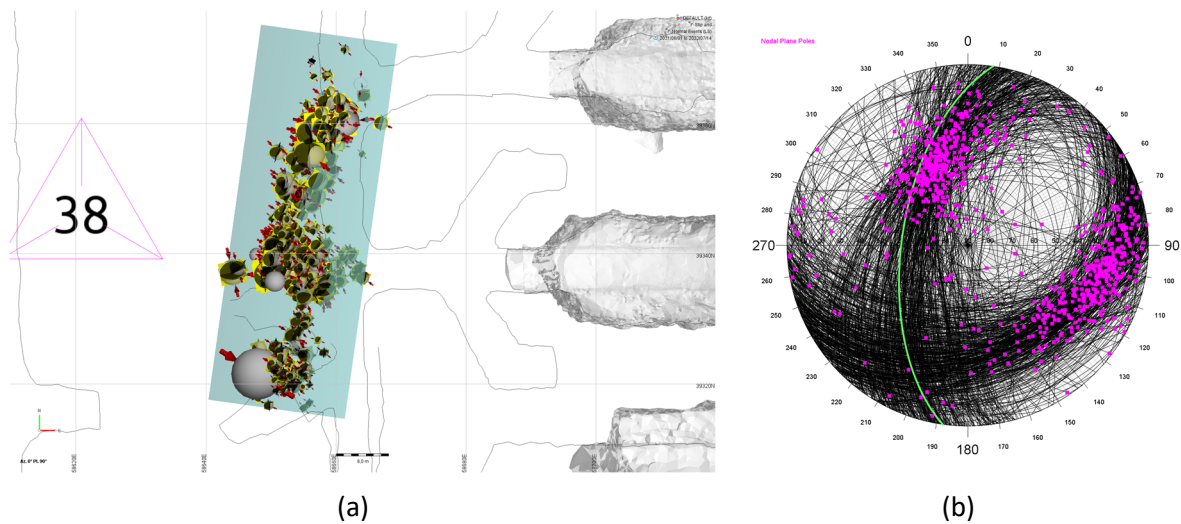
**Figure 17 (a) Level layout of the events with source mechanisms. Interpreted average plane of the structure ( $60^\circ/278^\circ$ , d/dd); (b) Stereonet plot of the event set nodal plane solutions with the inferred plane in green**

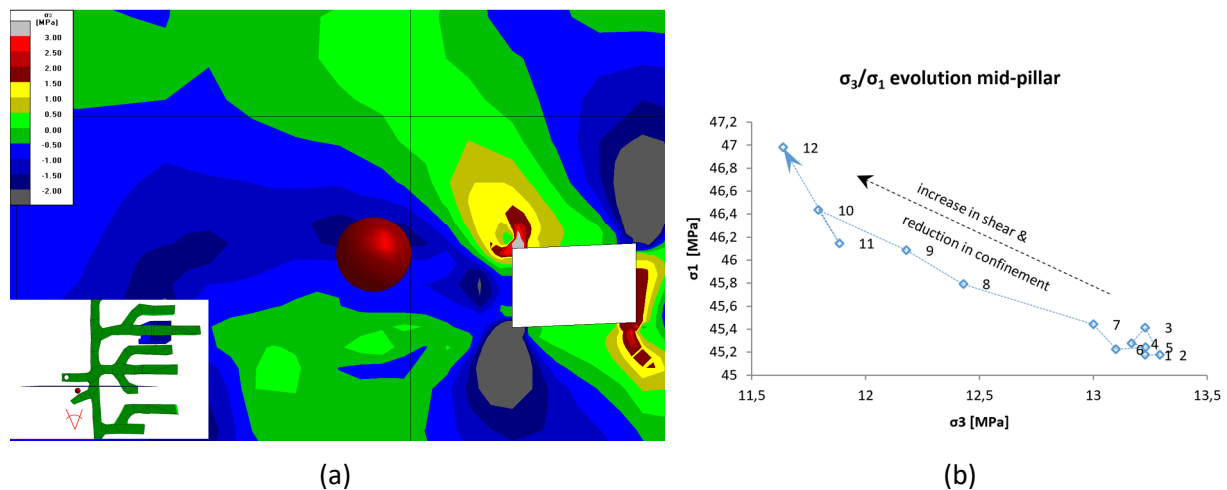
In order to verify the seismic data observations, a numerical elastic model was built to test the effect of the mining sequence on the local pillar and structure (Figure 18a). Mid-pillar confinement ( $\sigma_3$ ) decreases and loading ( $\sigma_1$ ) increases during the mining steps/stopping advancement, indicating progressive weakening of the pillar. In-plane normal stress ( $\sigma_{ip}$ ) decreases on the plane parallel to the weakness zone intersecting the pillar. Values from elastic modelling are indicative but concur with the actual monitoring results (Figure 18b).

**Figure 18** (a) Section view of the modelled change in the confinement/minor principal stress  $\sigma_3$  (from the year before to the time of the event) displayed on a vertical grid mid-pillar, MW1.0 event with red sphere, looking north, 25 m grid spacing. Similar viewpoint to Figure 13; (b)  $\sigma_3/\sigma_1$  evolution over modelled mining steps

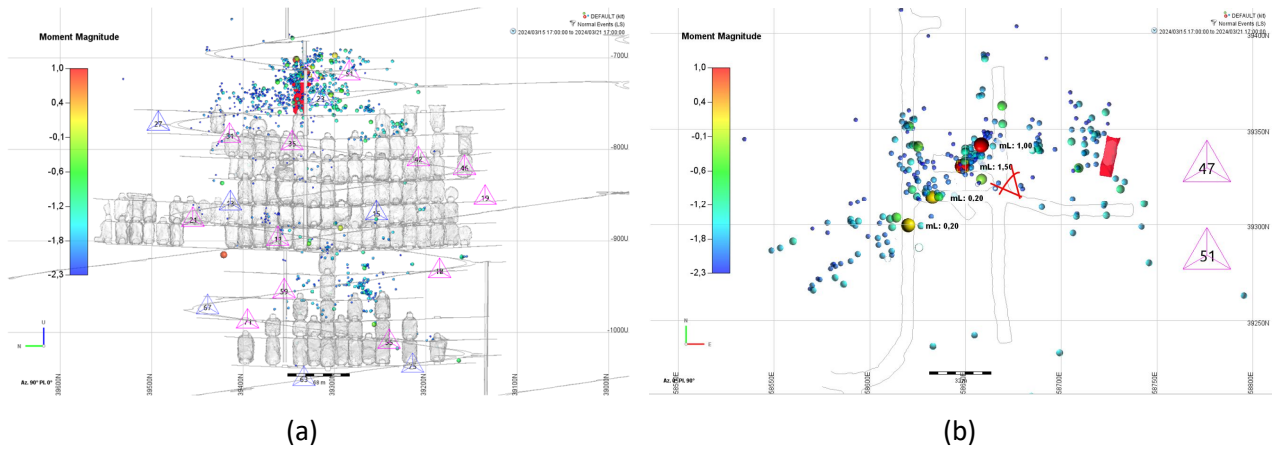
In March 2024, one hour after a nearby stope blast, a rockburst occurred on the X700 level (Figures 19 and 20). Three MW > 0 events were recorded in the area. MW1.5 waveform is complex, starting as a reverse faulting event. The MW1.0 event source mechanism is crush-type, indicating sub-vertical loading to the intersection area. Smaller slip-type events were located in the footwall area. Development design between the level access and the exhaust air raise left a very narrow pillar in between creating an area of high local extraction ratio. The area was supported with static ground support (FRS and resin grouted rebar) which proved inadequate for the dynamic loading. The intersection back (span  $\varnothing 10$  m) was also supported with 6 m-long cement grouted straight cables with plates in a  $2 \times 2$  m pattern as part of the standard ground support for intersections. The cabled back remained stable.

**Figure 19** X700 level events six days after the initial MW1.5: (a) Longitudinal view of the events in Rimpi, With the blasted stope that triggered the MW1.5 event in red; (b) Layout of the X700 level. Viewpoint of Figure 20 marked in red

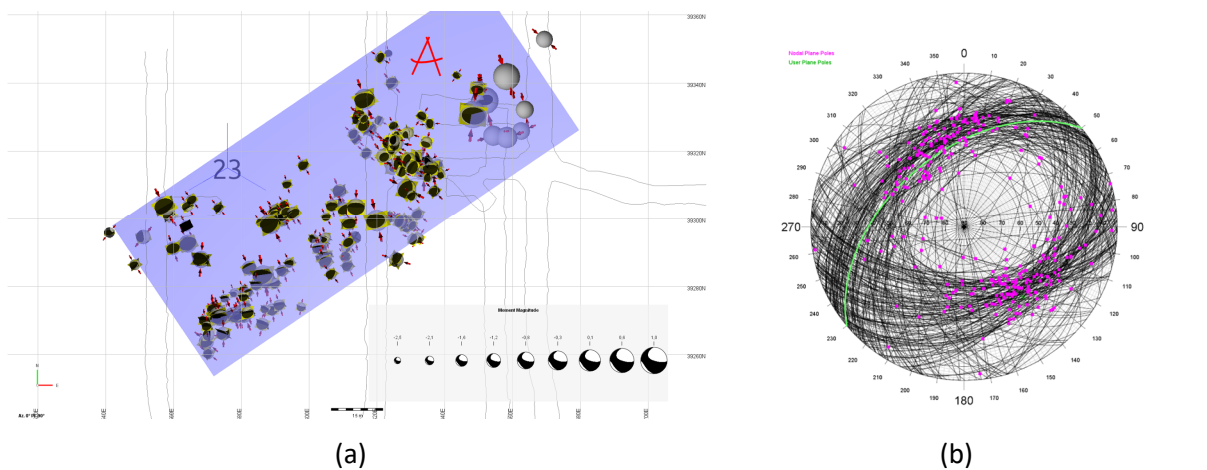
The cluster of larger events was located 25 m above the Rimpi stoping at X700 level. Increased activity in the area started after the nearby longitudinal stope blast and small increases in the overall activity rate can be linked to stope blasts. A planar cluster was interpreted from the event locations and nodal plane solutions, indicating a fault activation along 130 m strike length with a reverse slip source mechanism (Figure 21a).

**Figure 21** (a) X700 events around the identified northwest-dipping planar cluster (in blue). Figure 22 viewpoint marked in red; (b) Stereonet of the calculated nodal planes with the inferred plane in green

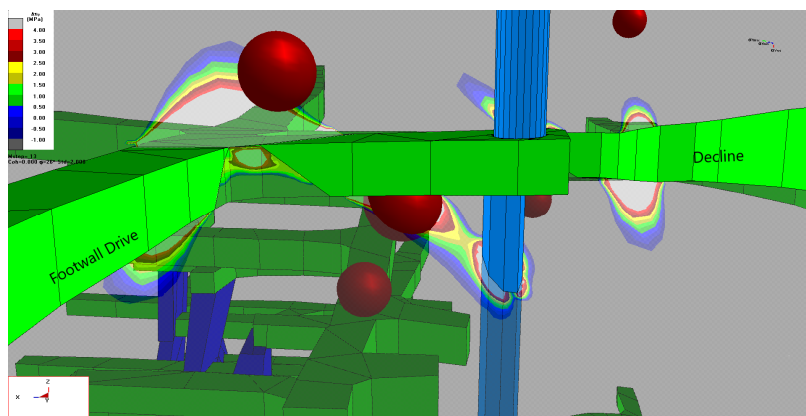
The model of the area highlights the narrow pillar in between the level access and the ventilation raise which matches the MW1.5 event location. The elastic model shows very small changes in excess shear stress between the mining steps, with the most critical factor being the fault plane location in relation to the development and ventilation raise (Figure 22).

**Figure 22 Modelled excess shear stress  $\Delta\tau_{ip}$  on the plane (cohesion  $c = 0^\circ$ , friction angle  $\varphi = 28^\circ$ ),  $MW > 0$  events plotted with red spheres. View looking south**
