# Rehabilitation of historical mine features: from mitigation towards true risk elimination

Erika Voyer <sup>a,\*</sup>, Jérémie Arsenault <sup>b</sup>

## Abstract

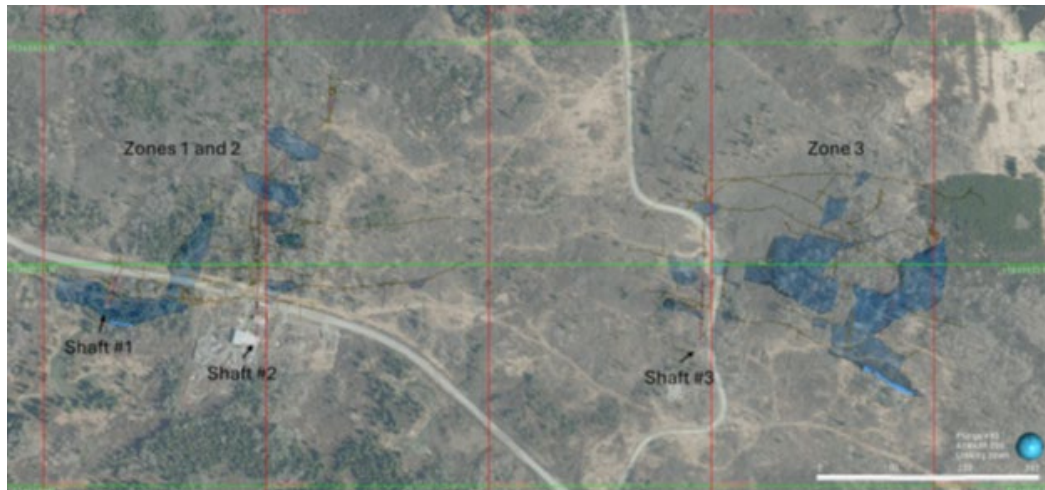
**Figure 4** Surface openings mine hazards location (blue zones are the stopes)

Near each shaft, several stopes were mined close to surface, leaving them open to surface with very thin crown pillars that may be unstable and at risk of failure (WSP 2025b). Figure 4 illustrates the locations of surface openings and the hazards specifically related to crown pillar conditions. This case study focuses on the recent investigation of shaft #3 and the East Open Stope, each presenting unique features, highlighting key findings and technical challenges.

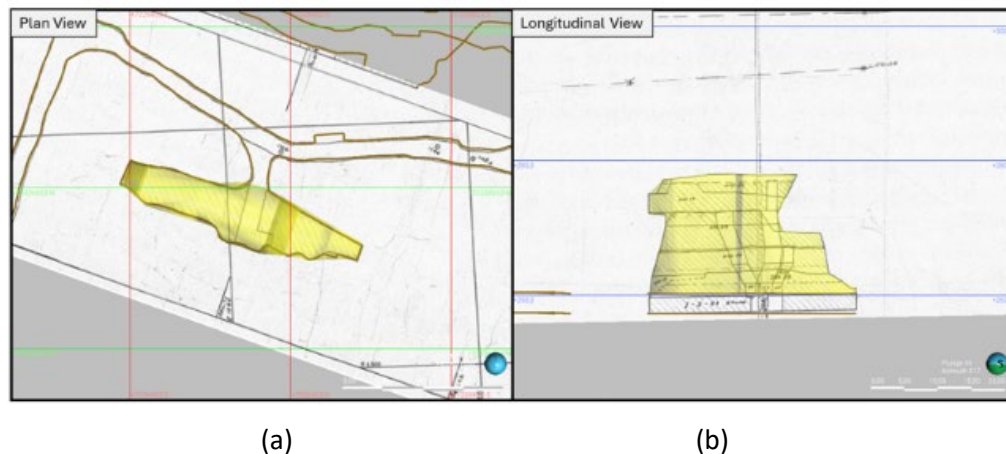
**Figure 7 Modelling of stopes 1-5-21 based on historical mine plan; (a) Plan view; (b) Longitudinal view**

At the outset of the project, a 3D model of site #1 mine was available for review. Historical mine plans and drawings produced were compiled and a 3D model for site #2 was constructed using Leapfrog Works. Figure 7 shows an example of the modelling of a stope based on the georeferenced mine plans. A site visit was also conducted to survey visible remaining surface infrastructure for comparison with the model and to provide confidence that the georeferencing was accurate.

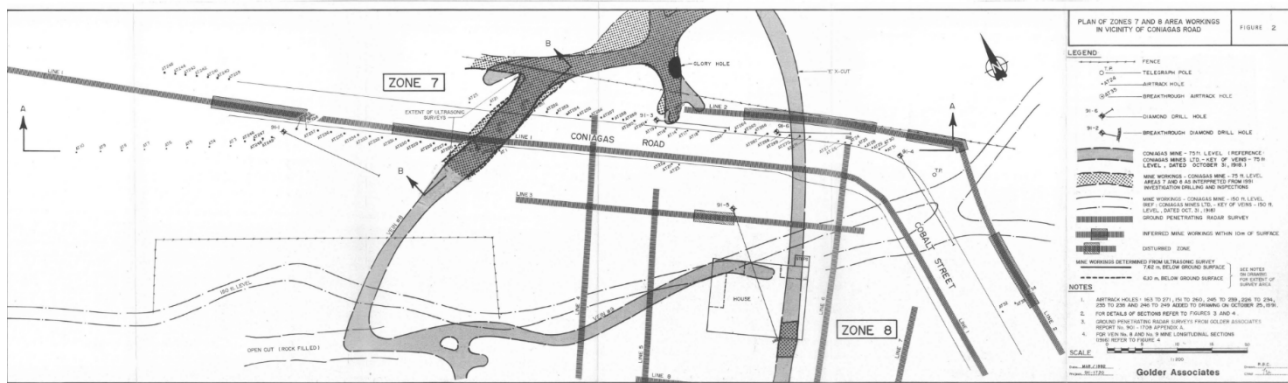
**Figure 10 Vein 9 stope plan drawing (Golder Associates 1992)**

The first data reviews, geophysical surveys and drilling investigations completed on the Vein 9 stope (Figure 9), indicated an undulating vein mined to surface in the west end and underground portion towards the east end (Figure 10). Based on the historical drawings and investigations by Golder, the width of the Vein 9 stope is approximately 5 m and it is 60 m long (striking NE–SW). Data also indicated the Vein 9 stope was partially backfilled with waste rock and included a wooden timbered floor. The open cut in the west end was backfilled to surface and secured with a mine hazard fence. Towards the west end of the Vein 9 stope is a residential property which has been reported to have had a surface subsidence event beneath the residential driveway (Golder Associates 1992).
