# Low-disturbance decharacterisation of a legacy bauxite tailings facility in the Brazilian Amazon: integrated drainage, revegetation and monitoring

<sup>a</sup> Mineração Rio do Norte, Brazil

*The SP-2/3 bauxite tailings storage facility is part of a 1,405 ha tailings disposal system on a plateau in the Brazilian Amazon, planned for progressive, integrated closure of its structure to restore land function and reintegrate the plateau landform. Constructed in 1988 for deposition of thickened tailings, SP-2/3 operated until 2000 when it became inactive and then the natural recovery process began, during a period of limited Brazilian requirements for dam decharacterisation. After approximately 20 years of rehabilitation and ecological re-establishment, it was necessary to develop a closure strategy aligned with Brazilian dam decharacterisation requirements (including ANM Resolution No. 95) and with international best practices, such as the Global Industry Standard on Tailings Management (GISTM), while preserving established vegetation and minimising disturbance to the tailings surface.*

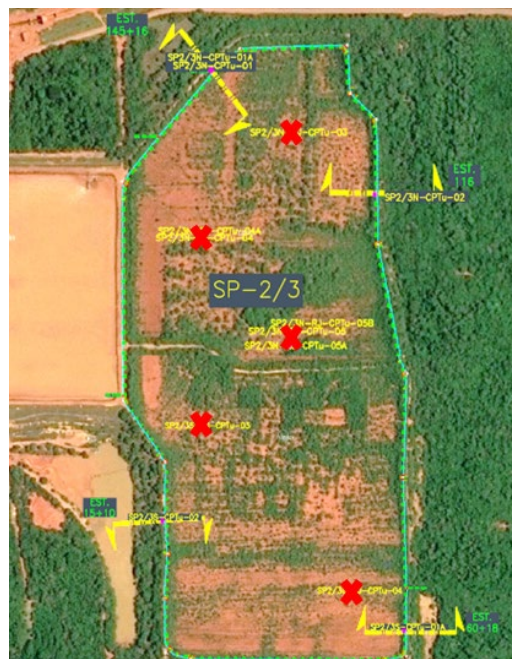
**Figure 2** Location of the CPTu tests within the impoundment

A geotechnical investigation campaign was undertaken in 2020 to support the diagnostic assessment of the deposited tailings and to inform low-disturbance closure decisions. The investigation included standard penetration test (SPT) soundings, sampling to determine solids content profiles with depth, and nine cone penetrometer with pore pressure measurement (CPTu) tests, 5 of which were performed within the impoundment footprint (Figure 2).

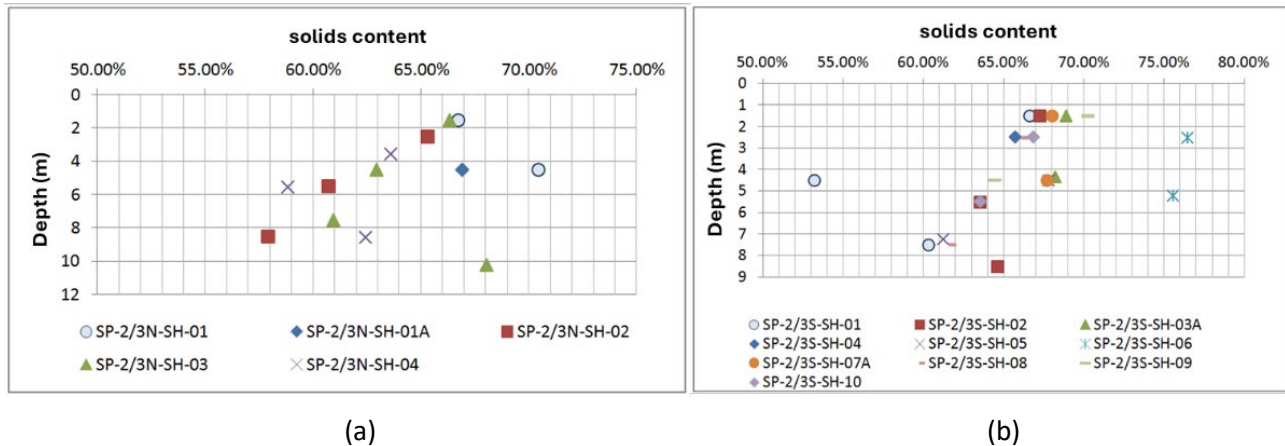
**Figure 3 Solids content profile; (a) Data from northern sector; (b) Data from southern sector**

Solids content profiles indicated values predominantly of 60–70%, without a strong systematic trend with depth. This behaviour suggests that the deposit had already reached an advanced state of consolidation following more than 20 years of inactivity after deposition ceased. Slightly higher solids contents (approaching 67%) observed in the shallow portion of the deposit are interpreted as the result of long-term desiccation processes, including evaporation and vegetation-driven evapotranspiration. Similar behaviour has been reported for fine bauxite tailings exposed to prolonged drying conditions, where desiccation can promote progressive moisture loss in near-surface layers (Feijó et al. 2025).

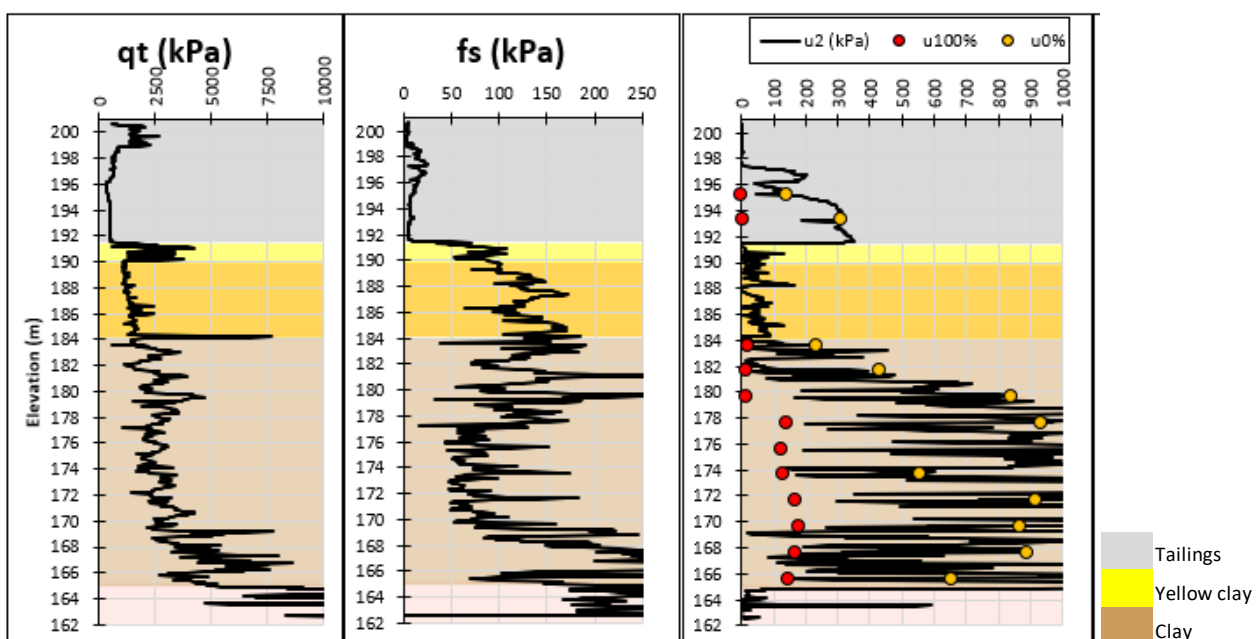
**Figure 4 CPTu test results obtained within the tailings impoundment**

CPTu results with dissipation testing were used to evaluate the tailings consolidation state and potential for long-term settlement. Cone tip resistance within the tailings layer was predominantly below ~750 kPa. Dissipation behaviour interpreted using the  $t_{50}$  parameter indicated rapid pore pressure dissipation, with excess pore pressures approaching zero at the tested locations. Figure 4 illustrates a representative result from CPTu testing, whereas Figure 5 presents one of the dissipation tests carried out in the tailings layer. This behaviour is consistent with the absence of persistent internal flow conditions that would indicate a stable phreatic surface within the impoundment. The results indicate that self-weight consolidation had largely occurred by the time of design, providing confidence in long-term surface stability and supporting the adoption of decharacterisation solutions based on low-disturbance interventions with minimal internal remobilisation of tailings.

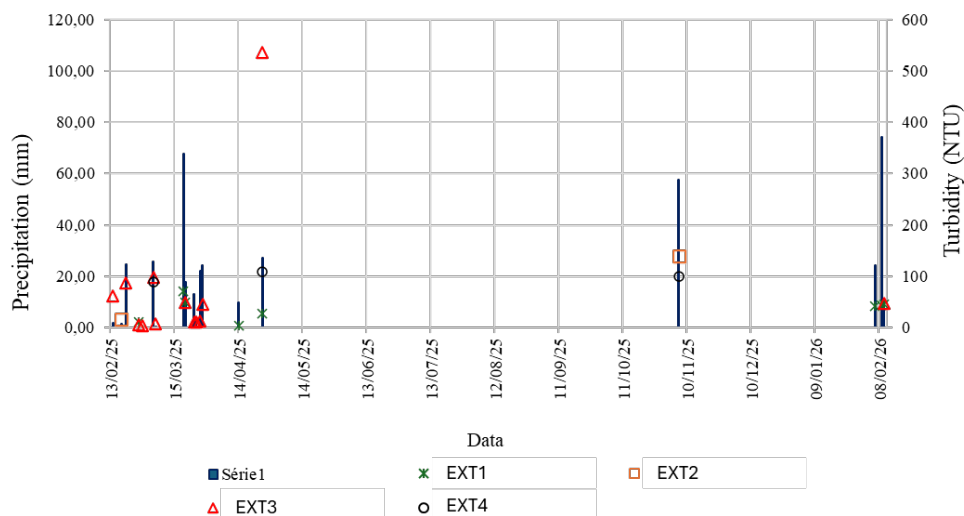
**Figure 9** Turbidity measurements and precipitation

Water quality analyses were conducted for turbidity (NTU) and settleable solids (mL/L), and results were evaluated in relation to rainfall events. As shown in Figure 9, turbidity values exhibited temporal variability across the monitoring points, with increases generally associated with precipitation events, reflecting sediment mobilisation driven by surface run-off during rainfall.

As shown in Figure 9, EXT-1 and EXT-2 exhibited moderate turbidity values, typically below 150 NTU, while EXT-4 showed an intermediate behaviour with occasional increases during rainfall events. EXT-3 recorded a single isolated event of elevated turbidity. These responses are consistent with the early post-construction phase, when some areas remained under progressive vegetation establishment and surface stabilisation.

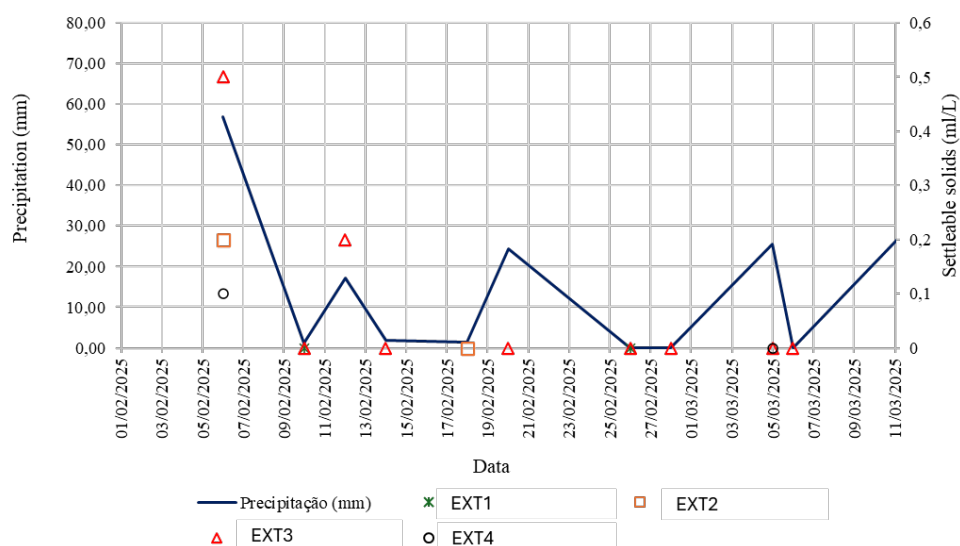
**Figure 10 Variation of settleable solids (mL/L) over the monitoring period, correlated with precipitation events**

Settleable solids were assessed using a 1-hour Imhoff cone test, as required by CONAMA Resolution No. 430/2011 (CONAMA 2011), which establishes a maximum allowable limit of 1.0 mL/L for effluent discharge into surface water bodies. Furthermore, for receiving environments with negligible circulation velocity, such as lakes and lagoons, settleable materials are required to be virtually absent due to their cumulative depositional impact.

Monitoring results presented in Figure 10 show that settleable solids were predominantly below 0.2 mL/L across all discharge points throughout the monitored period. These values represent performance significantly better than the regulatory limit and are consistent with the technical interpretation of 'virtual absence' of settleable solids for low-energy receiving environments.
