# Innovative Mine Closure Design Based on Observations of Mine and Natural Analogues

**D.J. Williams** *The University of Queensland, Australia*

**J.T. Kline** *BHP Copper, San Manuel Mine, USA*

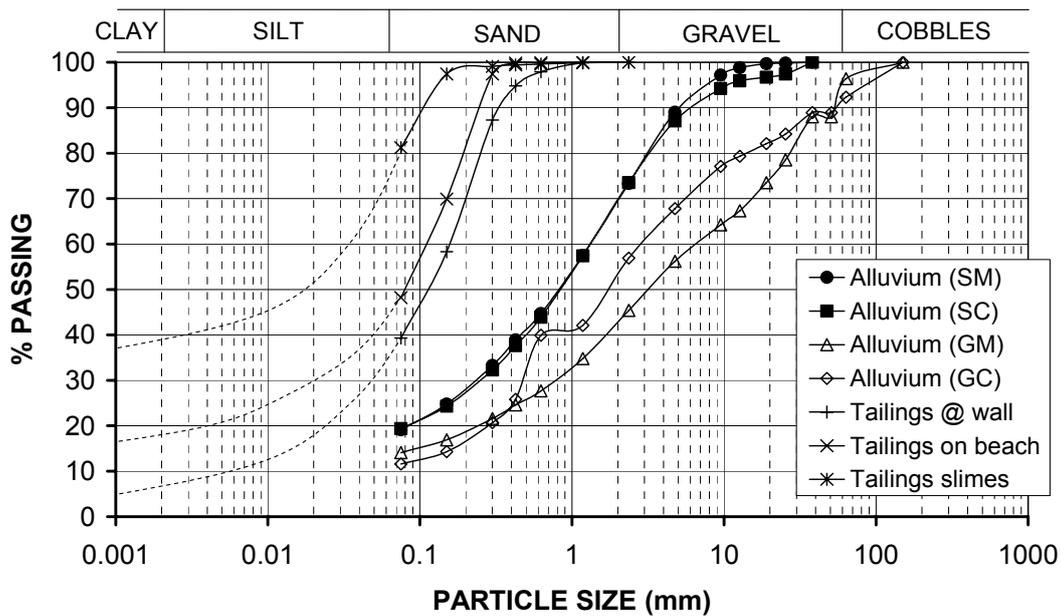
**Figure 1** Typical particle size distribution curves for tailings and natural alluvium

The natural soils in the region comprise coarse-grained alluvium in the vicinity of 5 and 6 Dams, and fine-grained alluvium (up to about 25 mm in size) elsewhere. Figure 1 shows typical particle size distribution curves for the natural fine-grained alluvium (Unified Soil Classification SM and SC) and coarse-grained alluvium (Unified Soil Classification GM and GC). The fine-grained alluvium is dominated by rounded, sand-sized particles, with about 20% fines, while the coarse-grained alluvium is a sandy gravel with 10 to 15% fines. Also shown on Figure 1 are typical particle size distribution curves for the tailings at the wall, on the beach and in the slimes pond. The San Manuel tailings are silty sand-sized on average (see Figure 1), with the pond tailings (slimes) somewhat finer-grained than the beach and wall tailings, with saturated hydraulic conductivities of about  $10^{-6}$  m/s and  $10^{-5}$  to  $10^{-4}$  m/s, respectively.
