Extraction of Two Sill Pillars Under Paste Backfill at Louvicourt Mine, Canada

C. Doucet, *Natural Resources Canada, CANMET Mining and Mineral Sciences Laboratories*

S. Lampron, B. Bisson, R. Harrisson, *Aur Resources, Louvicourt Mine, Canada*

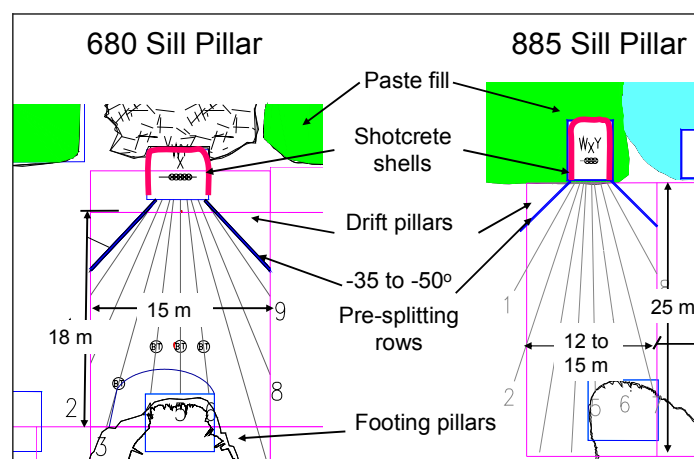
The primary stope design was relatively simple, since they are surrounded by rock on two sides. Initially, a skin pillar was left in the stopes located under poor quality paste. Modelling revealed that regardless of paste quality, the stope back would remain stable as long as drift pillars located on each side of the drill drifts were stable and shotcrete was used. Special care was taken when blasting the stopes to ensure the stability of the drift pillars, which would ultimately be crucial for the stability of the secondary stopes. This was achieved by using emulsion explosives and electronic caps. Figure 3 shows the primary stope designs for both sill pillars.

Figure 3 Primary stope designs – East-West sections looking North (not to scale)

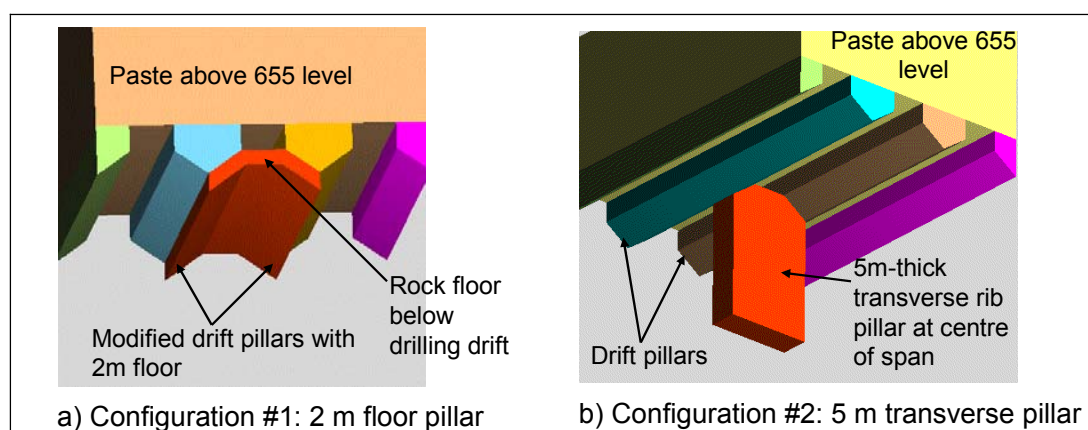
The secondary stope design considered many aspects: paste quality in the stope back, stability of the drill drift pillars in the adjacent stopes, in both the transverse and longitudinal directions. Three modified configurations were modelled using *3DEC* (Andrieux and O'Connor, 2004).

Of the three scenarios proposed, a combination of configurations 1 and 2 was used (Figure 4). A 4-m thick, arched skin pillar was designed, as opposed to the 2-m thickness modelled (Figure 5). The main disadvantage with this pillar design is that its stability depends on the degree of rockmass fracturing. To increase its stability, 4-m long cables were inserted between drilling rings for a 3 m by 2 m pattern. In the long accesses (where many stopes needed to be mined, such as panels 26 and 28 of the 680 sill pillar), 6-m thick transverse pillars were located in less fractured and lower grade zones.

Figure 4 Secondary stopes configurations modelled with 3DEC (after Andrieux and O'Connor, 2004)

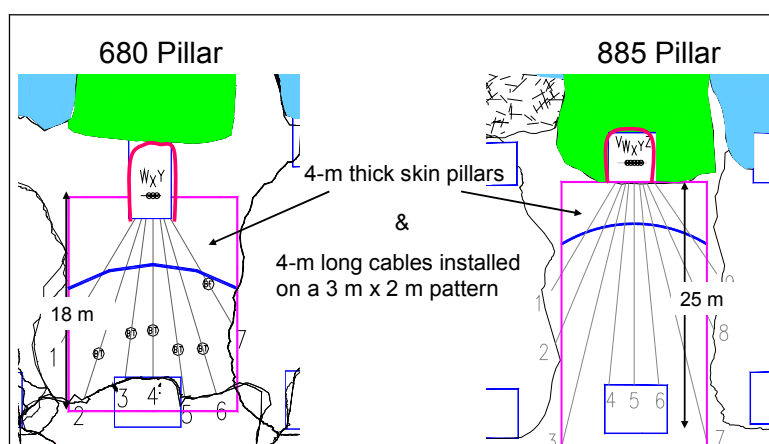
Figure 5 Secondary stope designs – East-West sections looking North (not to scale)

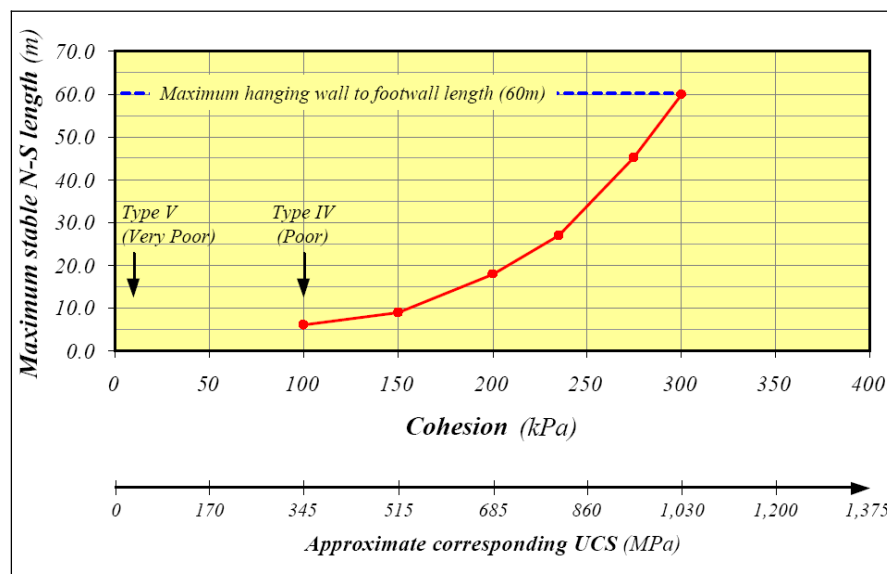
Stope lengths were determined with the help of numerical modelling results. The original 15-m length was later increased beyond the modelling results, as the mine gained experience and confidence with mining secondary stopes under paste. A risk assessment was performed on the probability of failure of the skin

pillar and the shotcrete shell. The shotcrete shell designs having a high factor of safety, it was felt that the probability of complete failure was low. In order to evaluate the worst case scenario i.e. if complete skin pillar failure and the shotcrete shell rupture were to occur, thus exposing backfill in the back on the entire stope width (15 m), a model of an open secondary stope with various paste qualities in the back was constructed. Stable exposed fill lengths on a width of 15 m were determined for various paste qualities and the results plotted in Figure 6. It shows that a poor quality paste can be exposed on surface of 15 m by 6 m. Paste was exposed in only two occurrences which are discussed in the next section.

Figure 6 Evaluation of stable secondary stopes lengths (after Andrieux and O'Connor, 2004)
