Assessing the flowability of bauxite tailings at East Weipa, Queensland

D.J. Williams *The University of Queensland, Australia*

G. Price *Golder Associates Pty Ltd, Australia*

H. Li *Rio Tinto Alcan, Australia*

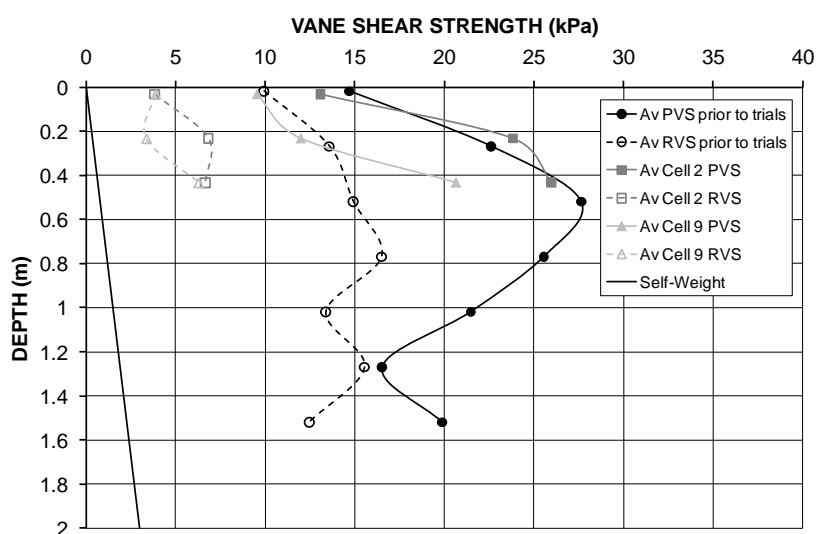
Figure 4 shows average vane shear strength profiles with depth in East Weipa bauxite tailings, including the average peak and remoulded vane shear (PVS and RVS) profiles in the 2 week old desiccated tailings located in the vicinity of Cells 2 and 9 tested prior to the trials, and the average profiles for 2 day old tailings in Cells 2 and 9. Also shown in Figure 4 is the estimated (based on previous measurements in similar tailings) shear strength profile due to self-weight settling of the tailings only, which increases from zero at the ground surface at a rate of 1.5 kPa/m depth, or about 0.22 times the vertical effective stress.

Figure 4 Average vane shear strength profiles with depth

It is clear that all of the tailings beaches were on average well-drained and desiccated by the time of testing (2 days to 2 weeks old), since they all plot well to the right of the self-weight only profile. The coincidence of the average peak vane shear strength profiles for the 2 week old tailings beach and the 2 day old Cell 2 beach demonstrate little increase in strength between 2 days and 2 weeks, due to rapid drainage. However, the average peak vane shear strength of the 2 day old Cell 9 closed-ended beach is about two-thirds that of the other two, due to the capture and retention of fines, and drainage at the end of the beach being restricted.

For the 2 week old tailings beach, the average remoulded to peak vane shear strength ratio was about 0.65. For the 2 day old tailings beaches, this ratio was only 0.3–0.4, indicating that the remoulded vane shear strength was much less well developed after 2 days than after 2 weeks.

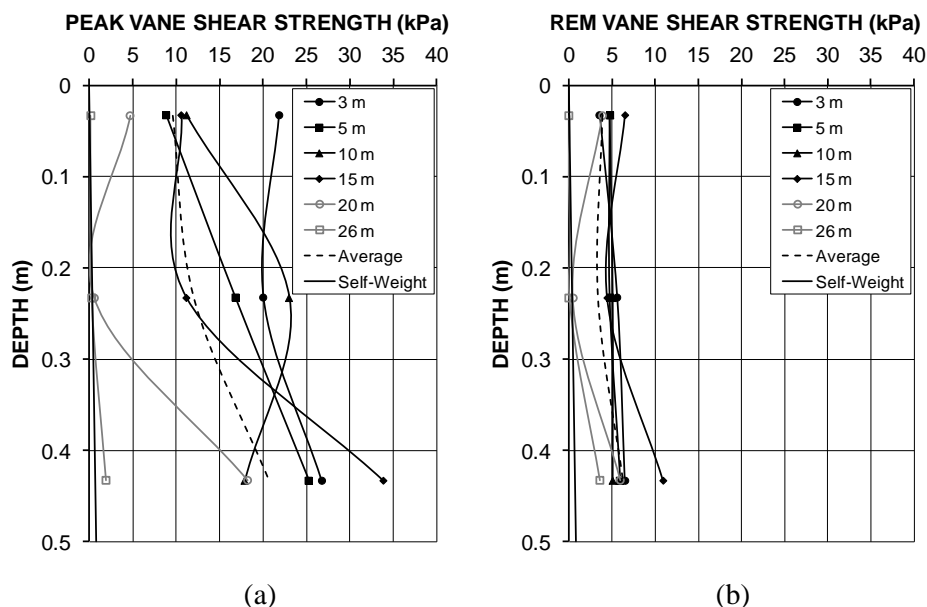
Figure 5 shows the peak and remoulded vane shear strength depth profiles with distance down the 2 day old closed-ended Cell 9 beach. The closed end is a worst case, forcing the capture of fines and restricting the drainage of the beach, which would not occur in practice. There is a very general trend of decreasing strength (both peak and remoulded) with increasing distance down the beach, as expected. Of key significance, at the closed end (26 m), where fines were trapped and water remained on the surface at the time of testing, the peak and remoulded vane shear strengths over the upper 0.25 m depth were at or below the self-weight profile. This location was the only one tested that showed the tailings to be flowable. Thus a criterion for flowability is that it occurs where the shear strength is at or below the self-weight only shear strength.

Figure 5 Closed-ended Cell 9 (a) peak and (b) remoulded vane shear strength profiles with depth

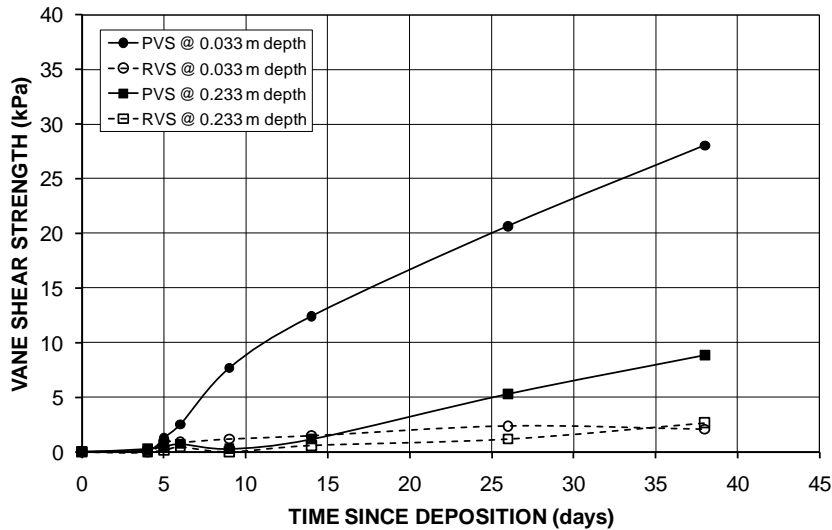
The increase in peak and remoulded vane shear strengths with time (as the tailings desiccate) for the closed end of Cell 9 at 26 m is shown in Figure 6. It is clear from Figure 6 that the near-surface shear strength kicked off about 5 days after deposition, while at 0.233 m depth this occurs more than 10 days after deposition. The increase in strength with time is clearly driven by solar-induced desiccation from the surface, rather than drainage, since the effect is very much more rapid and marked towards the surface. Despite the fine particle size distribution at this location, the near-surface peak vane shear strength rises to a high value of almost 30 kPa at 40 days after deposition. However, the near-surface remoulded vane shear strength remains low at less than one-tenth of the peak value.

Figure 6 Increase in vane shear strengths with time for closed end of Cell 9 at 26 m

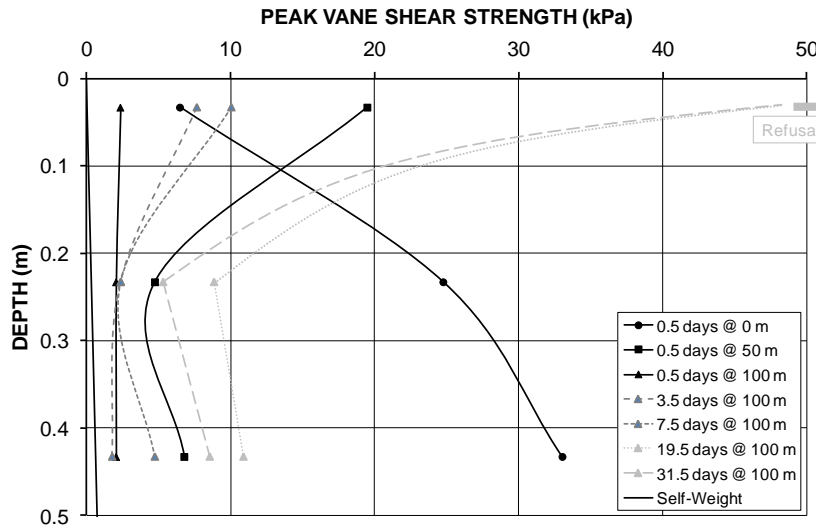
Figure 7 shows a general increase in peak vane shear strength for the spigot beach, for selected distances down the beach at selected times. The recent deposition of tailings at the top of the beach (0 m) limits the initial near-surface strength, while at depth the tailings at this location have had a chance to settle, drain and

consolidate to a high strength. Further down the beach (at 50 m and 100 m), the peak vane shear strength reaches a maximum towards the surface, dramatically increasing due to desiccation with time (as seen at 100 m down the beach), until it approaches a maximum value at about 20 days after deposition. At depth, the increase in the peak shear strength is much less dramatic, while it also reaches a maximum value in excess of 50 kPa at about 20 days after deposition.

Figure 7 Increase in peak vane shear strengths for spigot beach, with distance down beach and time

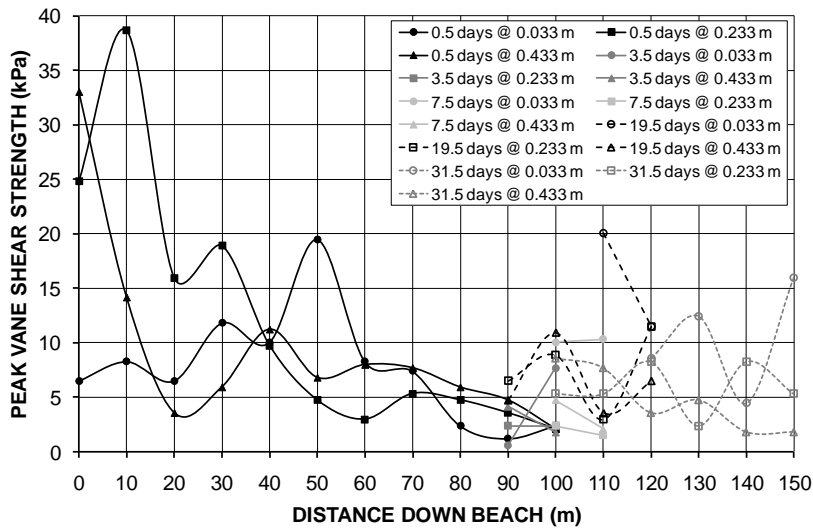
Figure 8 shows that to about 50 m down the spigot beach, the near-surface peak vane shear strength is initially reduced due to fresh deposition near the spigot, while the strength at depth is increased by settling, drainage and consolidation. Initially, from 50–100 m down the spigot beach, the peak vane shear strength reduces down the beach. Beyond 100 m down the spigot beach, with time the peak vane shear strength increases, particularly near the surface due to desiccation.

Figure 8 Increase in peak vane shear strengths along spigot beach, with depth and time

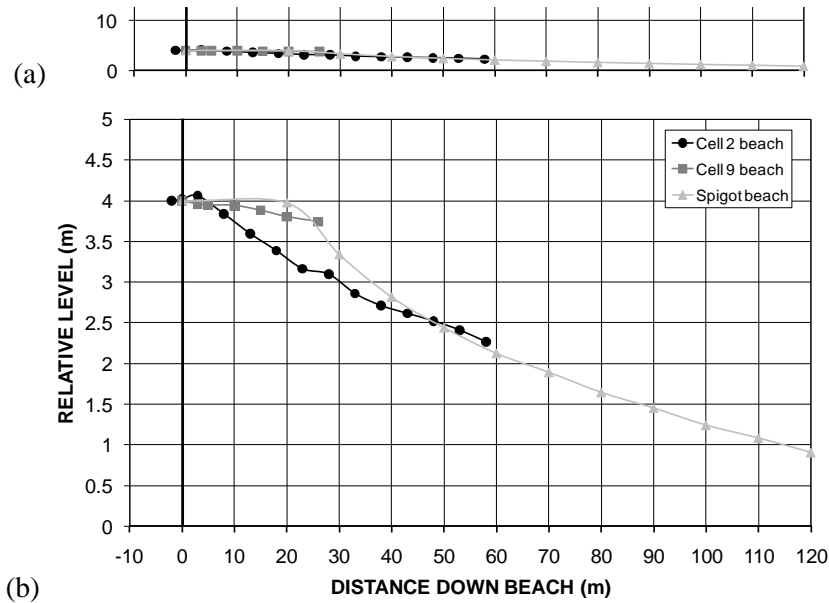
Figure 9 shows the profiles for Cells 2 and 9 and the spigot beach to natural and exaggerated vertical scales. The open-ended Cell 2 beach had an initial slope of about 5% (or about 2.8°) dropping to about 2.5% (or about 1.4°) from about 25 m down the beach. The closed-ended Cell 9 beach had an average slope of about 1% (or about 0.6°). The longer spigot beach had an average slope of about 3% (or about 1.8°). These beach slopes apply to the upper 26–120 m of the beach and hence would likely over-estimate the overall average beach slope, as suggested by the beach slopes in the range from 0.4–2% for beaches 200–600 m long reported by GHD (2009).

Figure 9 Beach profiles to (a) natural and (b) exaggerated vertical scales

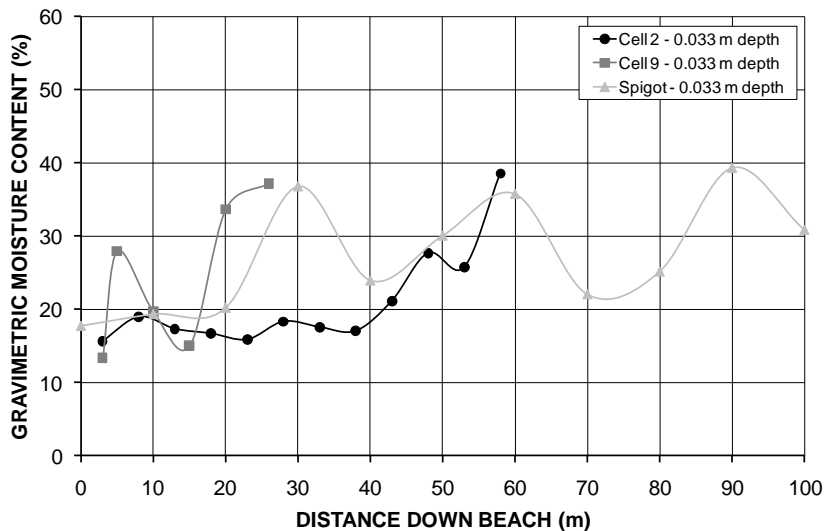
Figure 10 shows the gravimetric moisture content at 0.033 m depth with distance down each trial beach, with a general trend of increasing moisture content down each beach. This is expected due to the hydraulic sorting of particles down the beach, with the more free-draining coarse-grained particles dropping out towards the top of the beach and less well-draining finer-grained particles being carried further down the beach. Figure 11 shows the calculated dry density, with distance down the beach, for (assumed saturated) gravimetric moisture contents of greater than 30%. The calculated dry density shows a decreasing trend down the beaches. The average calculated dry density is about 1.30 g/cm³, and the maximum value is about 1.49 g/cm³, similar to the values reported by Swarbrick and Fell (1992), despite their testing being on fine-grained East Weipa bauxite tailings.

Figure 10 Gravimetric moisture content at 0.033 m depth, with distance down each trial beach

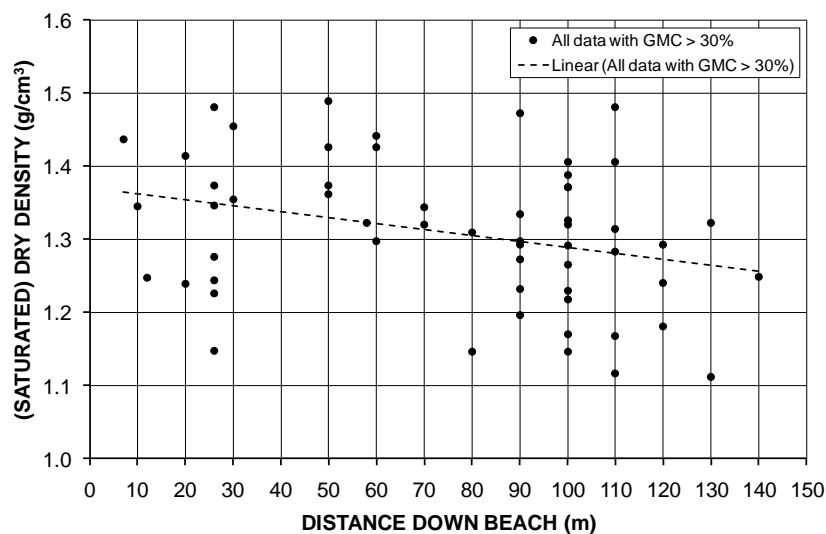
Figure 11 Calculated dry density, with distance down each trial beach, for (assumed saturated) gravimetric moisture contents of greater than 30%

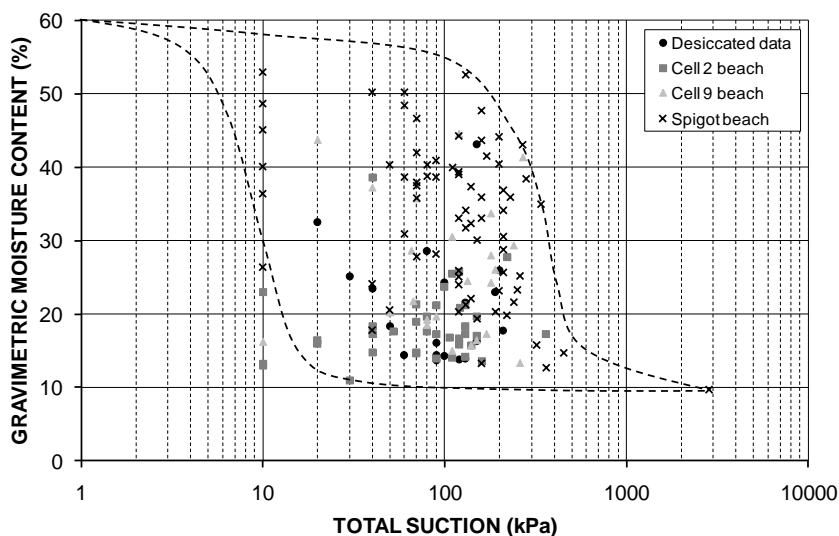
Figure 12 shows the considerable scatter of the as-sampled gravimetric moisture content versus total suction data for all of the desiccated and trial beach samples collected, which is partly due to the different particle size distributions of the samples. All of the samples collected, apart from the initial samples collected from the closed end of Cell 9 at 26 m down the beach, recorded a finite total (and hence matric) suction in the range from 10–3,000 kPa, and hence had experienced desiccation. It is noted that the spigot beach data show the most scatter since samples were collected over time from 0.5–31.5 days after deposition, and are hence affected by increasing desiccation with time as well as different particle size distributions.

Figure 12 Gravimetric moisture content versus total suction data for all desiccated and trial beach samples collected

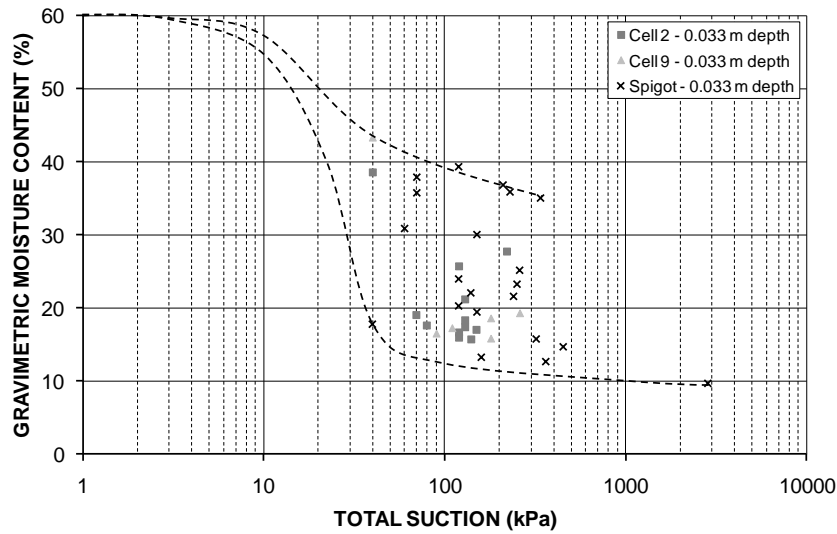
Figure 13 shows gravimetric moisture content versus total suction data at 0.033 m depth for all trial beaches. These data show much less scatter. They are for samples collected from near to the surface, and hence have been subjected to more desiccation, reducing the gravimetric moisture content to generally less than 40% and increasing the minimum suction to 40 kPa. However, these data are also affected by differences in the particle size distribution.

Figure 13 Gravimetric moisture content versus total suction data at 0.033 m depth, for all trial beaches

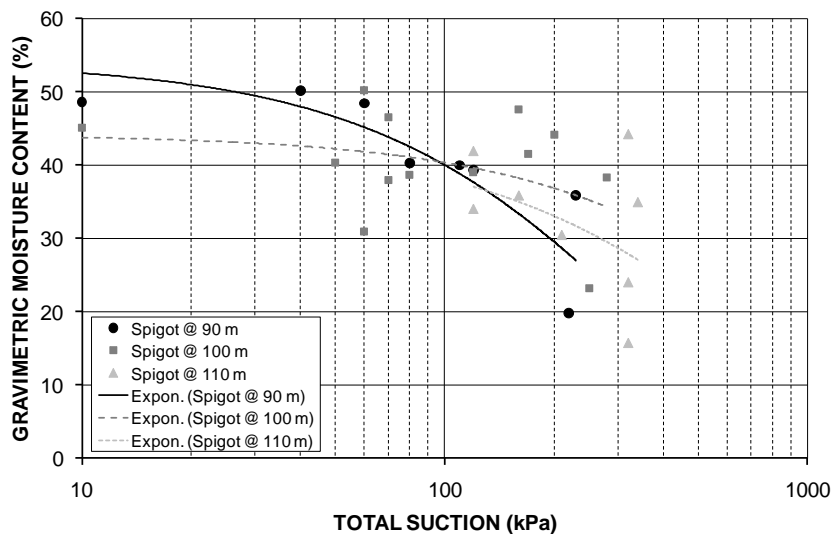
Figure 14 shows gravimetric moisture content versus total suction data for samples collected between 90 m and 110 m down the spigot beach over time. Being from a similar distance down the beach, these samples had a similar particle size distribution, and hence display more consistent (particle-size independent) trend lines.

Figure 14 Gravimetric moisture content versus total suction data for spigot beach from 90–110 m

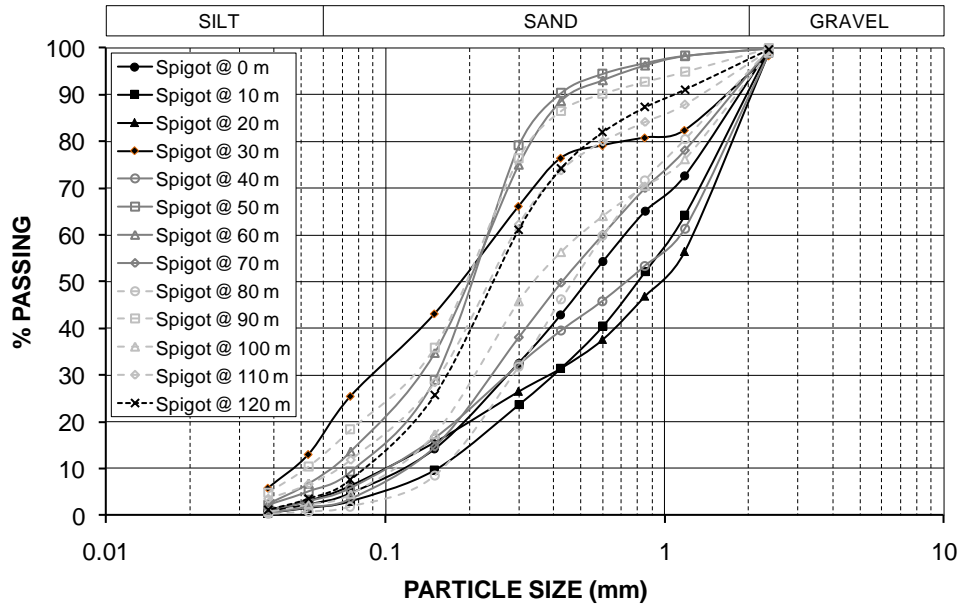
The particle size distribution curves obtained for the near-surface tailings (0.033 m depth) sampled with distance down the spigot beach are shown in Figure 15 to be gravelly silty sand, with up to 13% gravel, 78–90% sand, and up to 17% silt. Cell 2 beach samples covered a similar range, while the tailings captured on the closed-ended Cell 9 beach comprised an increasing proportion of medium to fine-grained sand at the expense of gravel and coarse-grained sand towards the closed end. Figure 16 shows plots of the median particle sizes D_{50} of the near-surface tailings (0.033 m depth) sampled down each of the trial beaches. The plots are reasonably well described by exponential trend lines, with the laterally confined Cells 2 and 9 beaches showing greater hydraulic sorting of particles than the spigot beach.

Figure 15 Particle size distribution curves for near-surface (0.033 m depth) tailings, sampled with distance down spigot beach

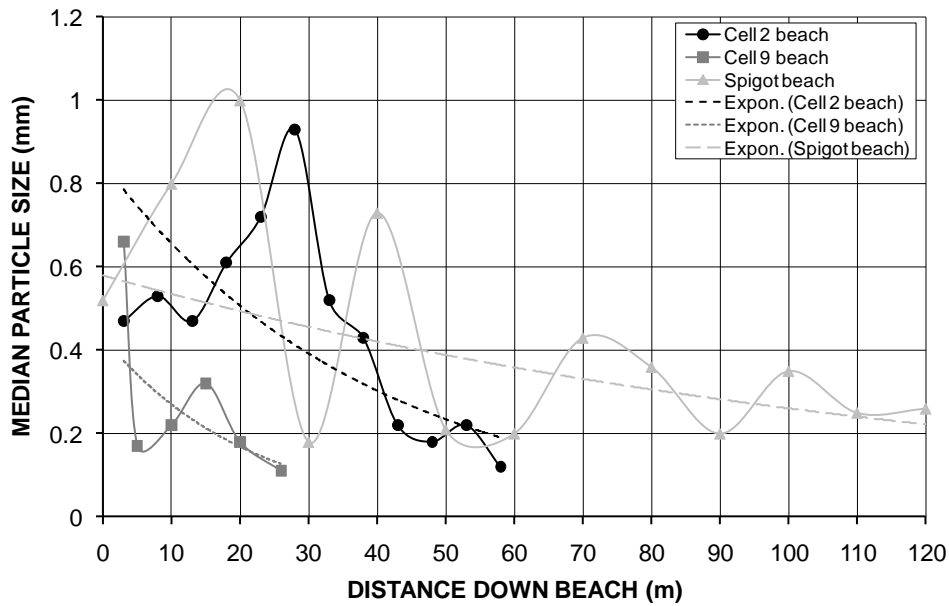
Figure 16 Median particle sizes of near-surface tailings (0.033 m depth), sampled with distance down trial beaches
