Lisheen Mine Tailings Management Facility – progressive reclamation project

S. Callery *Lisheen Mine, Vedanta Resources plc, Ireland*

Abstract

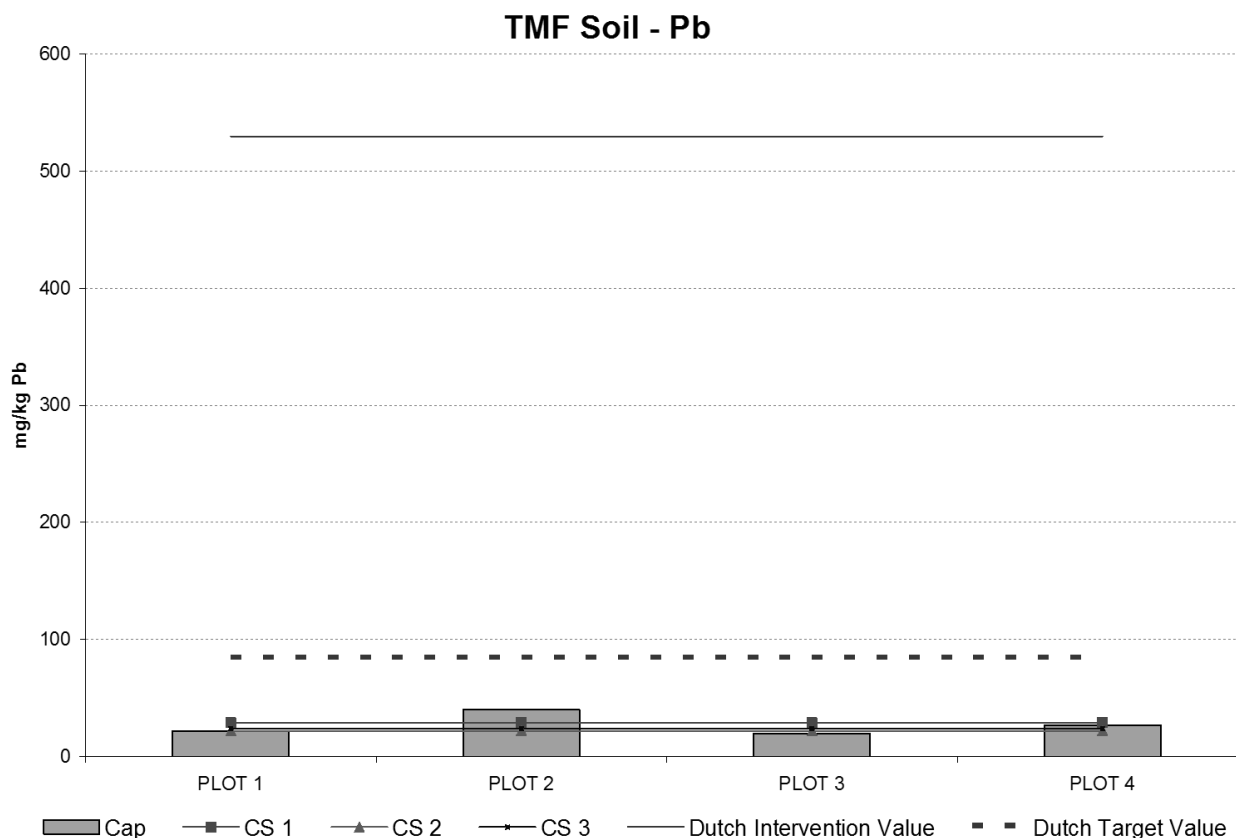
Figure 7 Typical Pb results from soil samples taken from Phase 1 rehabilitated section of the TMF

With regard to analysis of vegetation samples, vegetation analysis provides metal element profiles for above ground biomass and below ground biomass separately. This provides an indication of any metal uptake and partitioning by sequestration in either plant roots or shoots. The metal elements considered in vegetation analyses are S, Ca, Mg, Cu, Zn, B, Cl, Mo, Mn, Fe, Al, Si, Na, Pb, Cd and Hg. Results for soil testing were also compared against the ‘Dutch Values’ (Ministry of Housing, Spatial Planning and Environment, Netherlands 4th February 2000). Where applicable, the EU directive ‘2002/32/EC, on undesirable substances in animal feed’ was used as a guidance for the results of the vegetation analyses. An example of results received to date is given in Figure 7. CS 1 to 3 are Control Sites in the hinterland of the mine, ‘Cap’ is for composite samples taken on the rehabilitated section of the TMF.
