Design and management processes involved with extracting regional pillar stopes in a seismic setting at Darlot Gold Mine

Abstract

This paper outlines the protocols introduced for the management of potential seismic risk, including monitoring, numerical modelling, extraction sequencing and the necessary support upgrades to mitigate the risks at Darlot Gold Mine.

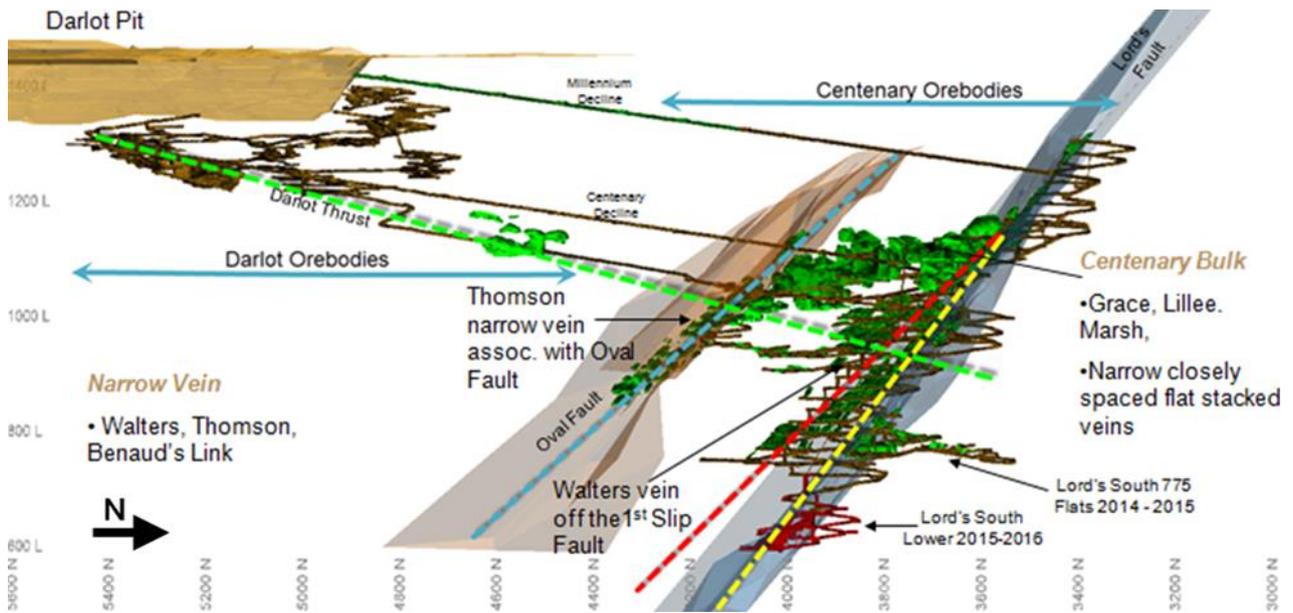
Figure 1 Darlot Gold Mine ore zones

Figure 1 shows the multiple ore zones currently extracted at Darlot. Gold mineralisation is predominately hosted in magnetic dolerite (85%) and magnetic quartz dolerite (8%). Mineralisation can also be found in the non-magnetic dolerite and felsic volcano-sedimentary rock types, typically in the following conditions:

The zone known as the Walters Lode is defined by a banded quartz vein. The vein varies from 50 cm to several metres in true thickness, with a 600 m strike length and extends 600 m down dip. Minor shallower dipping veining also occurs along the footwall (FW) and hanging wall (HW). The ore zone is hosted in very strong Dolerite (UCS = 220 MPa+) and is dominated by a regional fault structure known as the first slip fault. This fault varies in thickness with depth and is characterised by quartz intrusions, narrow alteration halos and a 0.5-1.0 m sheared contact zone along the plane. This leads to a poorer rock mass within the HW of stopes.

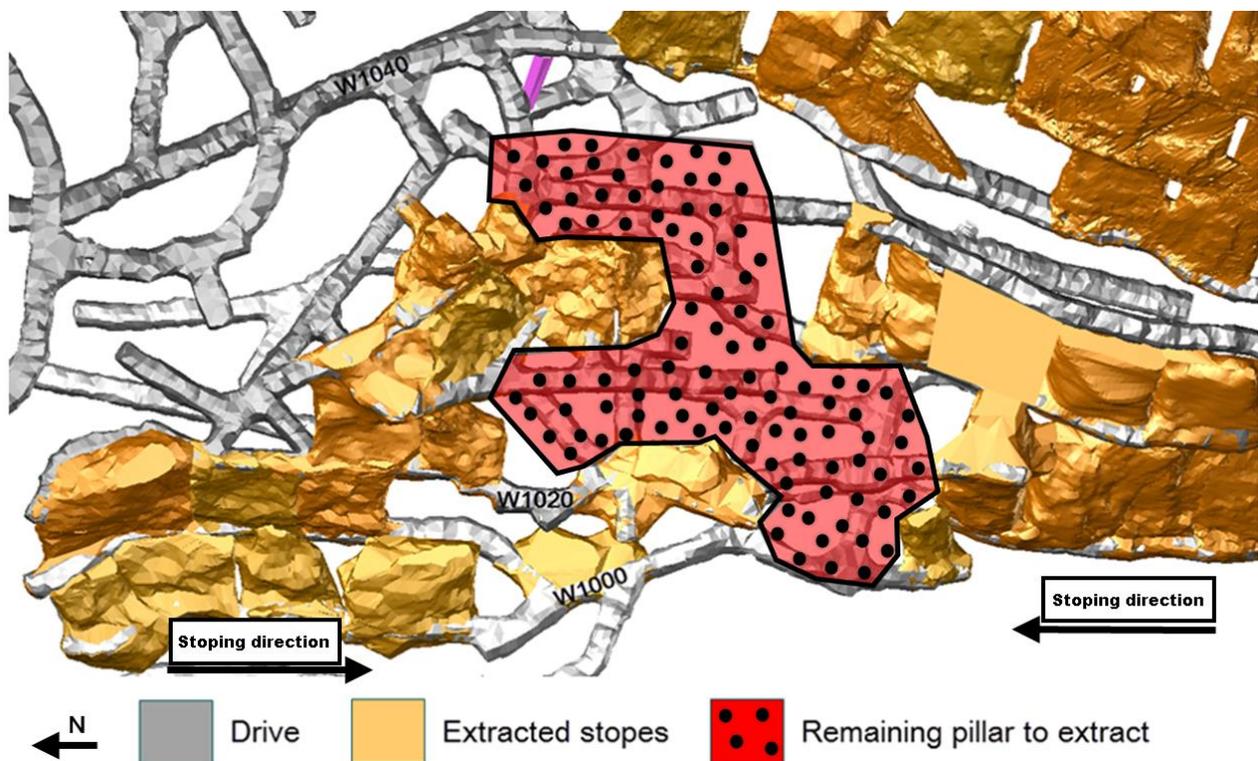
Figure 2 The remaining pillar as of September 2014

The Walters Lode was initially designed for extraction using a longhole retreat method towards a central access, which created a closure pillar and is illustrated in Figure 2. This initial extraction sequence utilised waste rock and cemented aggregate fill to mine a bottom up sequence. Rib and sill pillars were also used if ground conditions warranted them. Once paste backfill was introduced in 2006, the mining sequence changed to a top down mining method. This did not change the central pillar scenario, but enabled improved control of the unsupported stope spans, reduced the stoping cycle time, and reduced the damaging effects on the rock mass which could lead to fracturing and increased support requirements.

As the extraction sequence progressed, the stresses concentrated in the central pillar and other adjacent sill/rib pillars between stopes. Options for an alternative extraction sequences were reviewed, but were found to be unsatisfactory due to the main decline location and other nearby mining fronts encroaching on the area and because it was uneconomical to develop FW drives to provide dual access to the orebody.

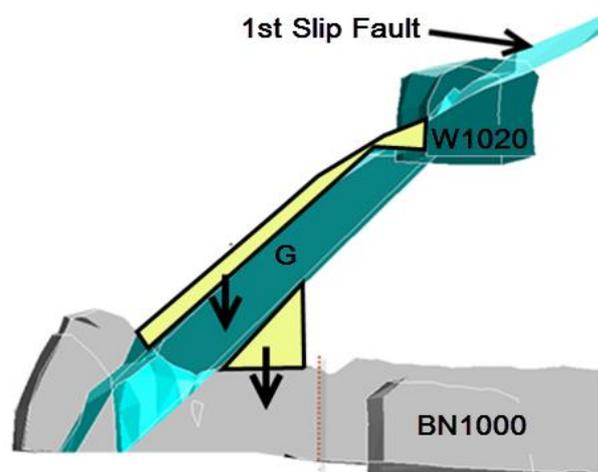
Figure 3 BN1000 HWN G Panel design cross-section

The stopes in the Walters Lode generally dip at 50° with HW parallel to the first slip fault. This is because the primary failure mechanism within the stopes is gravity wedge/slab failures associated with the HW breaking to the fault contact. Darlot Gold Mine also has a dominant horizontal joint set which interacts with the moderately dipping structures in the HW and increases the likelihood of failures or overbreak. An example stope design, along with potential failure zones within the Walters Lode, are shown in Figure 3.

Moderately dipping stopes have been predominantly designed with a hydraulic radius (HR) of 5.0 m to plot within the stable zone of the modified stability chart. This HR has proved successful when extracting alongside the first slip fault 20 × 20 m and allows a 20 × 20 m HW exposure.

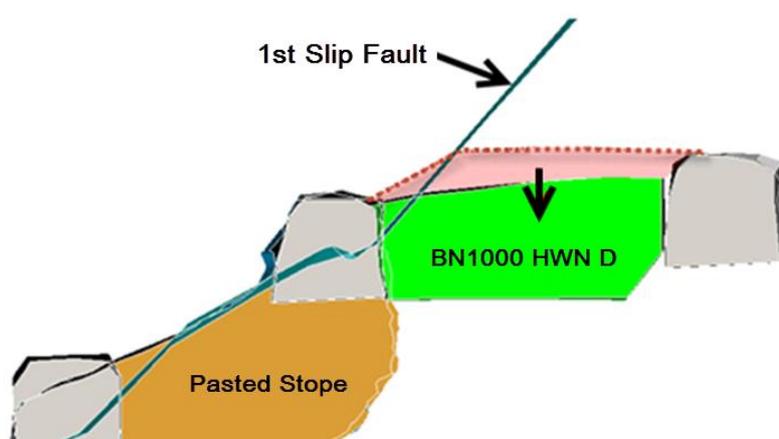
Figure 4 BN1000 HWN D failure scenario

All flat stoping areas are considered unstable at spans greater than a HR of 4.5 m. They have a higher risk, due to the increased potential of larger wedge failures, which can propagate up to the first slip fault. This HR constraint was put in place after a wedge failure within the Walters Lode stope occurred in early 2014. The stope was designed with a HR of 5.5 m with the first slip fault crossing the central backs at a 55° angle of intersection. The ore was extracted slowly under the full HW exposure, instead of prioritising quick extraction. This led to a large wedge failure in the central backs which diluted the remaining ore source and resulted in a production loss. Figure 4 shows this predicted extent of failure in more detail.

A long ‘stand-up time’ played a critical role in the performance of the stope, all flat back stopes are now designed with a HR value no larger than 4.5 m. The stope must be bogged clean between each firing and never left idle, or a production risk assessment must be completed to determine the production and financial impacts from potential wedge failures.

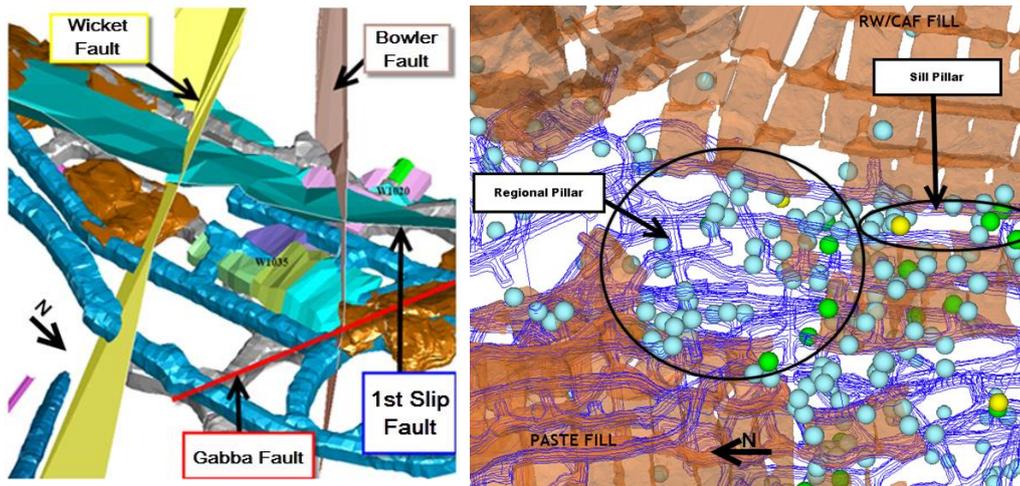
Figure 5 Fault structures and event distribution within the Walters Lode

As previously mentioned, the Walters Lode has one major and multiple smaller faults interacting with the ore zone, as illustrated in Figure 5. These smaller faults vary in seismic response as stope blasting occurs nearby. Back-analysis and review of the seismicity around the Walters Lode indicated that the first slip fault is the primary structure associated with seismicity.

Ongoing seismic analysis indicates extensive clustering on the first slip fault contact and in the HW rock mass, and it has also been calibrated as the source of the damaging seismic events. A summary of historical damaging seismic events within the stress window is displayed in Table 2.

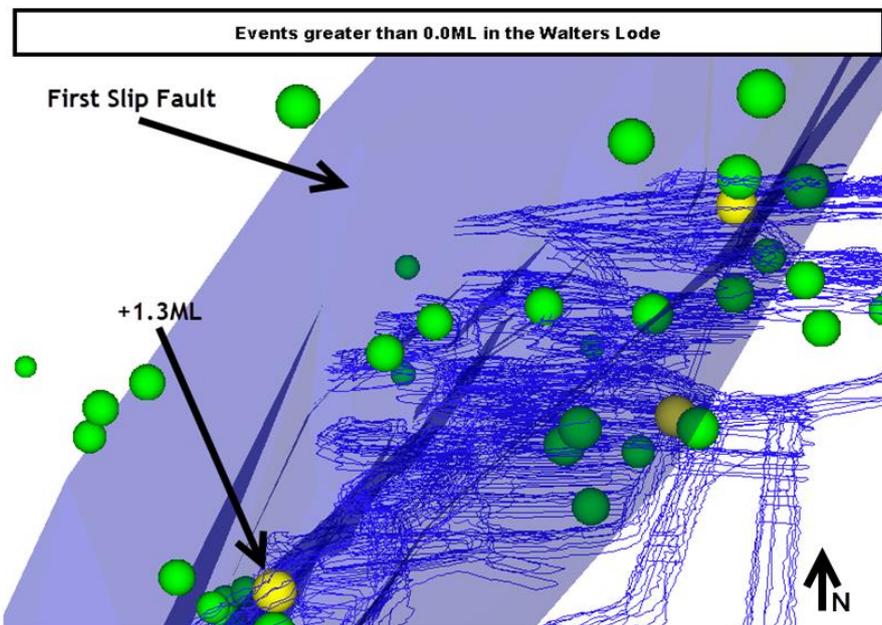
Figure 6 Seismic events >0.0 ML associated with first slip fault

The largest event 'recorded' on the system was an IMS local magnitude (M_L) of +1.3 on 20 February 2012, and it occurred forty minutes after firing a rise, which intersected the First Slip fault. This is illustrated in Figure 6.

Rise firings in the Walters Lode have been found to induce an elevated seismic response, and larger magnitude events, than standard stope firings into voids or existing rises. This increased level of seismicity from rise firings is thought to be due to the larger energy and vibration being transferred into the

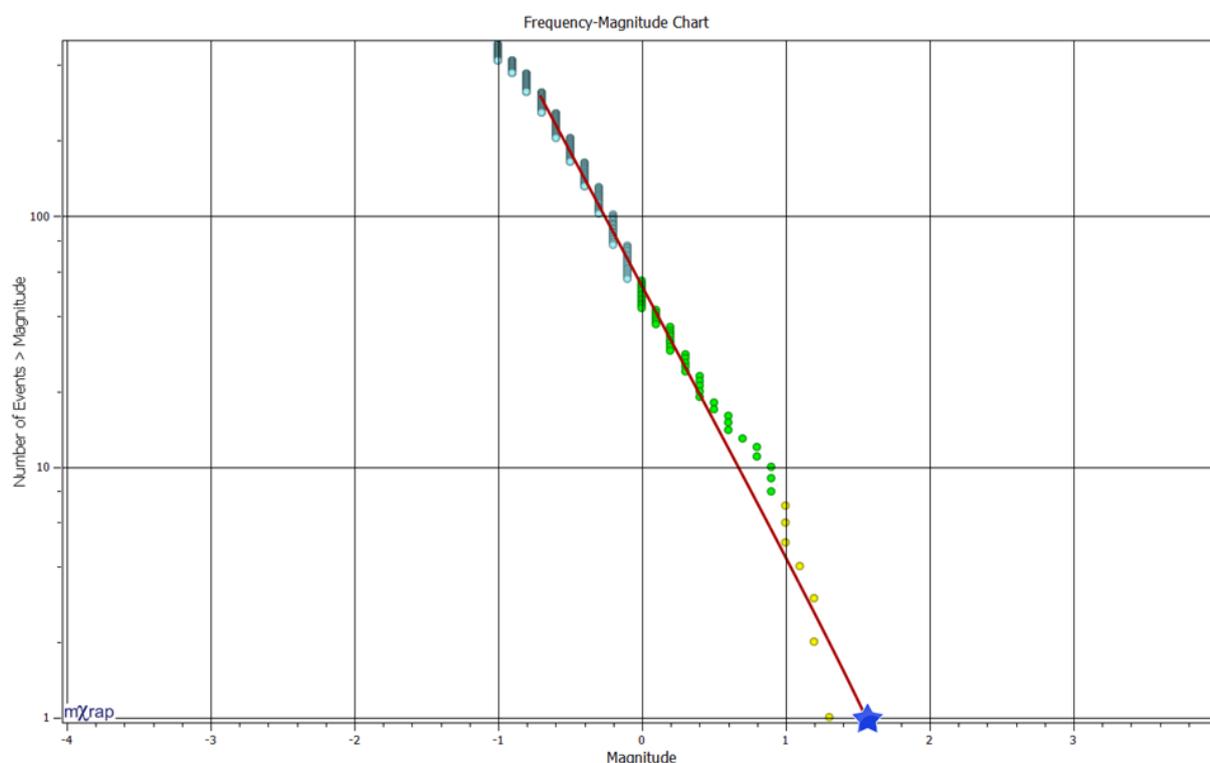
Figure 7 Frequency–magnitude graph

Determining the dynamic ground support requirements for the Walters Lode required the maximum potential event size to be assessed. This was calculated via the Gutenberg–Richter relationship (frequency-magnitude) distribution chart (Gutenberg & Richter 1944). The data set starts in November 2009 and shows an estimated design magnitude (x-axis intercept) M_L of +1.55. This is graphically shown in Figure 7. Based on this analysis, it was determined the initial support was not adequate for the largest potential seismic events.

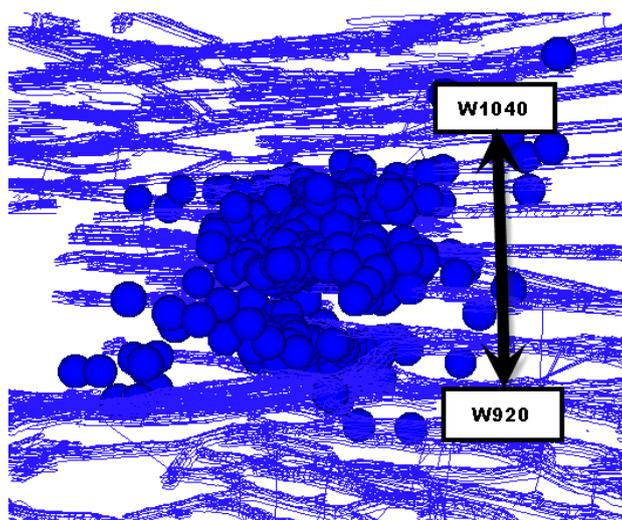
Figure 8 W1000 F Rise Firing 2012

Back-analysis of event distributions post firing the Walters Lode show events occurring between the W920 and W1040 along the first slip fault; this is illustrated in Figure 8. Most events are clustered around the fired stope; however, the damaging effects can be experienced along the fault planes and intersecting drives. Therefore, any stope firings within the Walters Lode incurs an exclusion zone between the W920 and W1040.

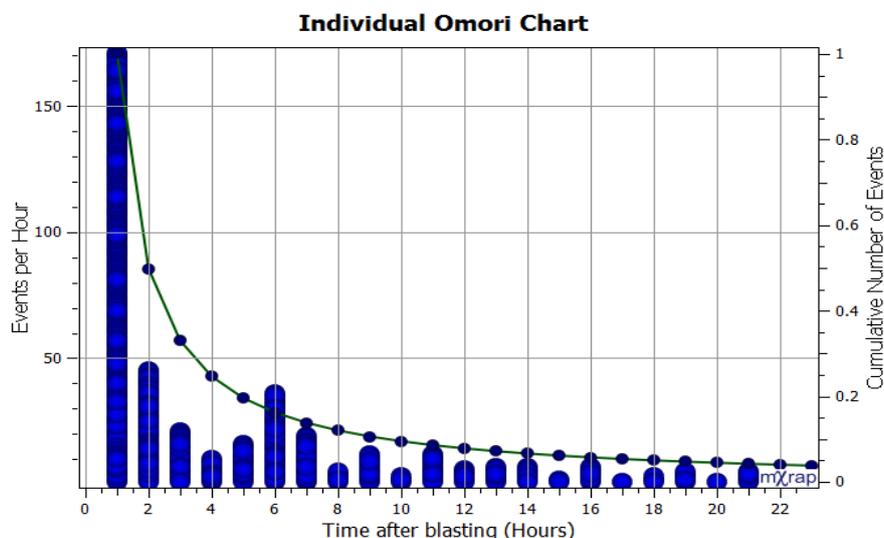
Figure 9 W1000 F Rise Omori Chart

Back-analysis of seismic activity after firing shows that the majority of events occur within the first hour in the Walters Lode. The actual events generally subside faster than the decay curve; however, spikes in the events per hour can occur randomly. These spikes do not necessarily intercept the decay curve; however, it does imply that there are seismic irregularities to account for before any personnel are granted access.

Back-analysis data shows that the level of seismicity decays to background levels within 18-20 hours, therefore the Walters Lode maintains a 24-hour standoff upon firing. An example of the Omori Chart is displayed in Figure 9.

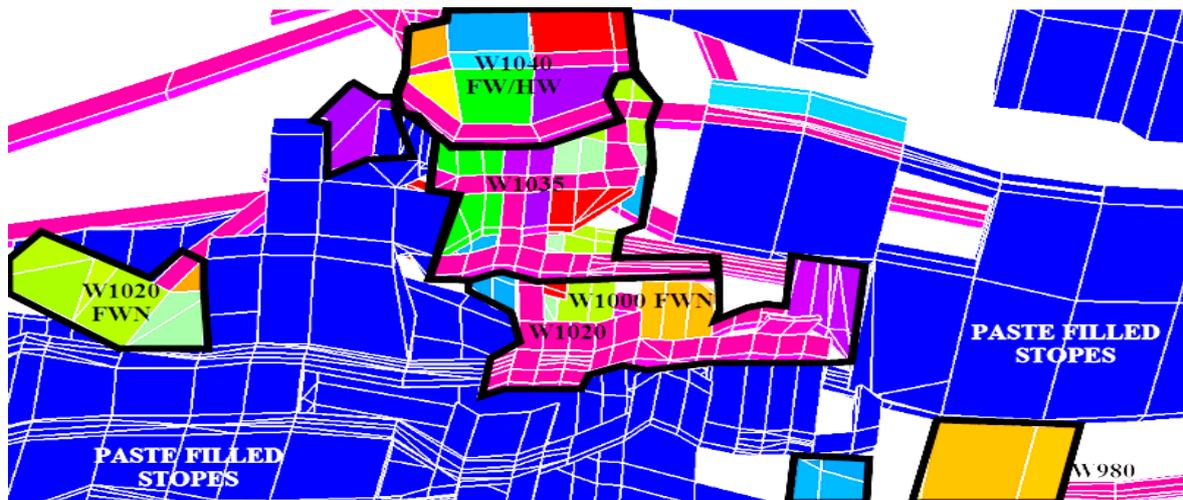
Figure 10 New proposed stopes alongside original stopes in July 2014 (perspective view looking east)

Since the non-linear model was conducted, in-house elastic numerical modelling was conducted due to the addition of new stopes outside the current extraction sequences (Figure 10). This modelling complemented the existing modelling to determine if there would be any new significant effects on the rock mass or stresses acting on the faults from further stope extraction. Back-analysis of historical failures and seismic events identified three criteria on which forward planning was made. Table 3 details the failure criterions that were assessed along rock mass parameters from Table 4.

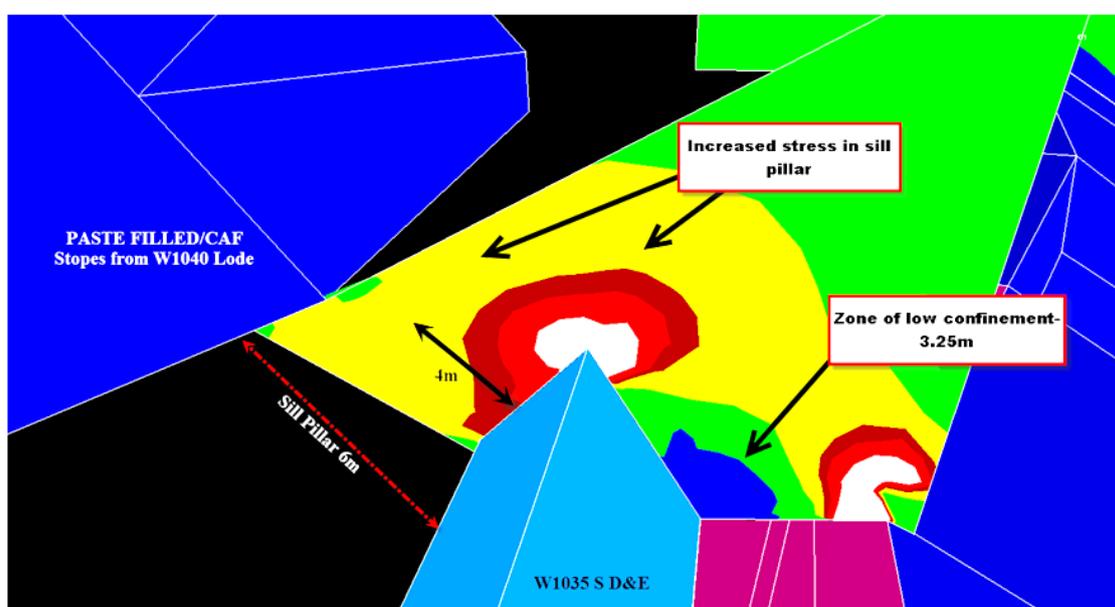
Figure 11 W1035 S D&E proposed shape in the sill pillar

As the extraction proceeded, modelling indicated that the majority of stopes located behind previously extracted and paste filled stopes were in a stress ‘shadow’ and were not expected to have increased seismicity. Stress concentrations remained within the central pillar access areas. Also, stopes which encroached on smaller sill pillars showed an increased field stress (70 MPa+) between the paste above and the stopes. This higher stress criterion indicated that 4 m out of a 6 m pillar could be expected to fail upon firing or induced seismic responses. Therefore, stopes that reduced the sill pillar were considered unsafe to mine (Figure 11).

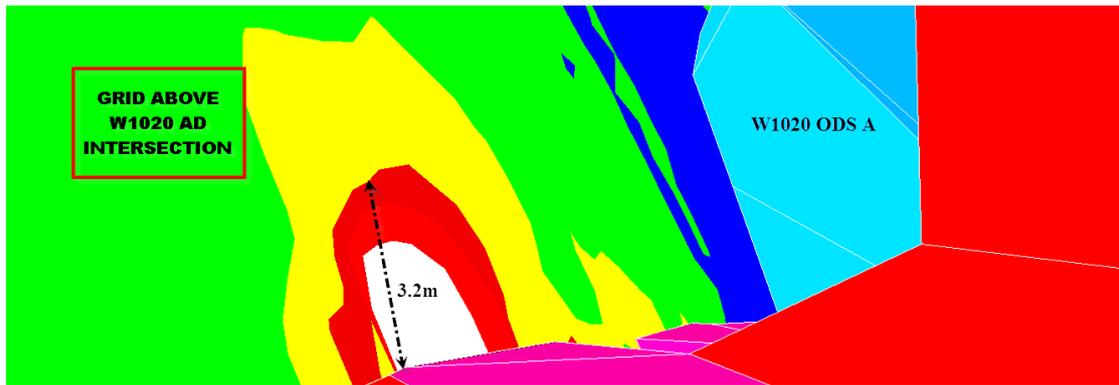
Figure 12 Rock mass damage potential in drives

The modelling indicated high σ_1 values approximately 3.2 m into the backs of the drive (Figure 12). This coincides with the anticipated wedge height potential discussed in Section 3.1. The de-bonded cable support will still have 2.8 m of embedment within competent rock and should still be effective through the entire stoping sequence. In addition, all brows in the Walters Lode will have extra cable support.

- Ground support needed to be upgraded in 1020 and 1040 Levels (HW/FW development access when it occurs) to account for the maximum depth of damage of 3.2 m into the backs.

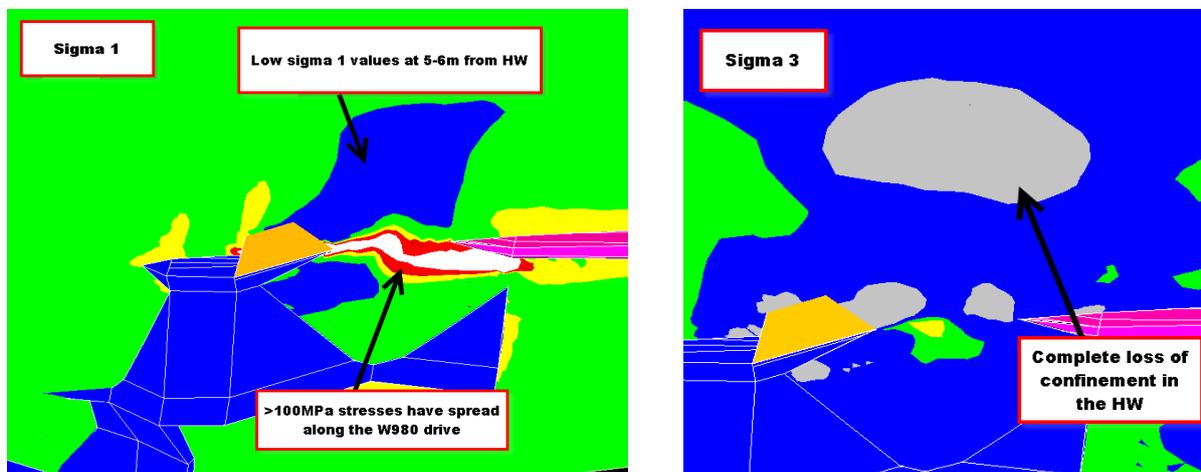
Figure 13 Loss of confinement upon extracting stopes central to stress window

It was found that loss of confinement in the HW could be a primary cause of overbreak within the majority of inclined shapes, especially with stopes which were overcut by extracted stopes above. The loss in confinement is because the rock mass in the HW is only confined on two abutments (Figure 13).

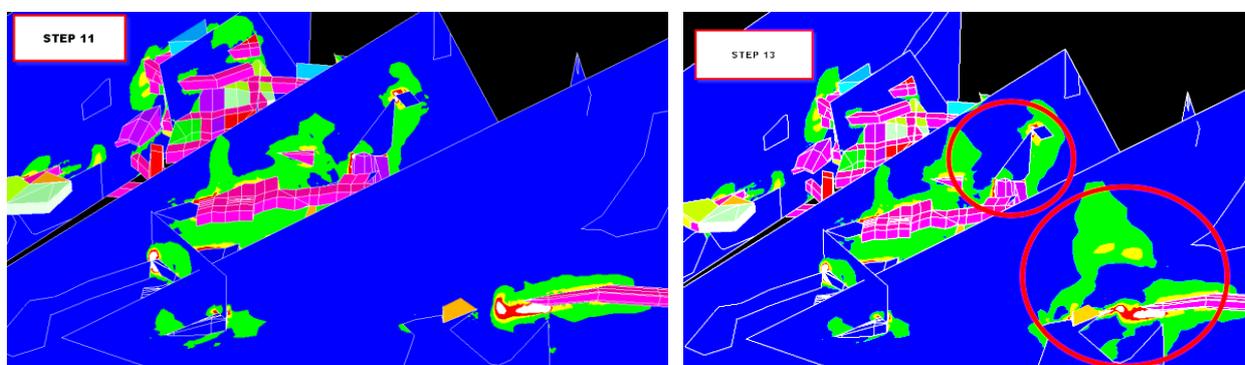
Figure 14 Regional shear stress change pre and post blasting W980 HW A Stope

The modelling also allowed for shear stress changes to be recognised at certain steps of the mining sequence. It was found that certain stopes could initiate a regional stress change along the fault structures. The mining steps that showed a sudden change were flagged as high risk stopes and were re-sequenced, where possible, to late in the Walters Lode sequence. An example of this is the W980 HW A (Figure 14) which induces a regional shear stress change on the first slip fault, and has potential to cause seismic induced damage and fall out.

- Any stopes that are left as pillars should be de-stressed by means of pre-condition blasting, so that they do not attract seismicity.
- Avoid stoping the W1035 H/G and W980 stopes at the same time. This could cause the pillar to crush and increase the shear stress along the first slip fault. This is illustrated in Figure 14.
