Transforming Ranger's TSF to a process water storage facility

Abstract

Keywords: *tailings storage facility, water storage facility, closure, geotechnical, hydrogeology*

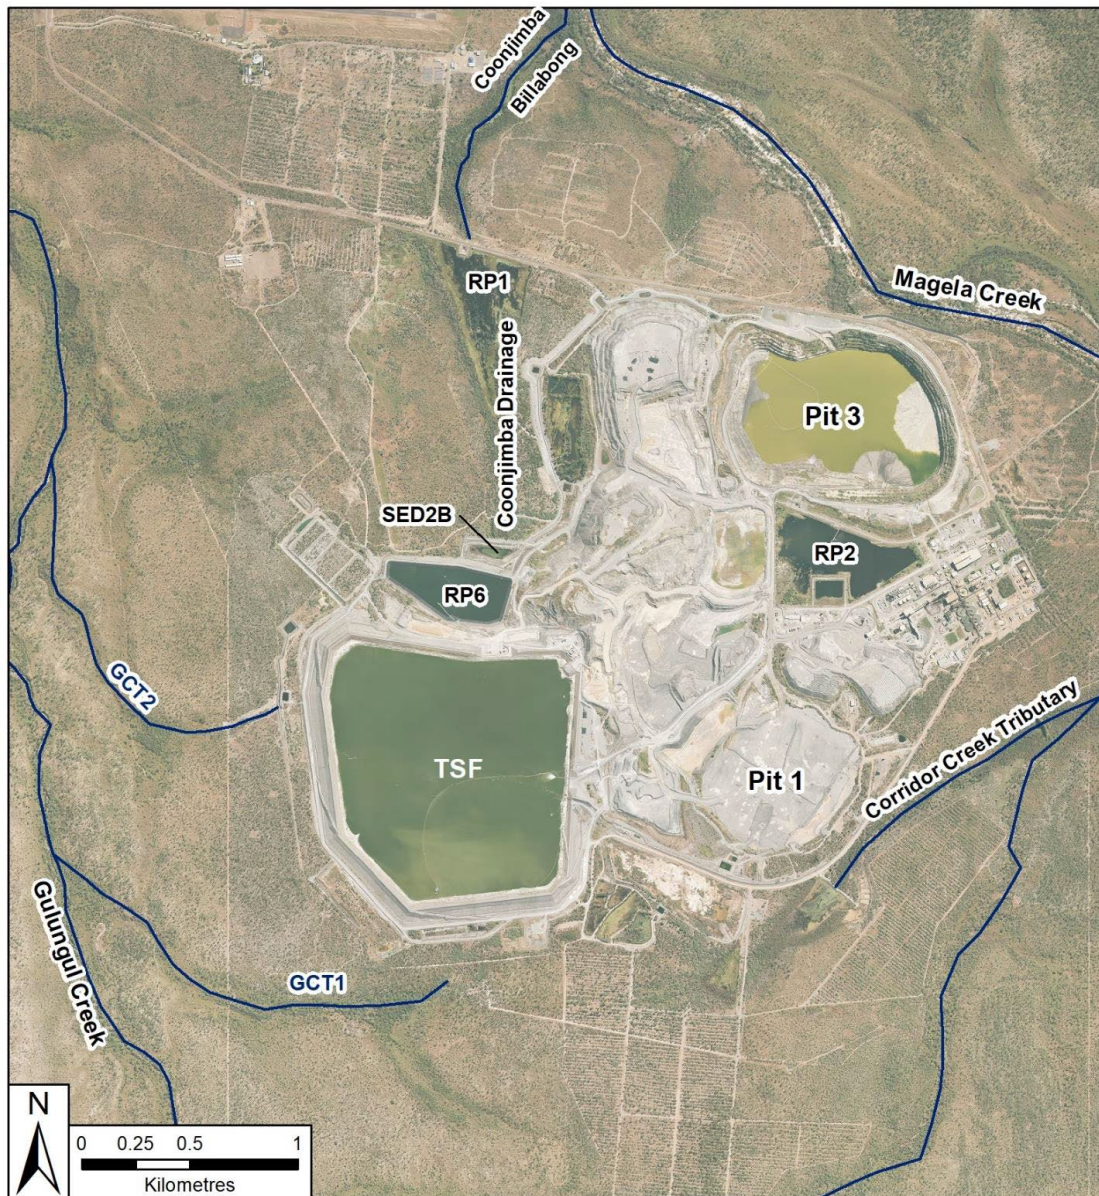
Figure 2 Location of the TSF at Ranger

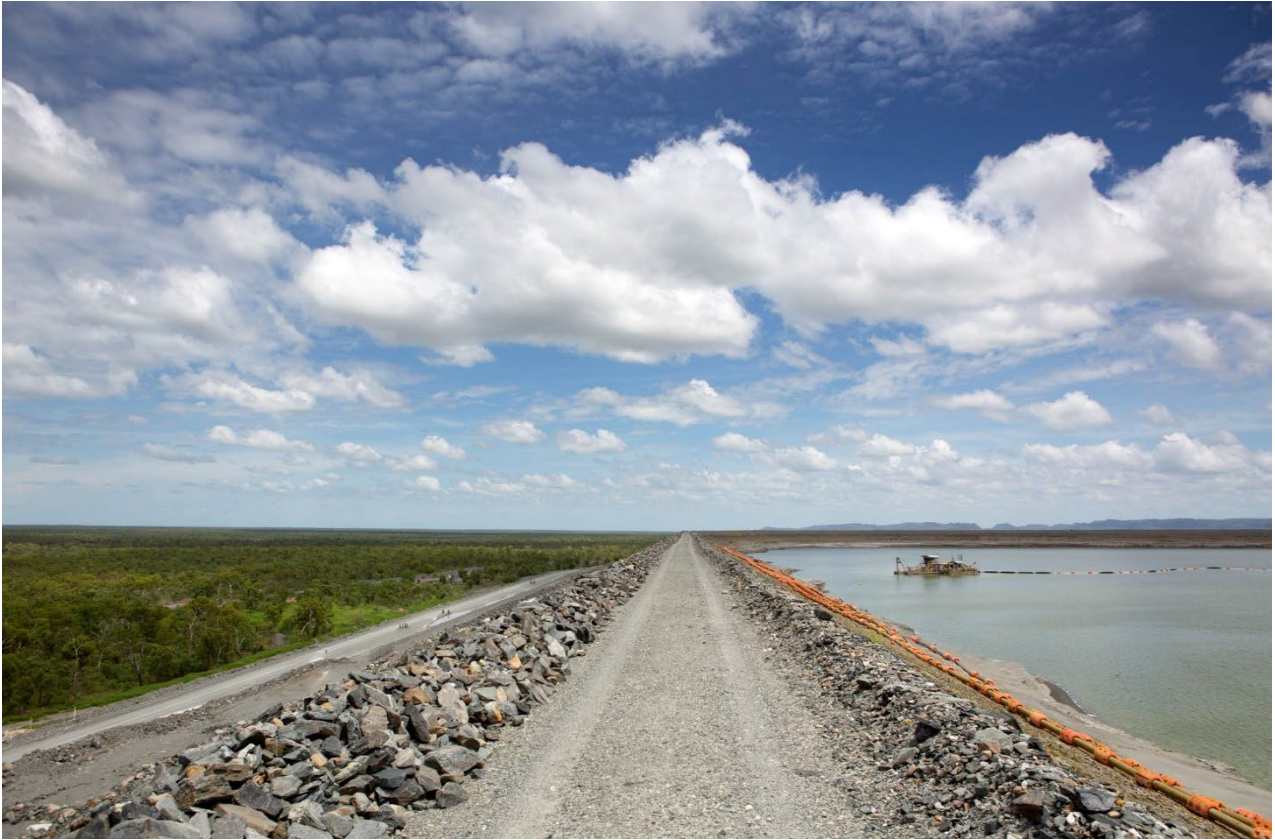
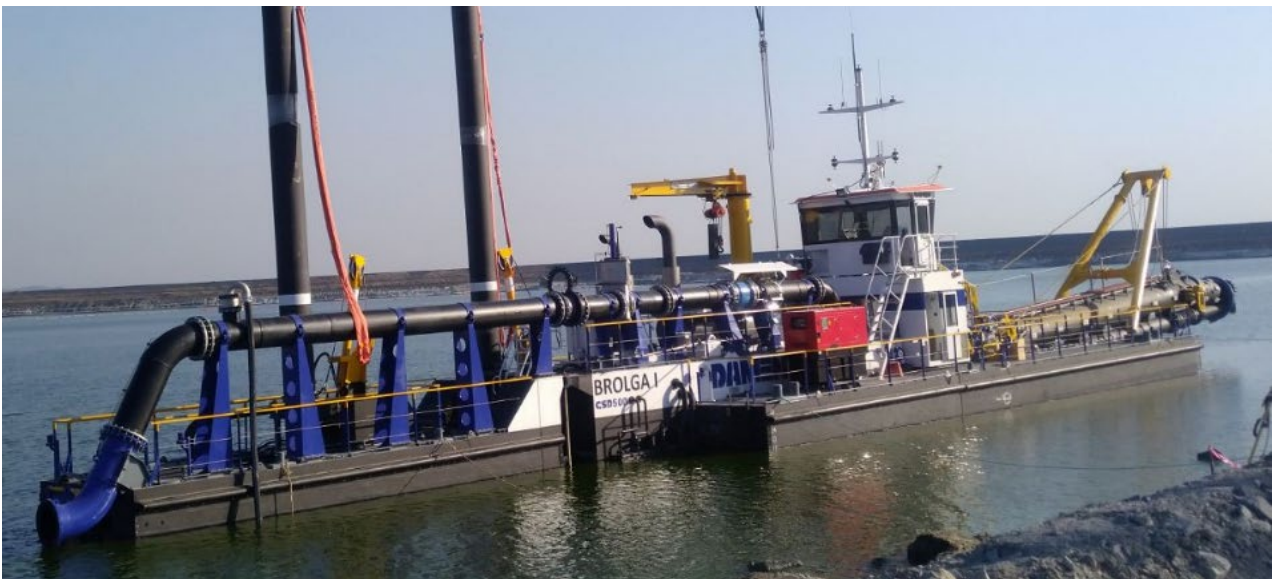
Figure 3 TSF dredging operations with Jabiru and Brolga I cutter suction dredges

Removal of the TSF tailings commenced in 2015 via a single dredge named 'Jabiru' (Figure 3) once Pit 3 became available for long-term tailings storage. The dredging created a need to continually lower the water

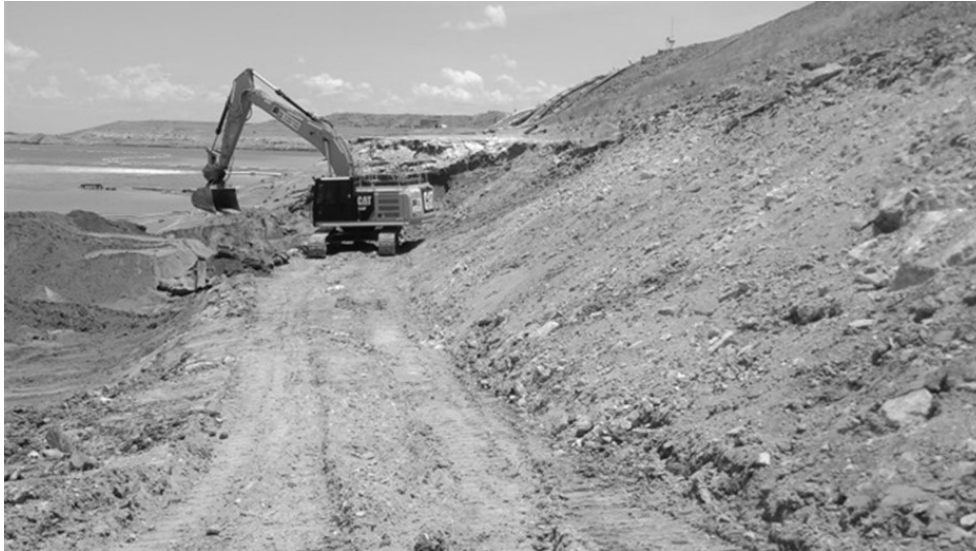
Figure 5 Excavator on temporary working platform inside the dam during dredging operations

Various methods of wall cleaning were assessed, including a sprinkler trickle system and hydromining, with a trial of the latter at one point carried out. Neither was deemed effective, as the sprinkler system would not provide full coverage and a hydromining trial created airborne spray that could not be conducted effectively from the embankment, and an alternative method was required. An experienced earthworks construction supervisor with many years' prior experience working on the dam in its active depositional phase was brought back onto the job by the mine and it was rapidly assessed that internal rockfill working platforms constructed of excess rip rap from higher up the embankment slope would be a possible solution, for support of conventional excavation equipment.

In situ testing of exposed remnant tailings was conducted using a dynamic cone penetrometer and the results were interpreted in an assessment which showed that the working platforms would indeed be stable under anticipated loading conditions with the buttressing effect of tailings lower down the batter slope. Mechanical clean-out of remnant tailings using 30 t excavators working on the 1V : 2H upstream embankment face thus commenced in late 2019, with the design engineer's approval, whilst the facility was being actively dredged (Figure 5). Some 500,000 m³ of tailings were ultimately safely removed from the embankment. Monthly drone flyovers of the facility were conducted during the works and the footage transmitted to and downloaded for review by the design engineer in Perth, Western Australia.

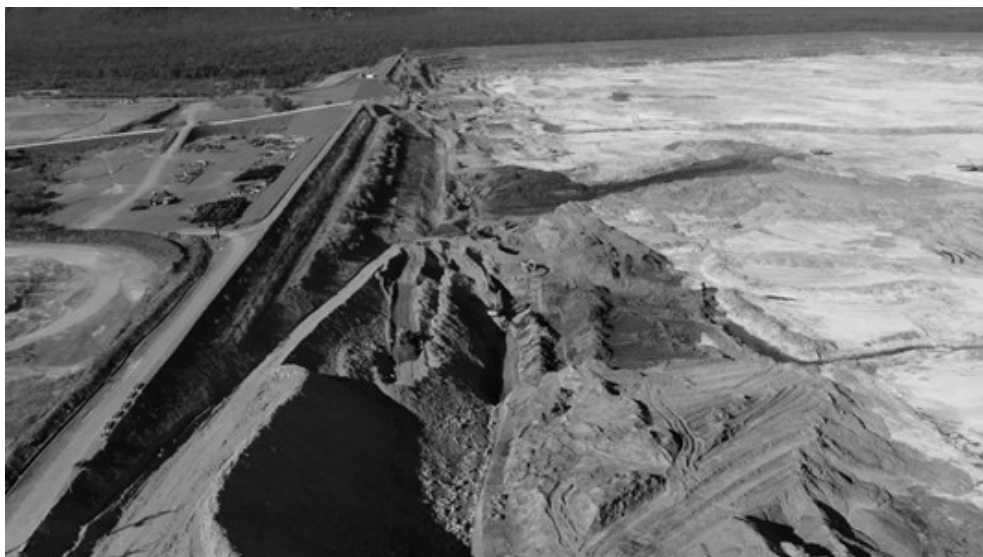
Figure 6 Image from drone flyover, showing north-east ramp construction in May 2021

excavators and haul the dried tailings from the TSF floor to a tip head at Pit 3. Both ramps were constructed of coarse mine waste rockfill. The north-east ramp construction had a nominal 12 m wide crest including safety windrow, 8% gradient, three benches with side slopes of approximately 40°, and berms at RL 44 m and RL 38 m (Figure 6). It was completed in mid-2021.

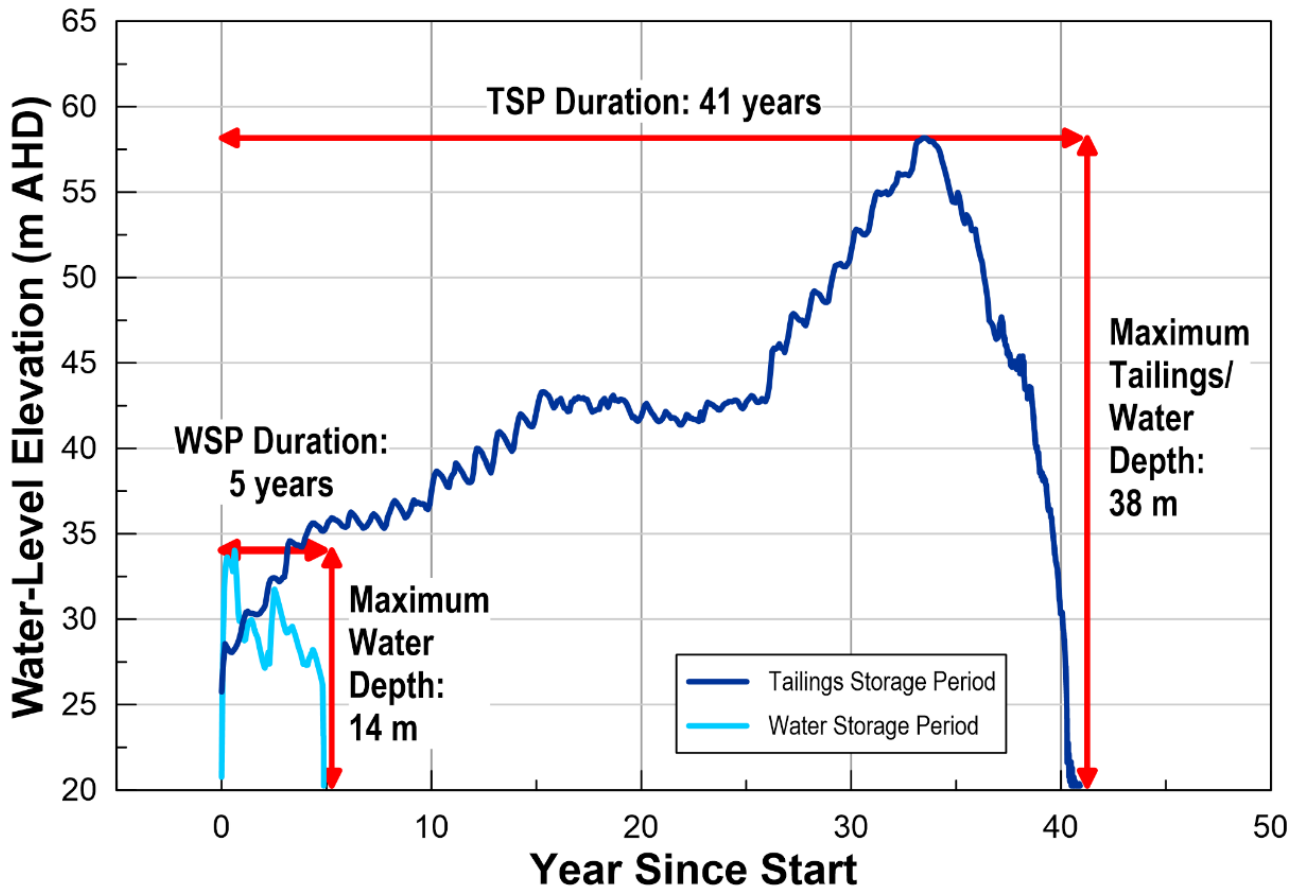
Figure 8 The storage duration and maximum water depth for the water storage period (WSP) are a factor of 8.2 (5 years versus 41 years) and 2.7 (14 m versus 38 m) less, respectively, than that for the tailings storage period (TSP)

Any seepage that does occur during the water storage period is expected to be significantly less than that during the tailings storage period. Both the storage duration and maximum water depth for the water storage period will be far smaller than the storage duration and maximum water depth for the tailings storage period (Figure 8). Water will be stored for 5 years compared to the 41 years of tailings storage, a factor of 8.2 shorter. The maximum water depth above the floor during the water storage period will be 14 m, which is a factor of 2.7 lower than the maximum water depth of 38 m during the tailings storage period. The water depths were calculated from the minimum floor elevation of about 20 m.
