# Transition of a major tailings facility in a sensitive environment — from operation to decommissioning at Brenda Mine

R.C. Lo *Klohn Crippen Berger Ltd, Canada*

## Abstract

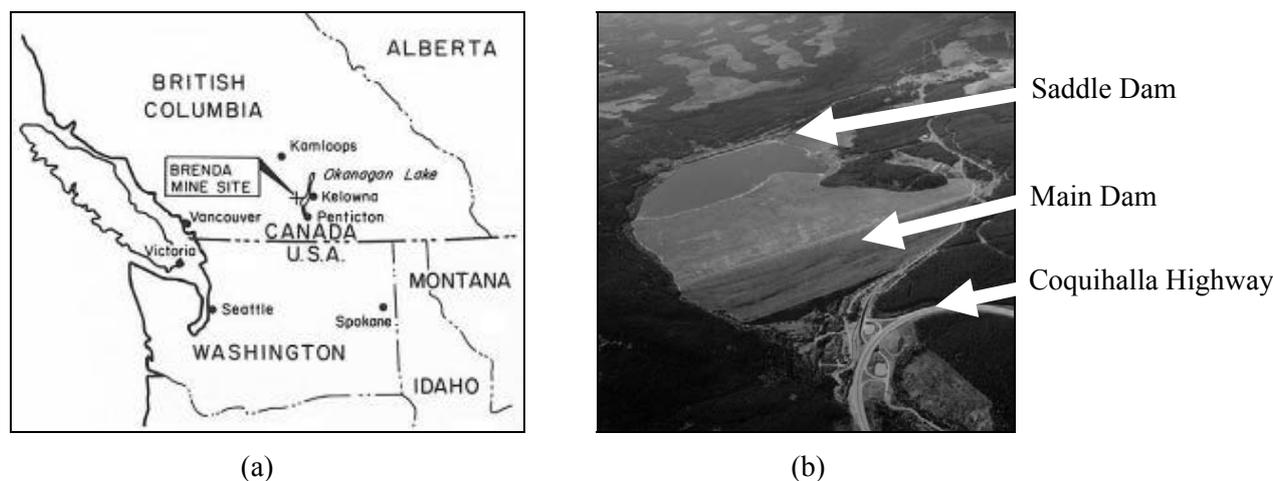
**Figure 1** (a) Location plan of Brenda Mine (Klohn, 1984); and (b) Brenda Mine tailings impoundment

Brenda Mine is located in south central British Columbia, Canada (Figure 1a). Its tailings impoundment, retained by two tailings dams (Figure 1b), is located in a relatively narrow MacDonal Creek valley with a steep gradient at the headwaters of a small stream, Trepanier Creek. The stream flows into Okanagan Lake, a major regional fruit and wine producing tourist and recreational area. Both Trepanier and Peachland Creeks adjacent to the mine are fish-bearing tributaries. The area of the former catchment is about 26,000 ha and the latter area is about 14,000 ha. There is 543 km of roads within the two catchments, including the divided, four-lane Coquihalla Highway skirting near the toe of the main tailings dam. Both catchments are under forest licenses.

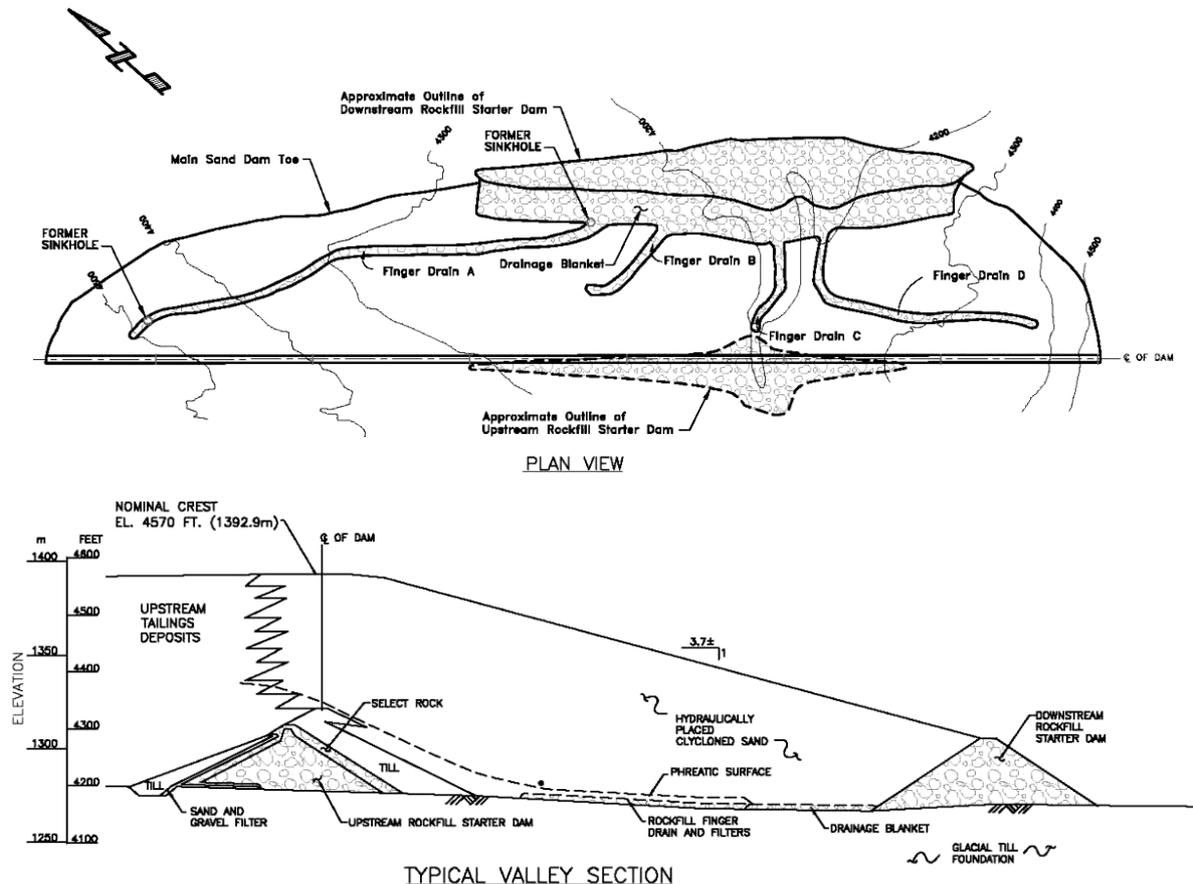
**Figure 2 Main dam – plan view (top) and typical valley section (bottom)**

The tailings facility consists of a 2 km long, 137 m high main dam (Figure 2) at the downstream end in the Trepanier Creek catchment and a 950 m long, 38 m high earth and rockfill saddle dam at the upstream end in

Figure 2 shows the plan view of various internal drainage features and the typical valley dam section. To implement the above design features, the following measures were taken:

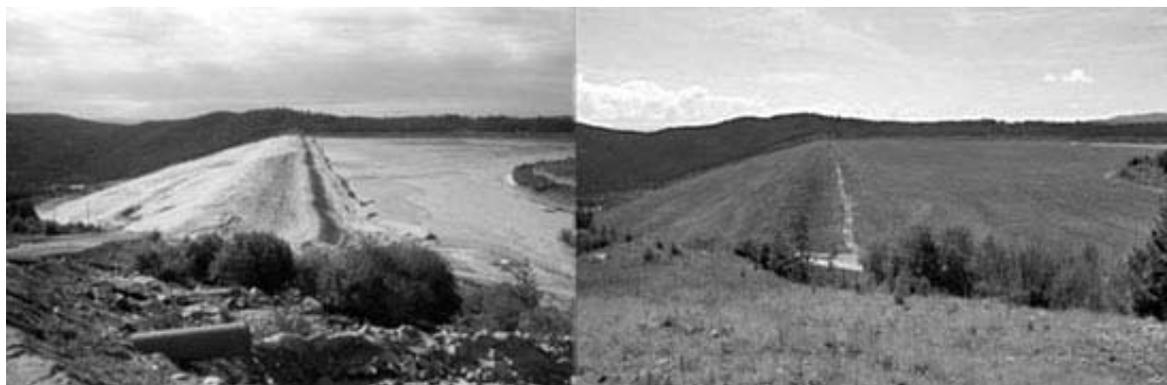
**Figure 3 Brenda Mine main dam: upstream tailings beach, dam crest and downstream slope before and after reclamation**

The downstream slope of the sandfill of the completed dam is about 3.7H:1V. The cycloned sandfill is a fine to medium sand with a fines content ranging from 5 to 10% passing through No. 200 mesh sieve. The  $(N_1)_{60}$  blow counts of the sandfill are in the range of 12 to 16 down to a depth of 75 m, indicating the medium-dense state. The dam was completed in 1990 and successfully reclaimed in 1990s (Figures 3 and 4a).

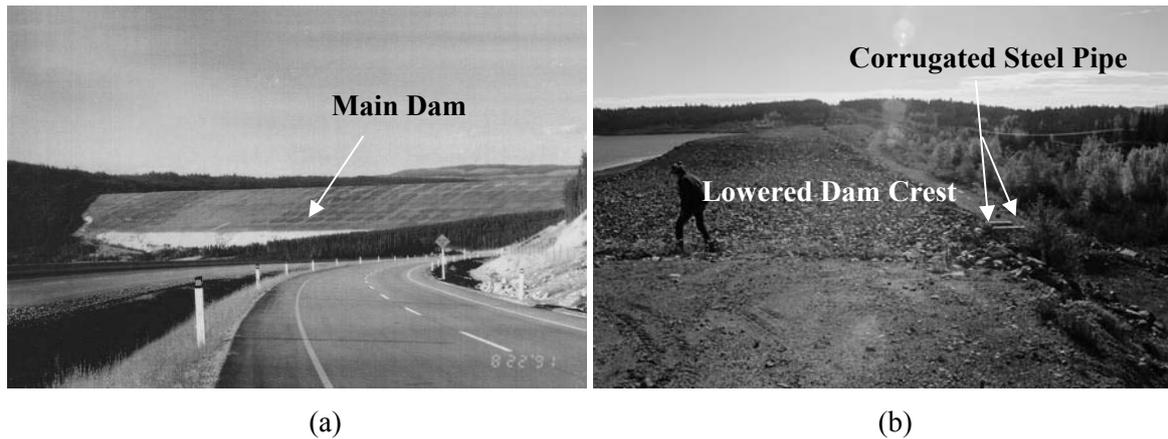
**Figure 4** (a) Downstream face of main dam — viewed from Coquihalla Highway; and (b) saddle dam with emergency discharge culverts and lowered dam crest

In 1999, an emergency discharge facility was constructed at the saddle dam to safeguard the main dam from overtopping. The discharge facility, designed by Agra (1999), consists of a 30 m wide free overflow segment of the saddle dam with the crest lowered by 2.4 m from the rest of the dam and two 900 mm diameter corrugated steel pipe culverts with the invert at El. 1,387 m (Figure 4b). Since 1999, the tailings pond level has been maintained within a 2.3 m range with a minimum freeboard of 1.9 m below the invert of the two discharge culverts, and a minimum freeboard of 7.8 m below the crest of the main dam.

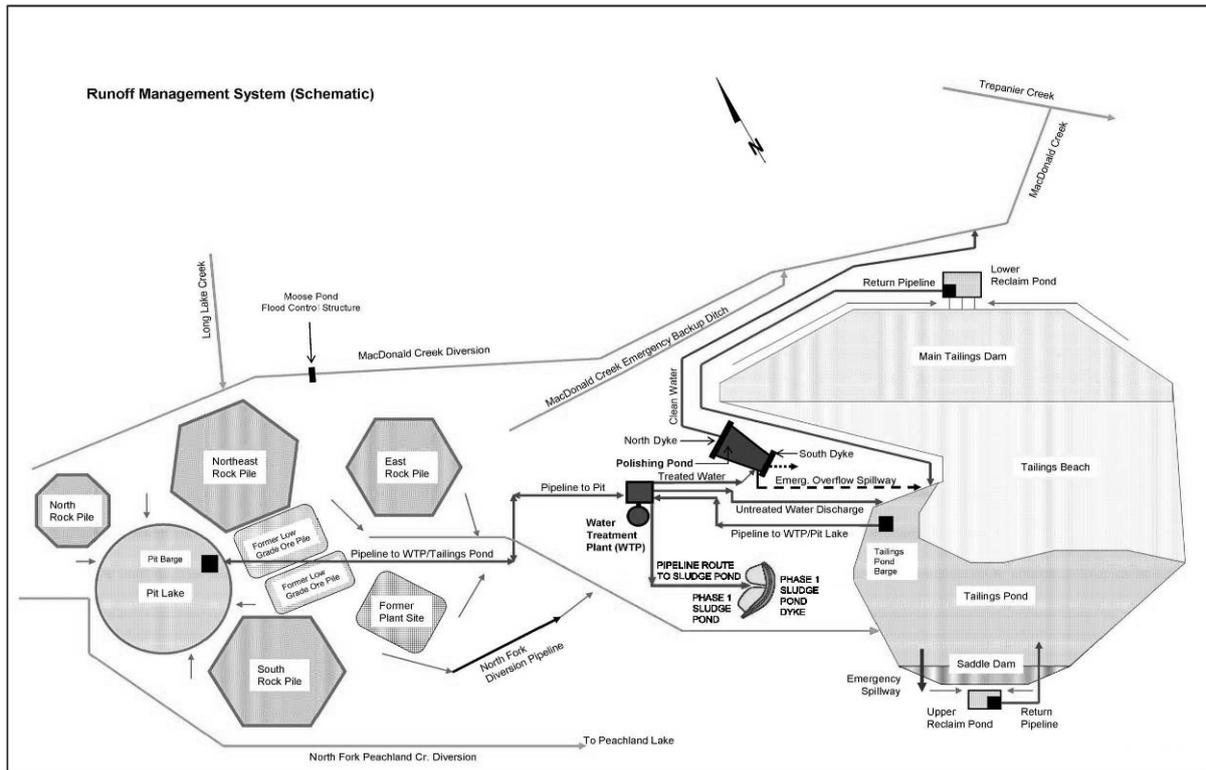
**Figure 5 Mine site runoff management scheme (Agra, 1998a)**

Key features of the runoff management scheme are the following:

- Divert clean water around the mine site to downstream creeks (Figures 6a and 6b).
- Collect molybdenum-bearing water in the tailings pond and pit lake.
- Treat water collected in the tailings pond and/or pit lake in the water treatment plant and store it in the polishing pond.
- Release treated water from the polishing pond to MacDonald Creek under permit.
- Store sludge from the treatment plant in the permanent sludge pond.

The polishing pond is located in a natural swale between the water treatment plant and the tailings impoundment (Figure 5). The pond is retained by two earthfill dykes of similar design: the 8 m high north dyke (Figure 10a) and 4 m high south dyke (Figure 10b). The dykes were designed by Agra, and constructed in 1998 (Agra, 1998b). Both dykes were essentially constructed of relatively impervious glacial till with a central cutoff trench and an upstream riprap slope protection zone overlying a filter layer. The cutoff

The permanent sludge pond is located about 600 m southeast of the water treatment plant on sloping ground, above the tailings impoundment (Figure 5). The sludge pond is retained by a crescent-shaped dyke constructed of pervious earth and rockfill materials (Figure 11a). The sludge dyke was constructed on stripped competent, water-tight ablation till foundation overlying dense basal till and coarse felsic intrusive bedrock. Two multi-level monitoring wells, BH#1 (three piezometers) and BH#2 (two piezometers), were installed, respectively, downstream and upstream of the sludge pond to monitor groundwater levels and quality. Downward groundwater gradient and seasonal variation were observed in both monitoring wells to date. At the deep piezometer in downstream well, BH#1, the piezometric level rose by about 1 m from 2002 to 2003 and stayed at similar levels since then. No other consistent piezometric changes could be discerned. From 2003 to 2009, water quality of groundwater remained unchanged at the upstream well, BH#2. At the downstream well, BH#1, dissolved molybdenum maintained at 0.001 to 0.005 mg/l level, while dissolved sulphate increased from 20 to 30 mg/l level to 200 to 400 mg/l level.

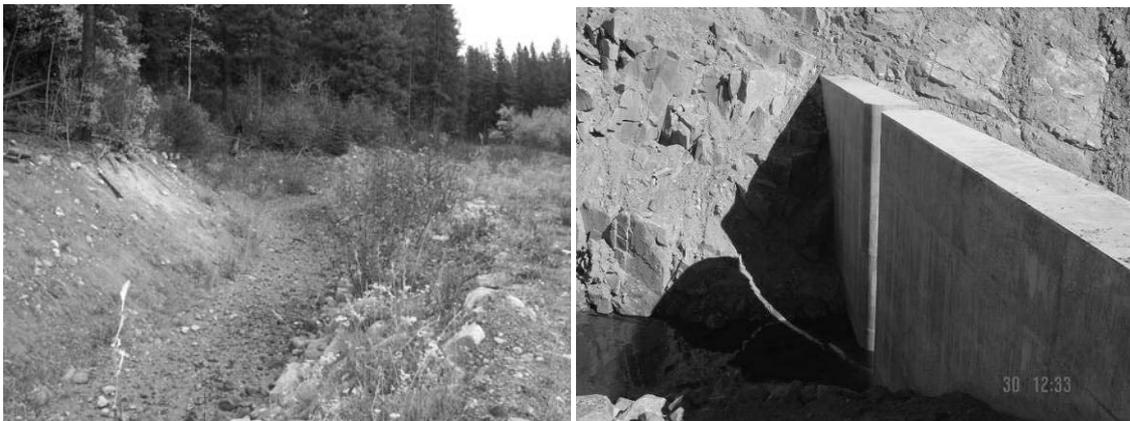
**Figure 6 (a) MacDonald Creek diversion channel; and (b) Moose Pond flow-control concrete weir used to attenuate flood flow to tailings pond**

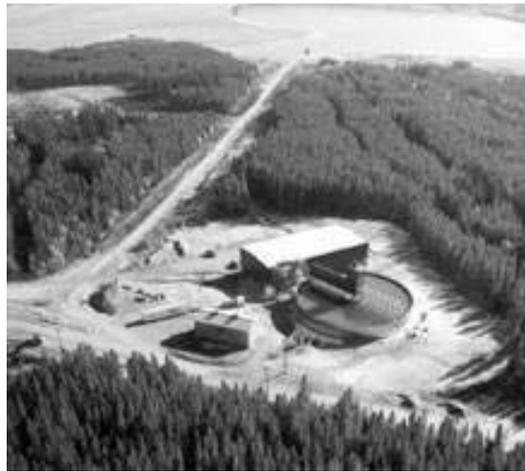
**Figure 7** Water treatment plant

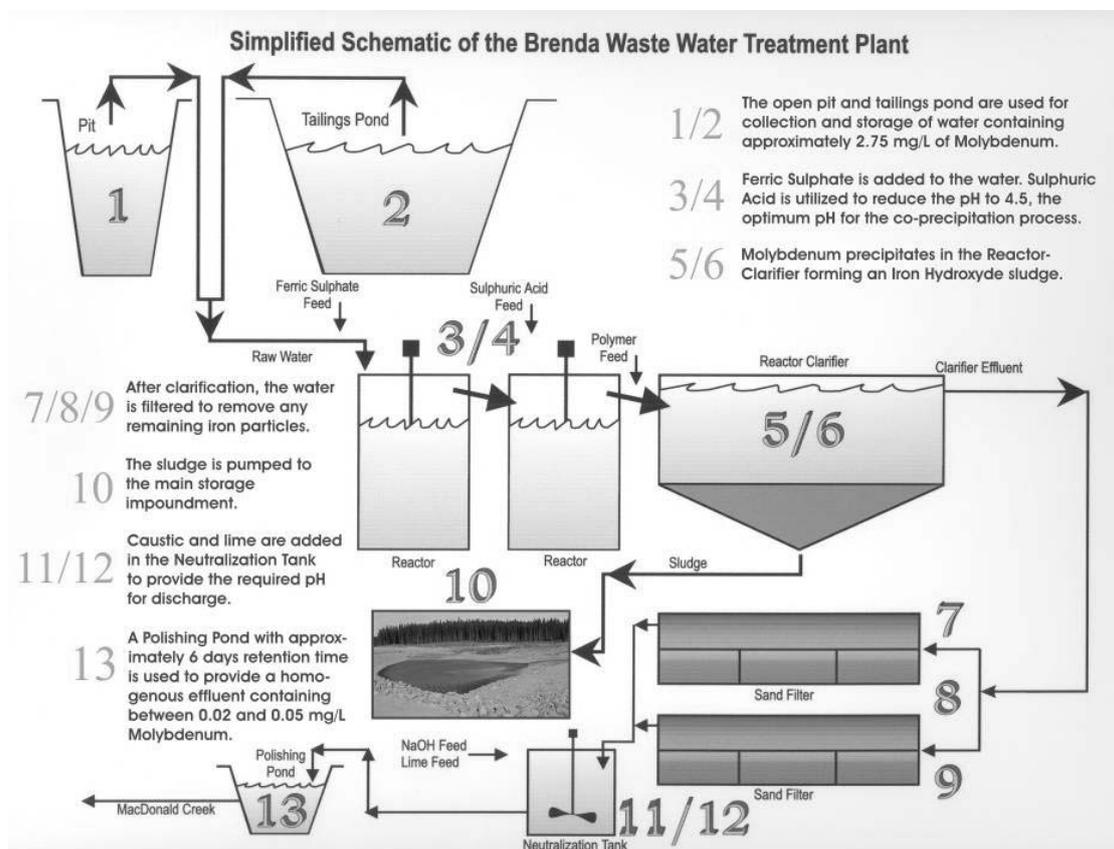
**Figure 8** Schematic diagram of water treatment process

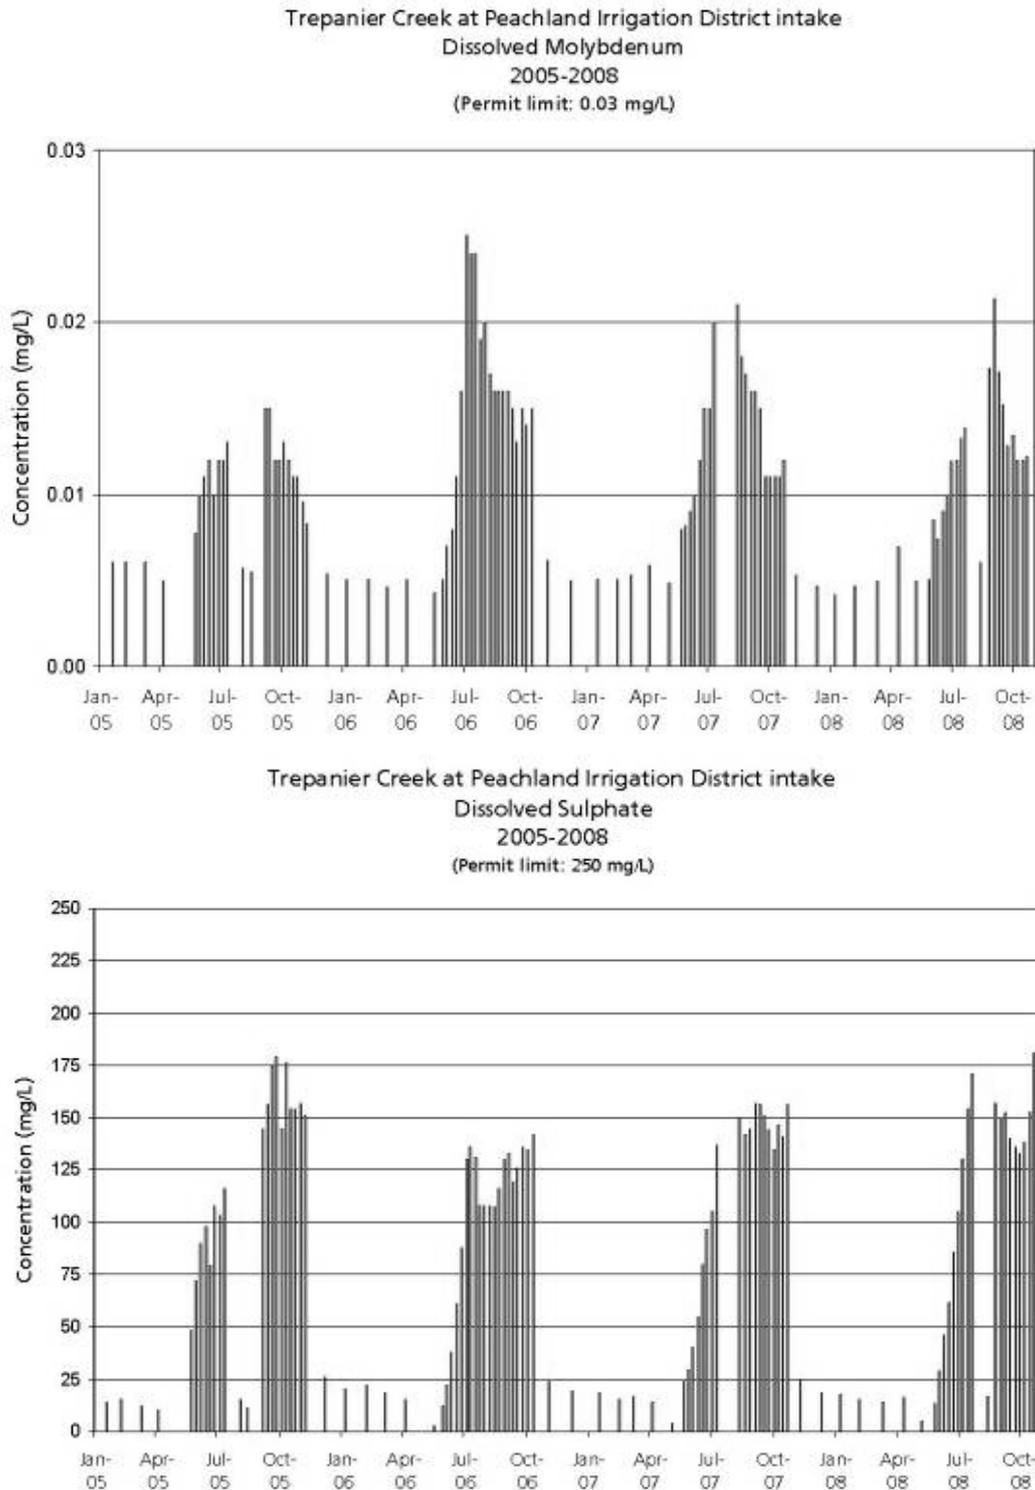
**Figure 9 Dissolved molybdenum (top) and sulphate (bottom) in Trepanier Creek at Peachland Irrigation District Intake (2005–2008)**

The release of treated water during the months of May to October (Figure 11b) are following a detailed permit (BCMELP, 2003) with specified water-quality characteristics of the discharge as well as water-quality objectives at the downstream irrigation intake works. The maximum allowed rate of discharge is 6 million m<sup>3</sup>/yr with an anticipated average rate of 3.1 million m<sup>3</sup>/yr. The permit also governs mine site management of sludge. Besides ongoing reporting to the ministry, Brenda has also published newsletters each year reporting the progress of water treatment plant operation and Trepanier Creek water quality monitoring data to inform the public (Figure 9).

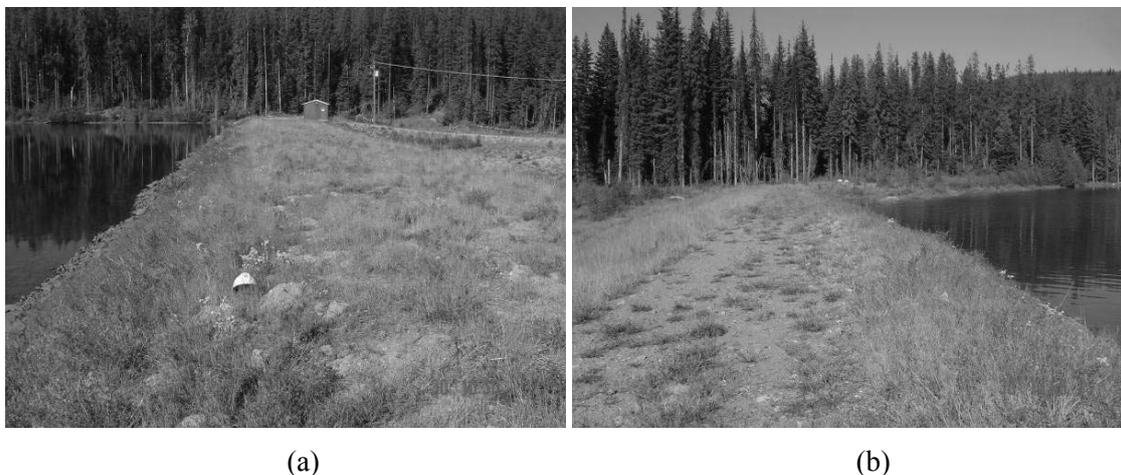
**Figure 10 (a) Polishing pond – north dyke and (b) south dyke**

trenches were backfilled with glacial till to tie in with the dense glacial till and bedrock foundation. A horizontal sand and gravel drainage blanket was provided at the base of the downstream shell in the north dyke, but not at the south dyke. A 45 cm diameter Sclair underflow drain pipe was installed through the foundation of the south dyke for the purpose of draining the polishing pond to the tailings pond in case of an upset in the water treatment system. A spillway is located at the east abutment of the south dyke.

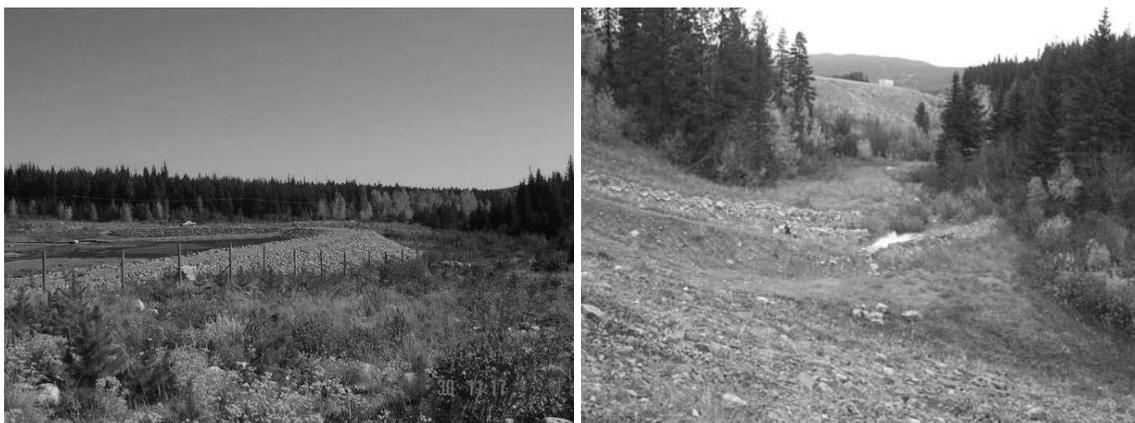
**Figure 11 (a) Permanent sludge pond retained by a crescent-shaped sludge dyke and (b) release of treated water through a pipeline from the polishing pond to MacDonald Creek**

The 6.5 m wide crest of the retaining dyke for the sludge pond is at El. 1,399.8 m. The invert elevation of the emergency spillway, located at the northwest abutment of the sludge dyke is at El. 1,398.9 m. The dyke consists of a trapezoidal-shaped fine rockfill section overlying a 0.5 m thick sand and gravel base blanket. Upstream of the fine rockfill zone are three zones in consecutive upstream order: a 0.6 m thick sand and gravel layer, a 0.3 m thick sand filter and a 0.4 m thick riprap zone. The pervious dyke is designed to facilitate the ongoing draining and consolidation of the sludge deposits.

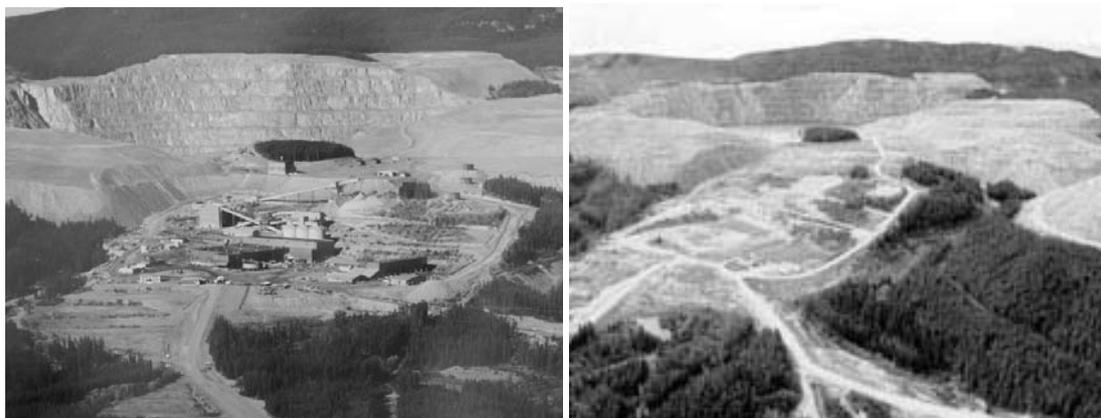
**Figure 12** Mine and mill site during mine operation and after decommissioning

The open pit, shown in the top of both photos in Figure 12, is located at the upper most part of the Brenda property, with the following physical characteristics: diameter 914 m, perimeter 5 km; depth (from rim) 335 m at the west end and 240 m at the east end. The volume of pit-lake water is typically about 34 million m<sup>3</sup>. Figure 12 also shows the conditions of the mine and mill site during mining operation and after removal of mining related structures for decommissioning. Figure 14a shows the pit lake with a pump barge viewed through a safety fence.

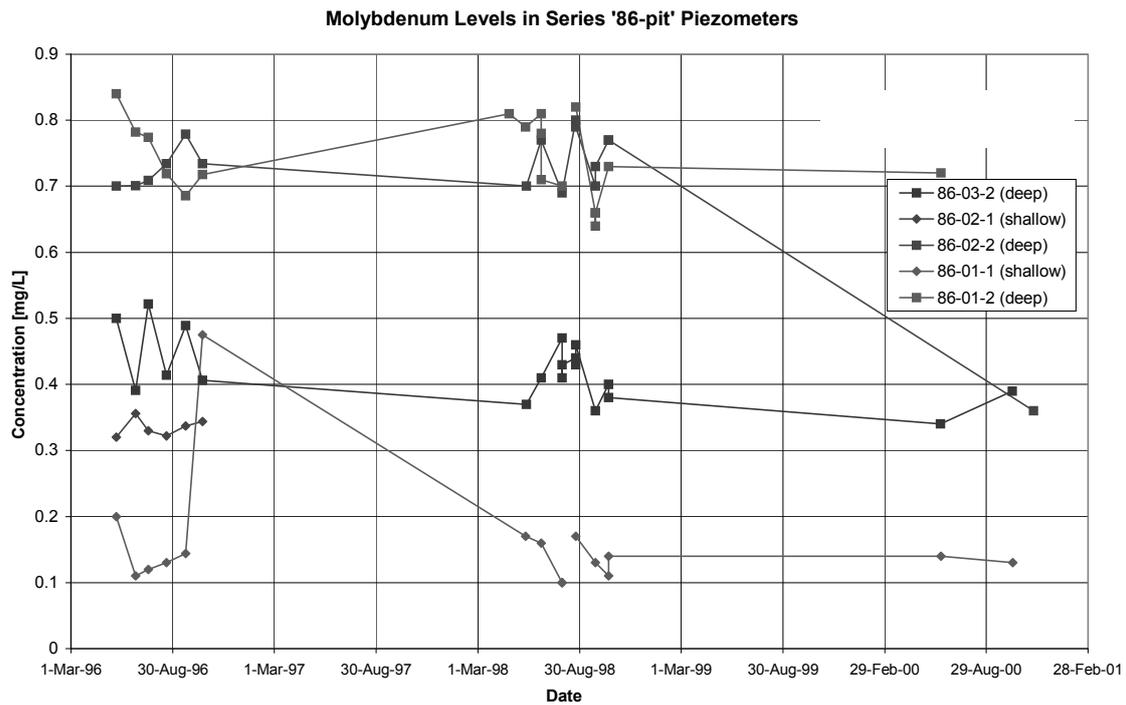
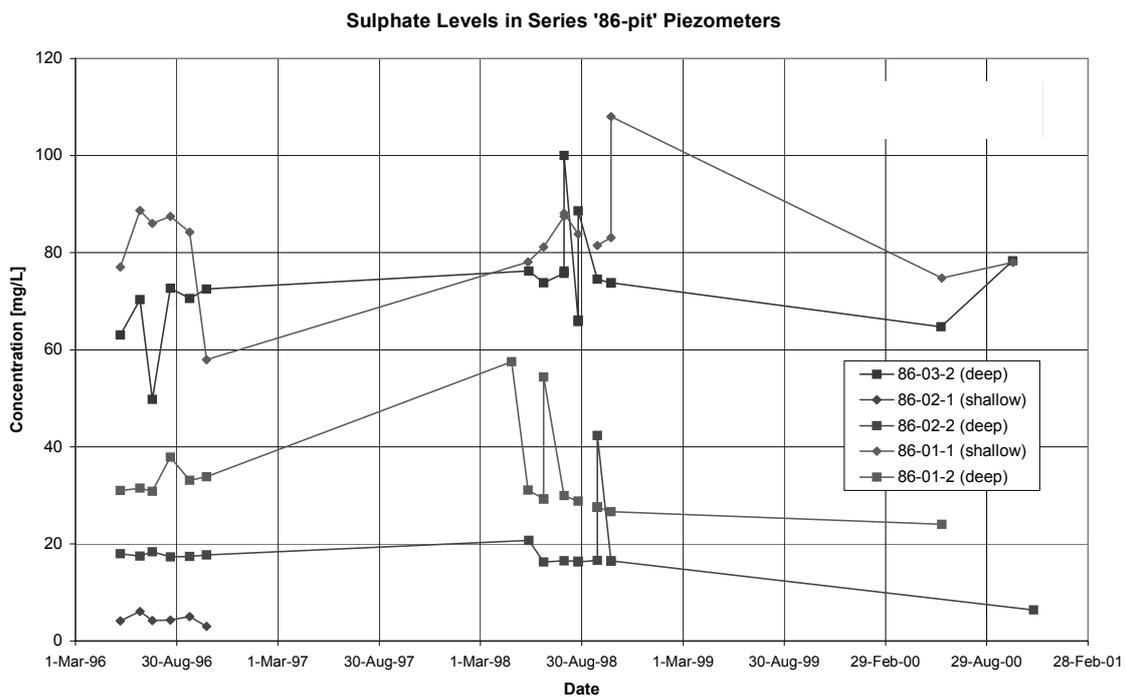
**Figure 13 Dissolved molybdenum (top) and sulphate (bottom) levels in 1986 series multi-level monitoring wells (1996–2000). Note that the interpolation between data points is neither necessary for the purpose of this evaluation, nor intended**

Results of steady-state groundwater flow analyses using a groundwater modelling indicated the presence of a local groundwater recharge zone around the pit lake. There is little likelihood of seepage losses from the pit lake towards the east low pit wall, as long as the lake level stays below the original ground surface around the pit wall at approximately El. 1521 m. Twenty groundwater monitoring wells were installed in 1986 and 1998 around the low wall side of the open pit for ongoing monitoring and confirming the water quality of groundwater in the vicinity of the pit lake (Klohn Crippen, 1998). Results of the dissolved molybdenum and sulphate levels monitored in the 1986 series wells from 1996 to 2000 are shown in Figure 13 (Amec, 2001). These results indicate that practically no changes to groundwater chemistry have occurred since 1996.

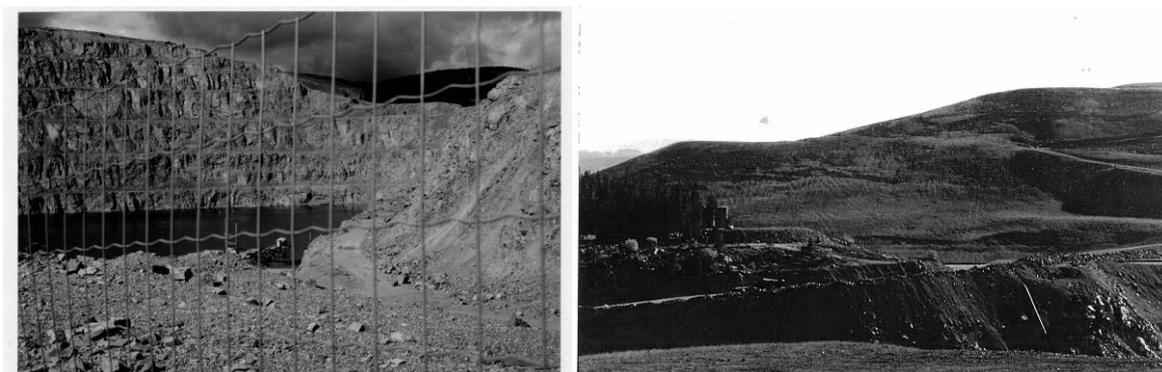
**Figure 14 (a) Pit lake with pump barge; and (b) northeast slope of south waste rock pile**

- North rock pile – 8.1 Mt of waste rock occupying an area of 18 ha with a maximum height of 89 m.
- Northeast rock pile – 54.3 Mt of waste rock occupying an area of 27 ha with a maximum height of 63 m.
- East rock pile – 25.5 Mt of waste rock occupying an area of 28 ha with a maximum height of 99 m.
- South rock pile – 21.2 Mt of waste rock occupying an area of 40 ha with a maximum height of 117 m. Figure 14b shows the view of the northeast slope of the south rock pile.
