Factors impacting and controlling water erosion of rock benches and slopes

NRP Baczynski Prime Geotechnics Pty Ltd, Australia N Bar Gecko Geotechnics LLC, Saint Vincent and the Grenadines NC Firouz Mount Moss Mining Pty Ltd, Australia

Figure 1 Examples of water runoff erosion problems on mine slopes

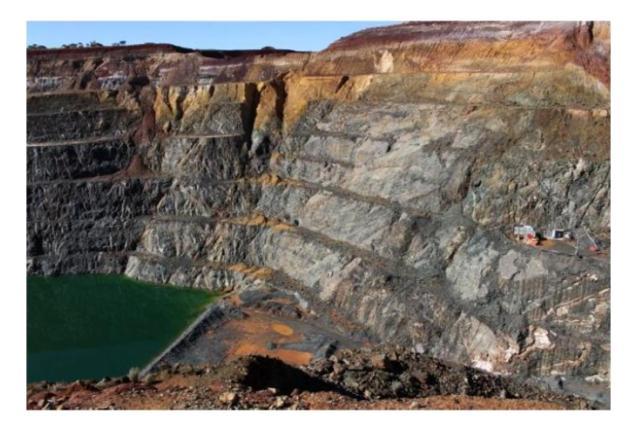
(a) Intentional water discharge into disused pit, Paddington WA; Quarters Pit (June 2019)

- Intentional discharge of rainfall/groundwater runoff into pits deemed to be abandoned (Figure 1a) or an expedient, but perhaps poorly considered, water management option (Figure 1e) where water is discharged from a slope cutback area across a toppling failure landslide.
- Lack of opportunity for surface water channel berm maintenance and its washout during periods of temporarily suspended mining activity (Figure 1b).
- Insufficient water runoff management on slopes destined to be a cutback area at a near future date (Figures 1c, 1d and 1f).

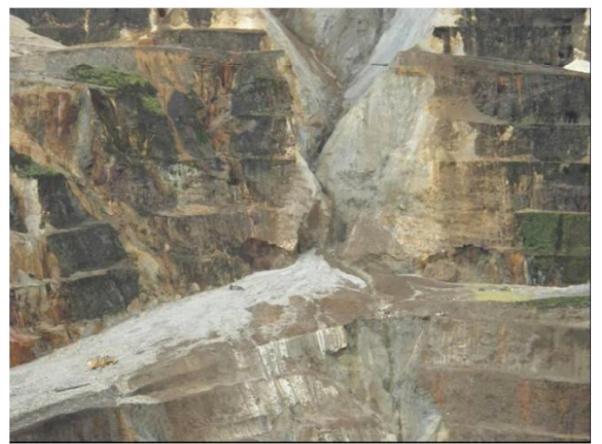
(c) Hard-attempted, but insufficient water runoff control on benches; chasm debris runout onto haul road, cascading to pit floor below, 15m high benches; Ok Tedi, PNG (Oct 2014)

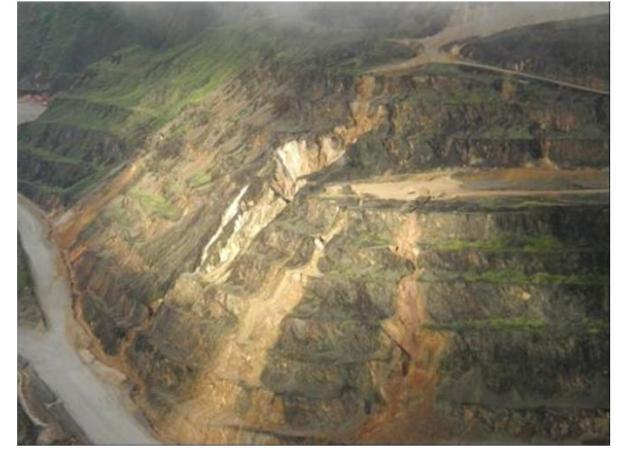
(e) Intentional water discharge from slope cutback mining across toppling landslide area; Ok Tedi, PNG; Paris area (May 2014)

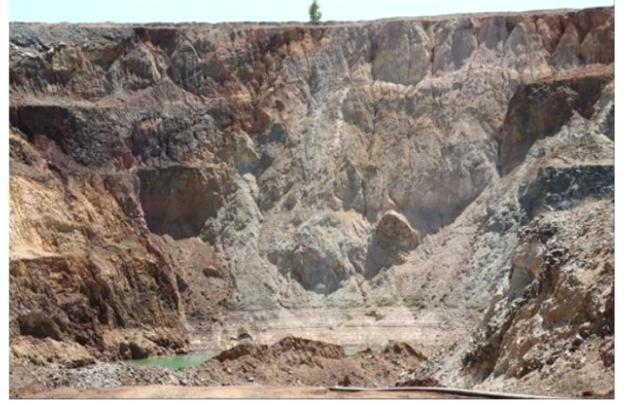
(b) Unintentional water runoff in 8-years' halted mining, Mt Moss, QLD; Lilley Pit (Sep 2022)

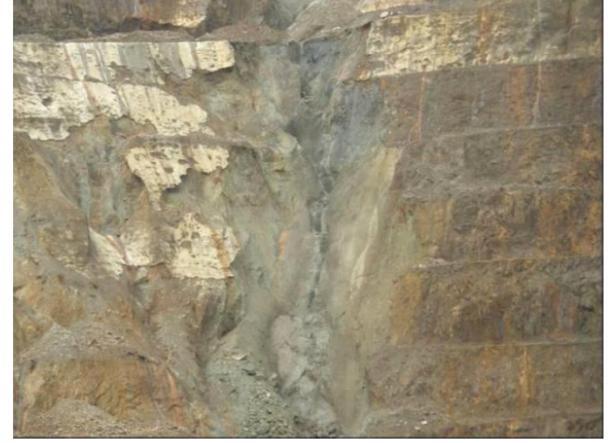
(d) Zoom of damage on ground-reinforced 15m high bench faces beneath pit haul road, with debris blockage of shafts to drainage tunnel; Ok Tedi, PNG; Berlin Chasm (Oct 2014)

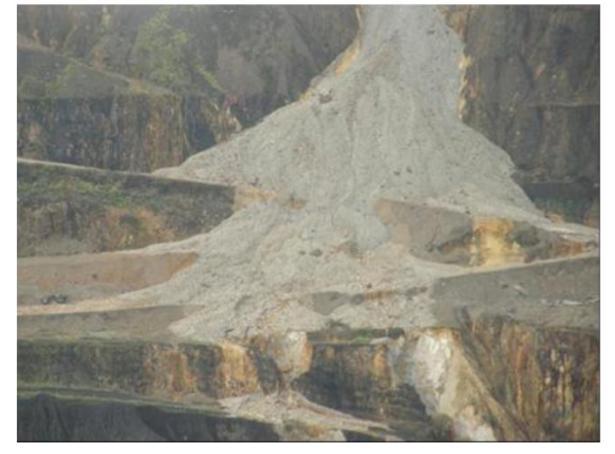
(f) Chasm debris runout onto LV down-slope ramp and pit haul road; Ok Tedi, PNG; West Wall, Berlin-Paris area (May 2014)

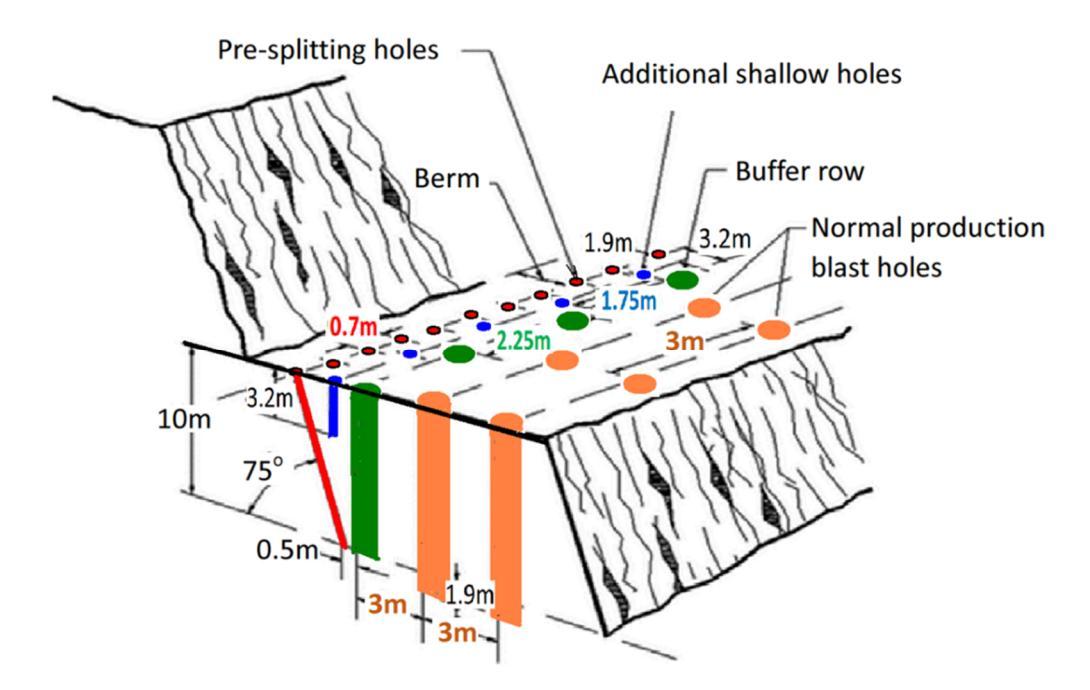
Figure 2 Example of a favourable blasthole pattern that might be used to mine final slope faces

A favourable blasthole layout that might be considered to mine final pit slope faces is shown in Figure 2. This layout comprises several types of holes; i.e. pre-splitting holes (red), additional shallow holes (blue), buffer row holes (green) and normal production blastholes (brown). Spacing and blast-initiation delay between each blasthole type will depend on ground conditions.

Notwithstanding the geotechnical merits of Figure 2, the main aim of blasting is to fragment waste rock and ore to a size that improves the productivity of blasted rock digging, transportation and crushing. In addition to blasting shock energy (fragmentation), there is gas or bubble energy. The latter not only promotes fragmentation but, more importantly, creates heave and muck pile looseness to greatly assist dig rates. This venting gas, if not effectively directed away from pit walls, can escape into fissures/joints in said benches, exacerbating weaknesses and, in extreme cases, destroying bench crests due to excessive back-break.

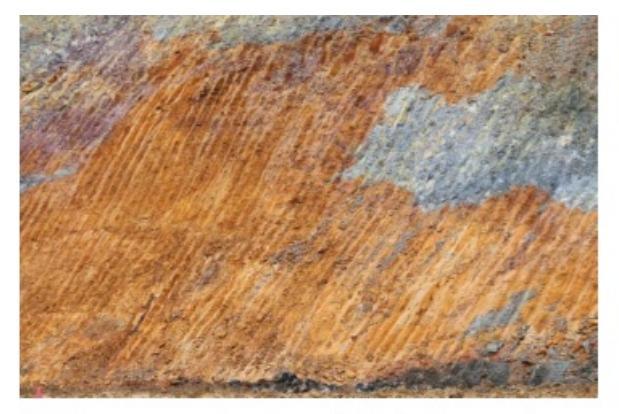
(a) Decomposed rock; not-blasted, excavator dug ore and bench face on final slope; Simberi, PNG; Pigibo Pit (May 2016)

- Excavator mining of the ground (without the need for blasting) and bench face trimming; i.e. typically in readily diggable ground on interim and final slopes (Figure 3a).
- Production blasting to improve mining productivity, with excavator trimming of bench faces; i.e. again, typically in readily diggable ground on interim and final slopes (Figure 3b).
- Production blasting only, without any special consideration near the proposed bench faces, and with excavator clean-up of still-diggable loosened rock blocks hung up on bench faces. Ideally used on interim slopes with a short design life but sometimes used on all slopes irrespective of design life (Figure 3c).
- Production blasting, but with special consideration of blasthole layouts (i.e. diameter, depth, declination and spacing), and the explosives, decking, stemming and timing sequence in the one to

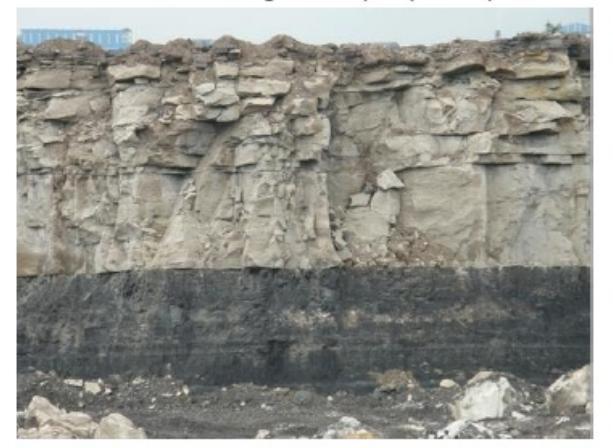
(c) Near-fresh strong rock, production blasted, excavator cleaned-up bench face; West Bokaro, India, Coal Quarry C (Sep, 2010)

Bench mining option listed in the third bullet-point results in least satisfactory bench faces (Figures 3c). The outcome is worsened where strike of geological structures is at <20° across the bench crest trend direction, as shown in Figures 4a to 4f.

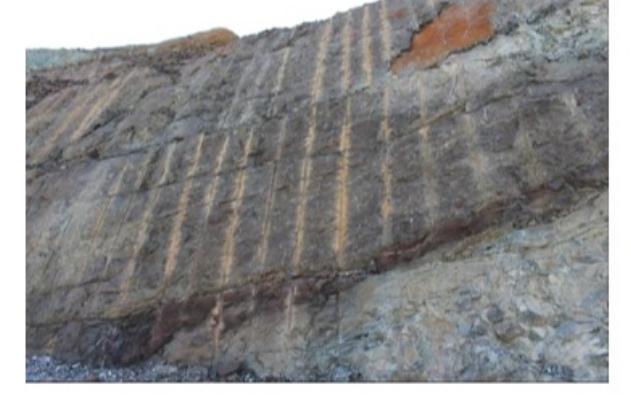
(e) Strong FR rock, effective pre-slit bench faces; Paddington, WA; Mulgarrie Pit (Aug 2019)

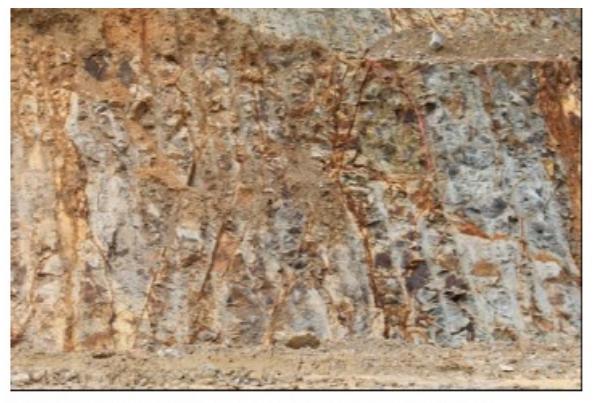
(b) Weathered rock; production blasted, excavator trimmed bench face on final slope Simberi, PNG; Pigibo Pit (May 2016)

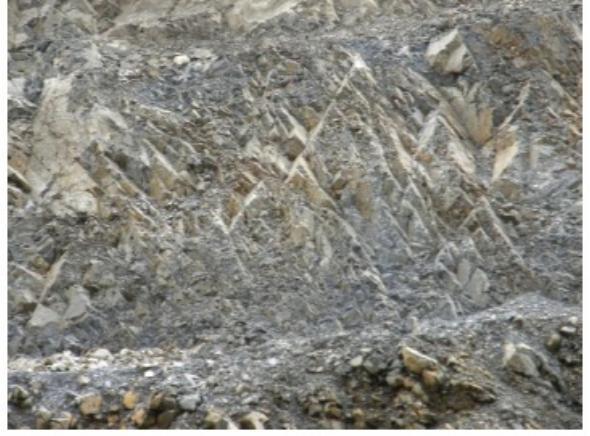
(d) Fresh strong rock, production blasted, fairly effective excavator clean-up of bench face; Ok Tedi, PNG, SE slope (Aug 2011)

three rows of blastholes nearest the proposed interim and final bench faces, to minimise blasting damage (Figure 3d).

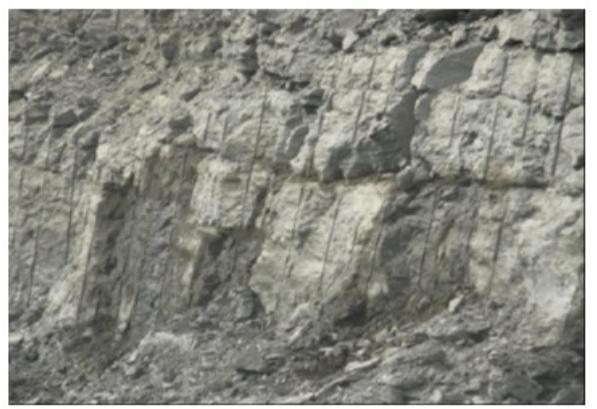
(f) Strong FR rock, effective pre-split bench face; Lumwana Mine, Zambia (Jul 2010)

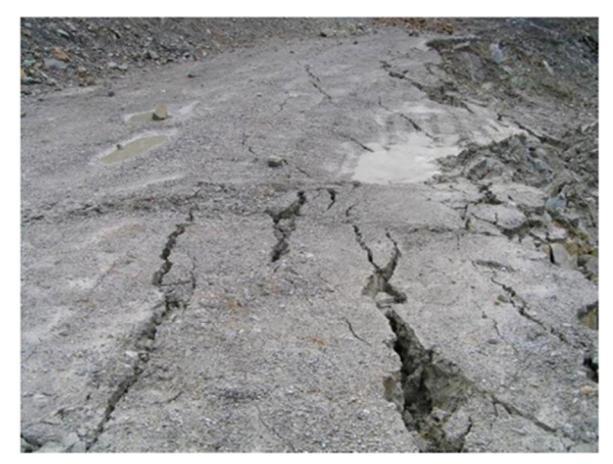
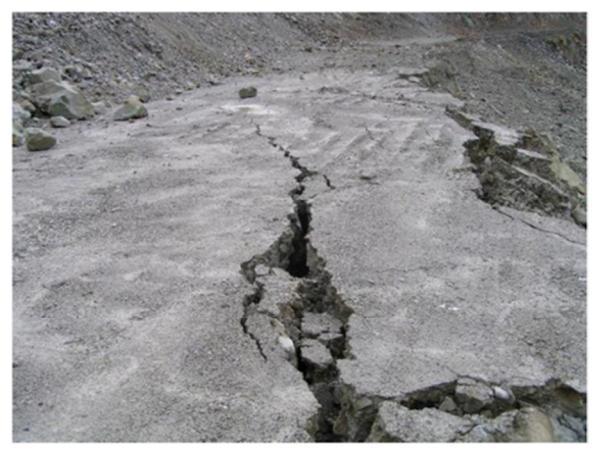
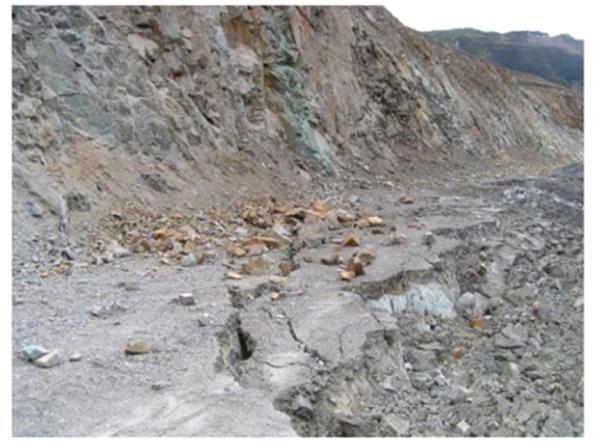
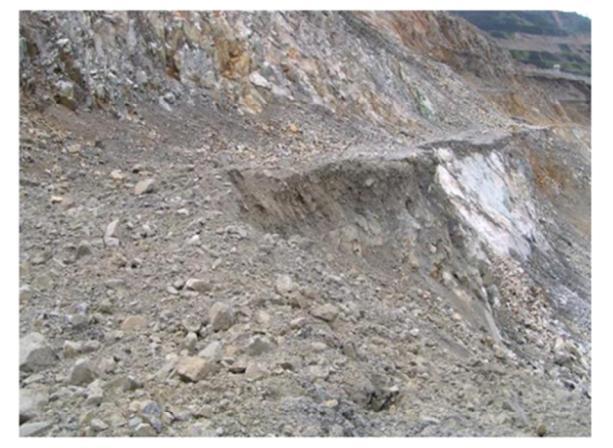
Figure 4 Bench width attrition by production blasts due to adverse defect orientations

(a) Igneous intrusive rocks, Ok Tedi, PNG, Taranaki NE slope (2003)

(c) Igneous intrusive rocks; Ok Tedi, PNG, Moscow SE slope (2008)

(b) Igneous intrusive rocks, Ok Tedi, PNG, Taranaki NE slope (2003)

(d) Igneous intrusive rocks; Ok Tedi, PNG Moscow SE slope (2008)

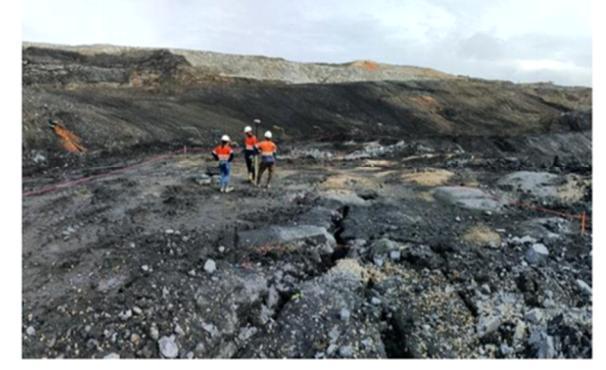
(e) significant backbreak from blasting induced gas-jacking along bedding planes; Pueblo Viejo, Dominican Republic, N slope (2021)

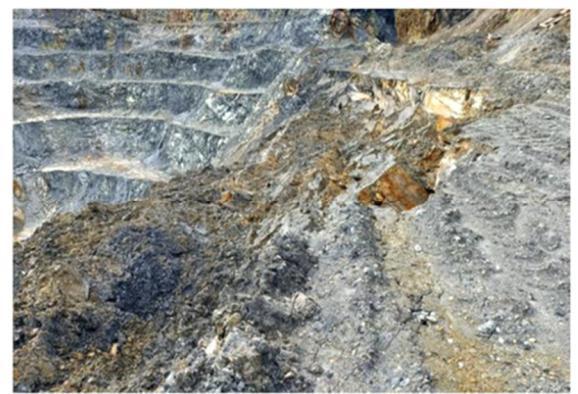
(f) Same as (e), plus unmanaged surface water flow inducing toppling instability (Pueblo Viejo, Dominican Republic, SW slope (2021)

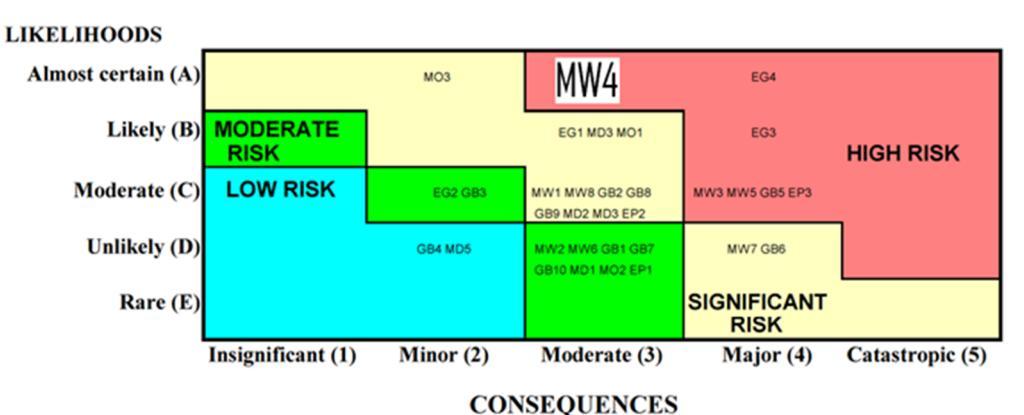
Little et al. (1998, 2000) interpreted high risk (MW4) for uncontrolled surface water erosion of Ok Tedi pit slopes (Figure 5). The likelihood of occurrence was rated as 'almost certain' and the consequence was rated as 'moderate'. This risk assessment reflects a typical rock condition scenario. This last comment is important because for purpose of 1996–2000 pit slope stability analyses, 36 geotechnical domains – most with two to three different slope-facing directions – were distinguished. Hence risks differed around the pit. Also, when this assessment was done, Ok Tedi pit slopes were 350–450 m high, structural data at 450–900 m depths was entirely based on orientated core drilling, difference existed between mapping and drilling data, and data was sparse in some existing pit domains and below its then pit bottom, especially for intensely fractured rock types (e.g. Taranaki, Parrot's Beak and Basal Thrust Fault Zones, some types of skarns, most siltstones and all mudstones). Some geotechnical models needed to be extrapolated over 400–500 m distances.

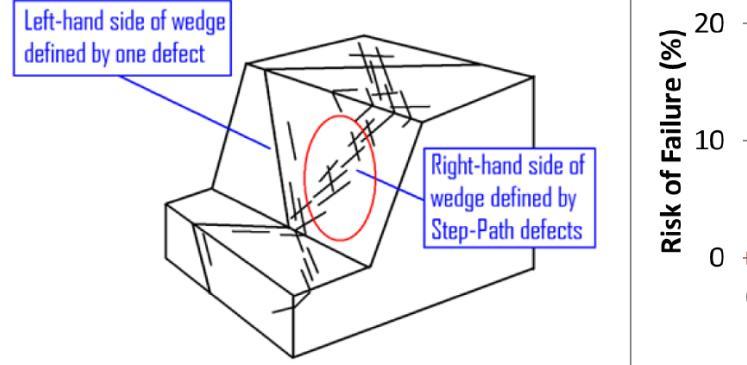
(a) Example of Step-Path Method (SPM) use for rock wedge sliding (Baczynski, 2023)

If one wishes to know how much of a bench height and its berm width are likely to fail, then defect length is important. In many rock masses, the majority (90–95%) of defects are often shorter than a typical 15 m high bench, but a full bench height failure might still develop by shearing along zones of coaligned shorter defects and through intact rock bridges between them (Figure 6a). Consideration of defect zones is a step-path method (SPM) approach (Baczynski 2023). Most times, zones of short defects are stronger than similar length individual defects. Thus, an SPM approach often reduces estimated bench failure risks. Figure 6(b to d) are examples of bench stability failure risks estimated in Little et al. (1999). Risks vary, with rock type, slope-facing direction, and relative proportions of bench height and berm width being considered. Risk that failure will impact one-quarter of bench height or berm width is much higher than the risk of losing the entire bench height or width.

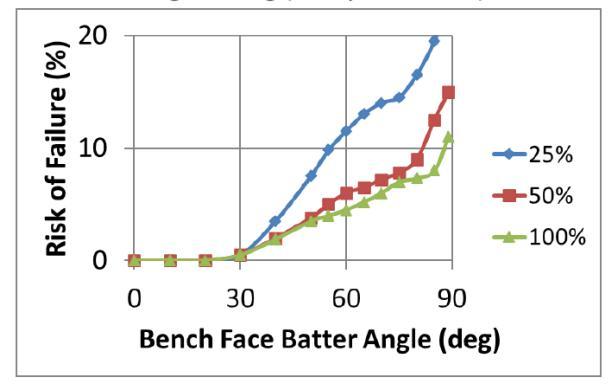
(c) Percent (%) of 15m bench height lost in Ok Tedi NE slope siltstone due to wedge-sliding

The above discussion, and examples in Figure 6, demonstrate that structurally controlled bench failures can be quantified, but the analyst needs to statistically consider all geotechnical factors likely to impact risks and not just use a simple stereographic projection kinematic stability approach. Figure 6b shows that with a 30° slope-facing direction for Ok Tedi Berlin Limestone, risk of wedge sliding bench failure is negligible for bench batter angles <45° but increases to ~15% for vertical faces. Figure 6c shows that bench wedge sliding failure for Ok Tedi New York siltstone is negligible for batter angles <30° but increases to >20% for near-vertical bench faces. For 15 m high benches with 65° batters in various Ok Tedi Moscow area rock types, Figure 6d shows that the risk of losing 25% of berm width is 6–22%, 50% berm loss is 5–19% and entire berm loss is 3–10%.

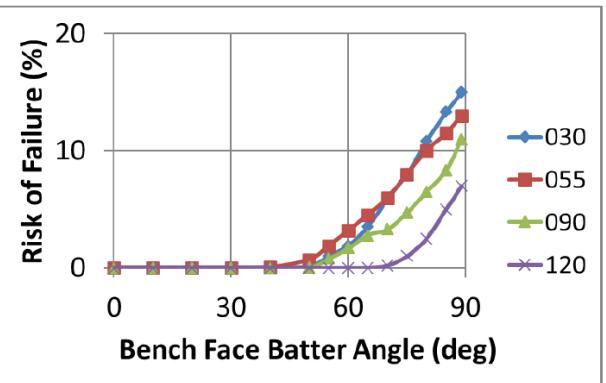
(b) Risk-impact of bench facing direction and face angle for Ok Tedi Berlin Limestone

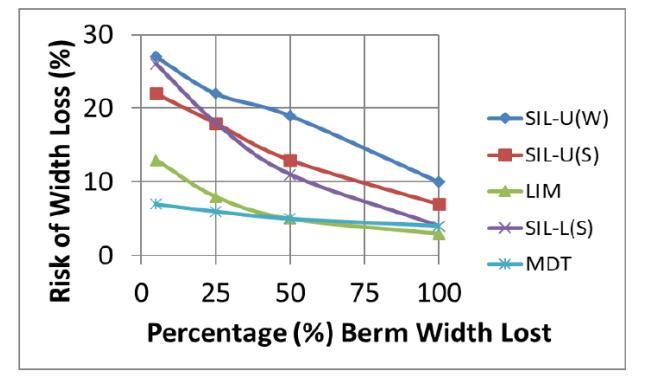
(d) Percent (%) of 8m berm width lost on benches with 65° batter angles in various rock types

In simple terms, Figure 6d shows that, on average, every 100 m of bench length was expected to have a 3–10 m cumulative length section where bench berm had totally failed by wedge sliding and a 5–20 m section where half the berm width is lost. This outcome highlights the challenges in water drainage along the mine's benches.

Figure 6d also indicates that even without bench water erosion consideration, some Ok Tedi rock types are more prone to structurally controlled failure. In the plotted results, Ok Tedi ieru siltstone [SIL-U(W), SIL-U(S) and SIL-L(S)] have a higher failure risk than darai limestone (LIM)or monzodiorite (MTD) intrusive rocks.

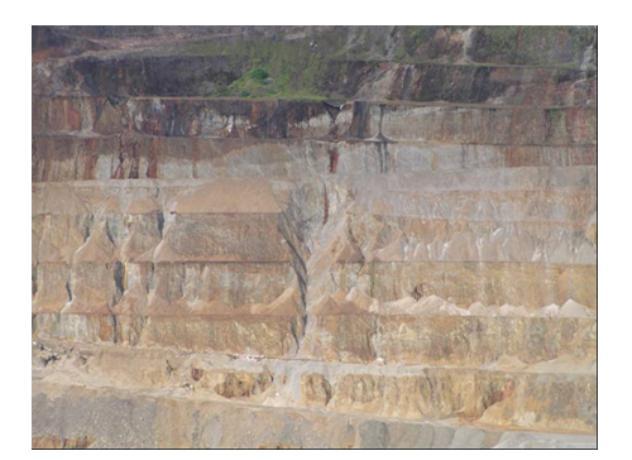
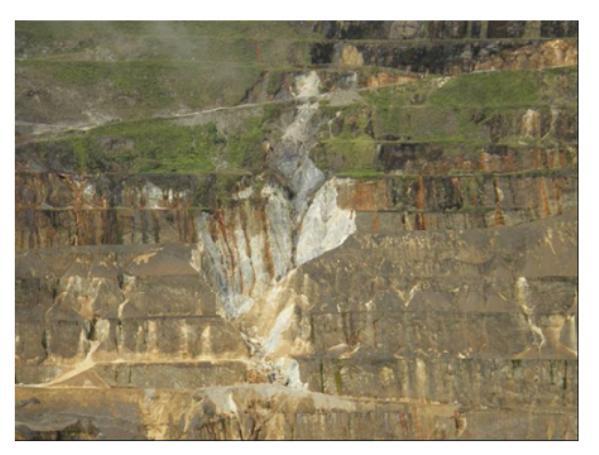
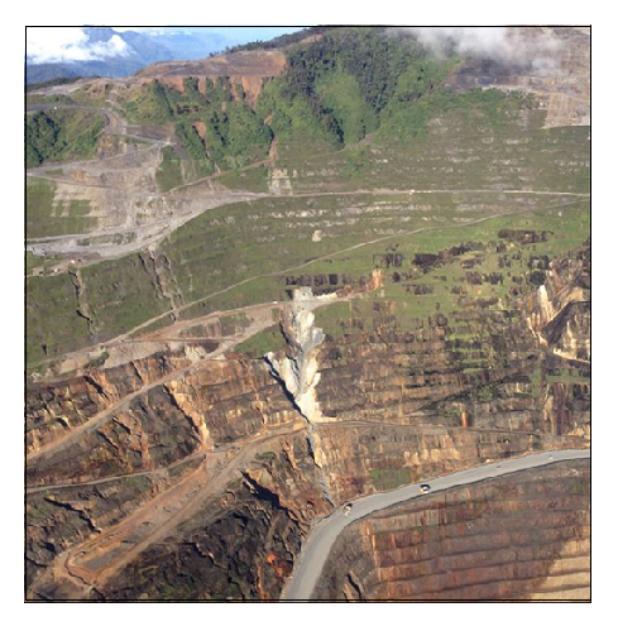
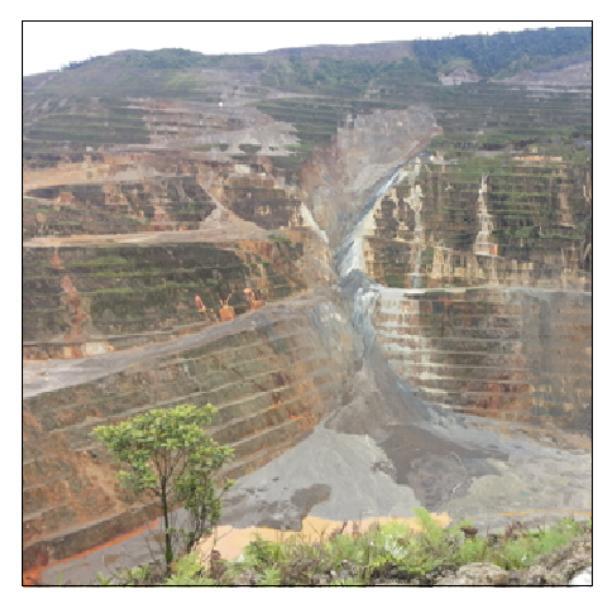
Figure 7 Progressive expansion of chasm W3 on the west wall at Ok Tedi Mine between 2006 and 2015

(a) Nov 2006 (50m high)

(b) Nov 2011 (120m high)

(c) Dec 2013 (180m high)

(d) Jun 2015 (450m high)

The timeline for chasm expansion without remedial measures is likely exponential, especially in weak ground and high rainfall situations. Chasm W3 shown in Figure 7 was first noticed in late 2004, when a cross slope light vehicle (LV) access ramp was being constructed. In its early stages, this chasm was repairable. Various options were discussed and recommended to reinforce this void's surface when it was still only two to three benches high, but none were agreed on or pursued. By 2009–2010, the chasm was 90 m high and considerable remedial effort was now being made to arrest further erosion of its crest and V-notch toe. Figure 7c shows that in December 2013, the chasm's toe was at the level of the LV cross slope ramp. By early February 2014, the chasm's toe had cut through the LV ramp to about 40 m below it. Prompt major repair action was urged. Use of pit mining equipment was needed to backfill the chasm's toe back above LV ramp level, but this task was not pursued. By May–June 2014, the chasm's toe had reached the pit haul road, regularly inundating it with huge volumes of debris (as shown in Figures 1c, d and f). Figure 7d attests that the chasm's expansion accelerated in 2014 until, by mid-2015, it was 450 m high (i.e. the same as a 150-storey high-rise building) and had destroyed the haul road.

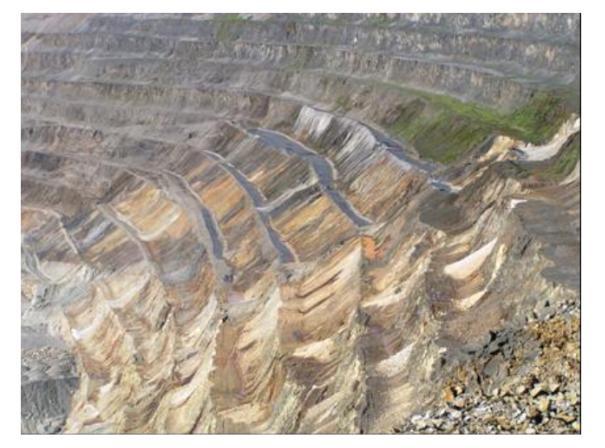
(a) Black HDPE lined bench berm, erosion on unlined berms, Ok Tedi, PNG (Sep 2003)

- Bench top cover (i.e. use of high-density polyethylene (HDPE) liner on bench berms; Figure 8a).
- Water drains lined with HDPE (Figure 9b), fibre-reinforced shotcrete (Figure 9c), the latter with steel mesh if required; placement of angular cobble rockfill blankets to protect the HDPE from ultraviolet damage and rockfall impact holes, and to slow water flow in drains; and lining drains with rock-filled gabion mattresses (this latter method was not used on the authors' mining projects).

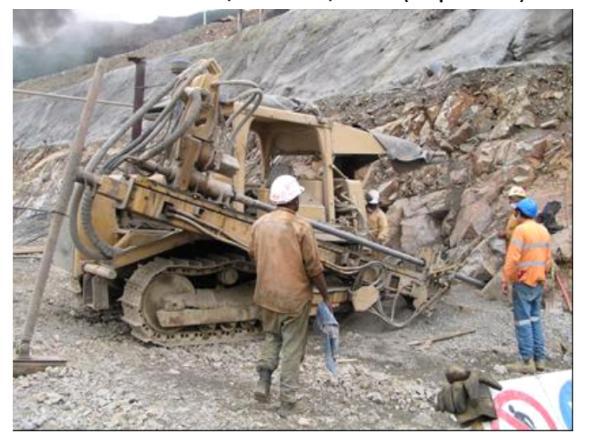
(c) Work-in-progress; meshed, 10-strand, 100t tensioned cable anchored, fibre-reinforced shotcrete sprayed bench face beneath mine office and in-pit crusher (May 2006)

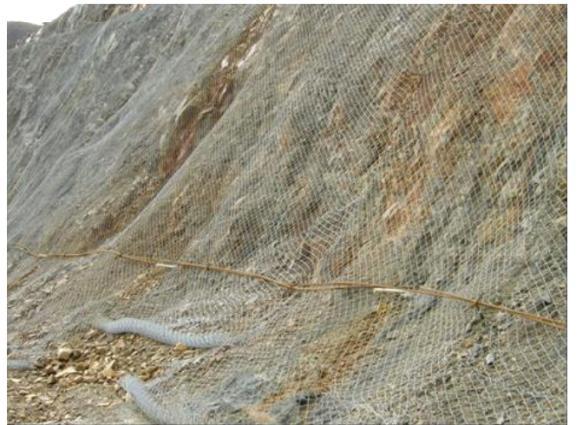
(e) Mesh, cable-dowels (before fibre-reinforced shotcrete) beneath mine access road in 60-80m thick thrust fault zone; Ok Tedi, PNG; Paris-Berlin SW slope (Apr 2012)

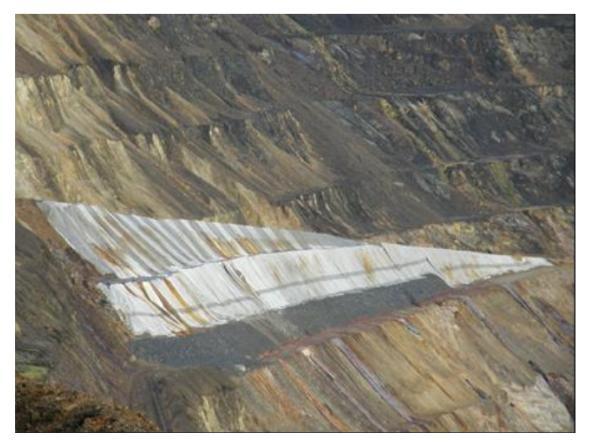
(b) Geotextile cloth covered face of access ramp to toe of Edinburgh Chasm (Jan 2008)

Water drains to ensure that water drains along bench toes are functional (i.e. engineered with survey-controlled gradients, able to long-term conduct the anticipated volume of flow of runoff water – both rainfall and groundwater from flow bores, to agreed and adequately engineered drop points either down into the pit workings or to designated on-slope catchment sumps for its pumping out from the open pit footprint area. • Bench face cover (i.e. geotextile cloth placed over bench faces in soft erodible ground is also a good preventative erosion control measure; Figure 8b).

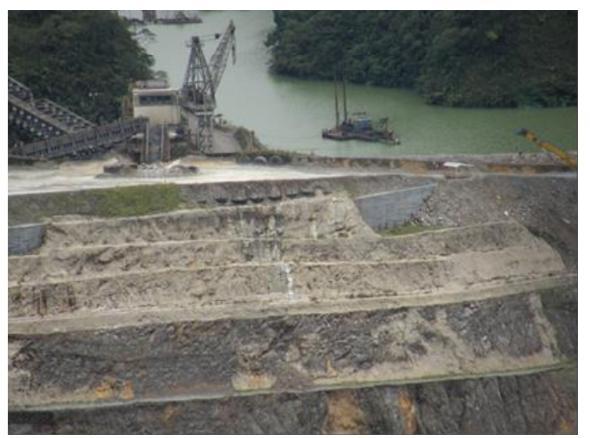
(d) Final-Slope in Photo (c); bench face beneath mine office and crusher; 1-2m thick thrust fault zone at 10-20m below reinforced slope (Feb 2007)

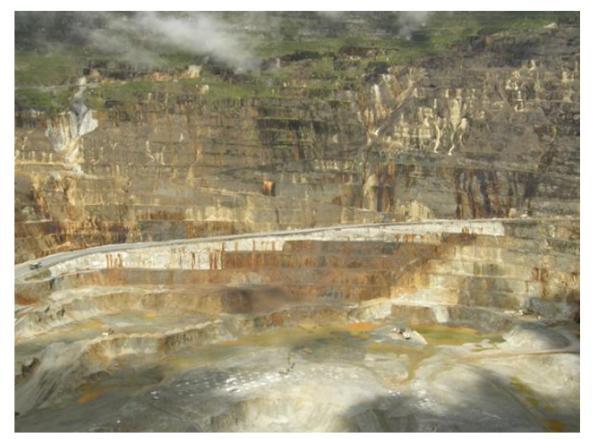
(f) Vertical crest piles, cable-dowels and mesh sprayed with fibre-reinforced shotcrete beneath mine access road located in the 60-80m thick thrust fault zone (Nov 2011)

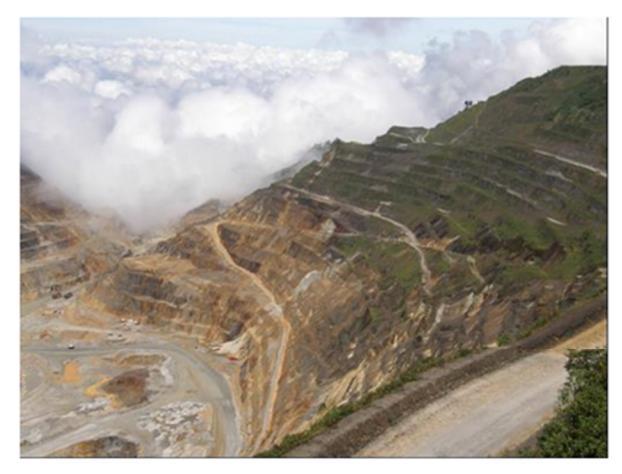
(a) Down-slope light-vehicle (LV) access ramp; Berlin-Paris area, West Wall (Aug 2009)

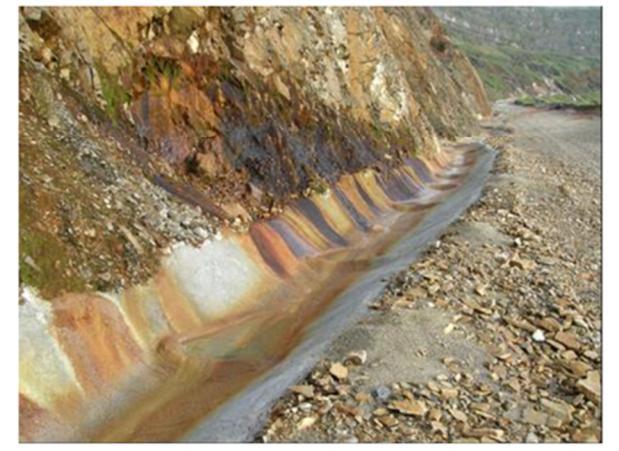
(c) Mesh and fibre-reinforced shotcrete drain; in-drain mini flow arrest dams, downslope LV access ramp, Berlin, West Wall (May 2010)

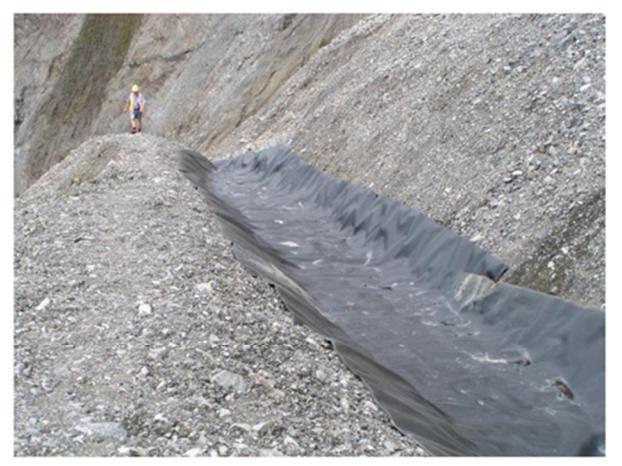
(b) HDPE lined, rockfill-shaped, water drain, Berlin area, West Wall (Mar 2005)

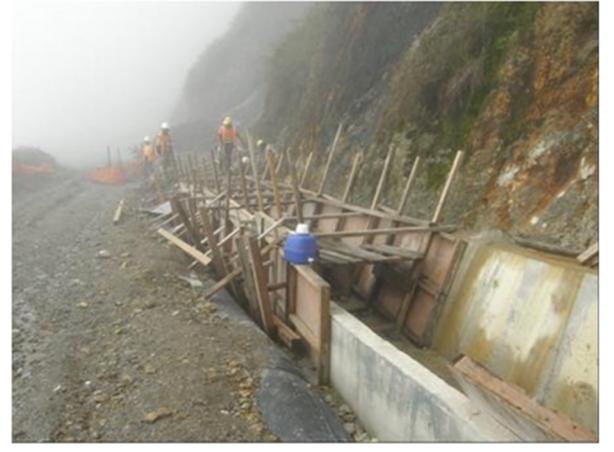
(d) Construction of cast in-situ concrete culvert open drains along downslope LV access ramp; Berlin area, West Wall (June 2011)

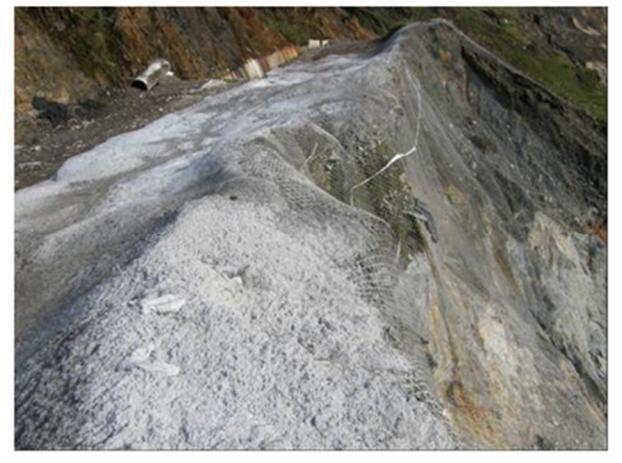
(e) Chasm crest reinforced with shear piles, mesh and fibre-reinforced shotcrete; Berlin Chasm. West Wall (Sep 2012)

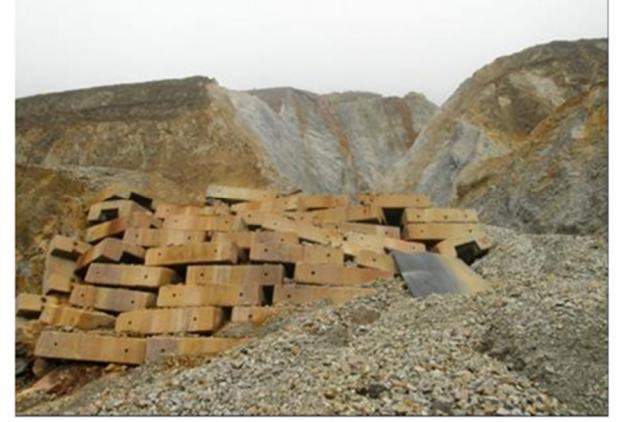
(f) Chasm's V-notch toe buttressed with leftover concrete sleepers from mine's 4km long drainage tunnel, Berlin Chasm (May 2010)

- Barricading/buttressing the toe of V-notch chasms to lessen the volume of runout debris and to slow the chasm toe's downwards migration towards the pit floor. If hard rock boulder-size rockfill is not available, any durable materials can be used to construct the buttress (as shown in Figure 9f). Ensuring that the chasm toe is long-term accessible to repair buttress washouts promptly after these occur.

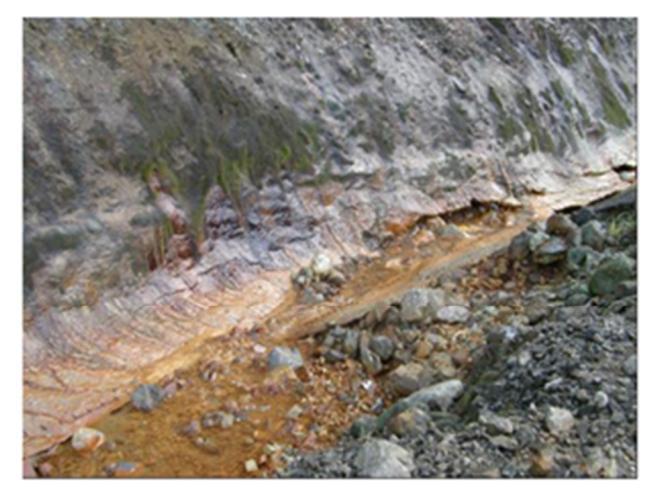
(a) Rockfall punctured and acid water corroded, meshed and shotcrete-sprayed drain, Berlin, West Wall (May 2014)

Figure 10 Ok Tedi, PNG: recurring damage to meshed and fibre-reinforced water drains on benches

There is little merit in having sufficient special/capital budget funds for installing the preventative/remedial measures but then not allocating adequate recurring funding for maintenance repairs. This is an ongoing task. HDPE liners become brittle and crack after periods of sunlight exposure. Shotcrete-lined drains are subject to acid mine water corrosion. Both HDPE-lined and shotcrete-sprayed drains may be punctured by rockfalls from the bench face above (Figure 10a). Shotcrete is cracked by ground displacements (Figure 10b). With such damage, much of the drains water flow occurs beneath the drain's lining; eroding and creating voids in the ground beneath the lined drain. Significant-size rockfalls block drains and this debris must be cleared to re-establish drain's intended function. Buried drainage pipes may likewise be blocked by rockfall debris washed into them; such blockage must be promptly cleared. Integrity of buried and above-ground pipe joins is also damaged by ground displacements.

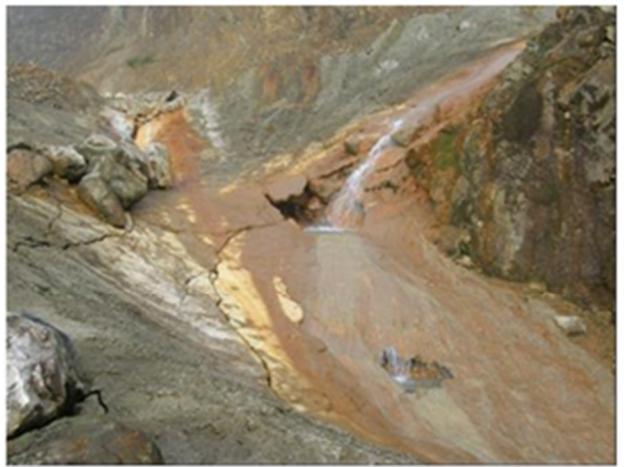
(b) Ground displacement-induced cracking and acid mine water corrosion of shotcretesprayed drains; Berlin, West Wall (May 2010)
