# Rockfill embankment construction on tailings — realistic, cost-effective and reliable application at Xstrata, Mount Isa, Australia

## Abstract

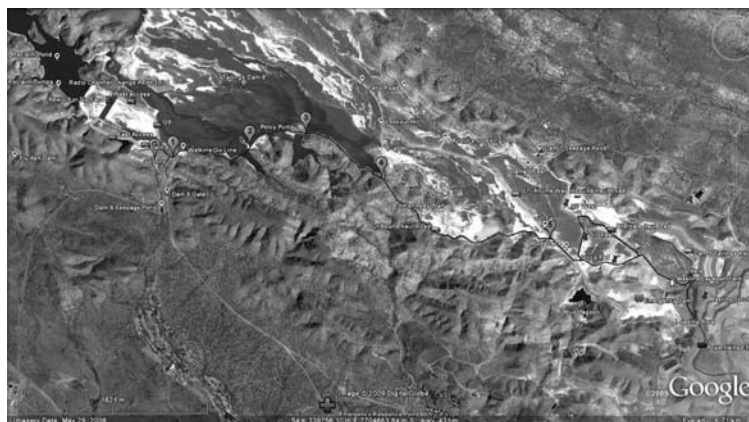
**Figure 1 Tailings storage general layout (north to left border)**

The ‘live’ TSF No. 7 and 8 comprise five external walls with nine internal groyne, the terminology designates the usage of the asset a ‘groyne’ is within the confines of the dam and a ‘wall’ is external part of the dam boundary, covering an estimated area of 1,300 hectares. An aerial photo of the existing tailings facility is shown in Figure 1. Current operational capacity, as of Q2 2009, was approximately 16 million m<sup>3</sup> with more capacity identified in late 2009 with the utilisation of the western and southern evaporation ponds.

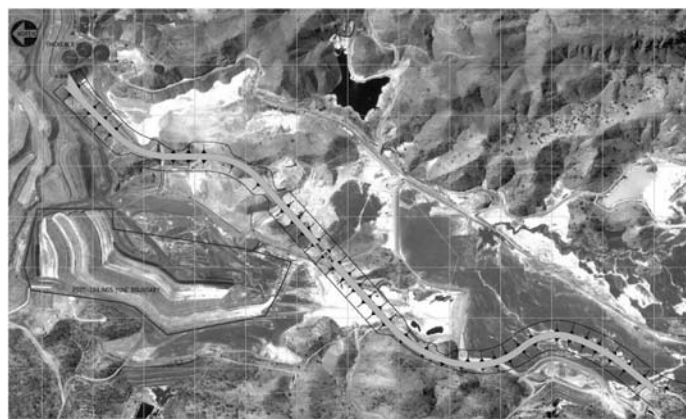
**Figure 2 Proposed outfall groyne tailings TSF No. 5**

The current tailings strategy is to continue depositing wet tailings sub-aerially via a gravity outfall line to the existing tailings dams, and to raise dam walls and groyne as they become necessary. The existing strategy will prove to be usable for two to four years by which time an alternative outfall should be established. A proposed outfall groyne at tailings TSF No. 5 is shown in Figure 2. The northern end of the groyne is approximately 35 m high, and the southern end is approximately 15 m high.

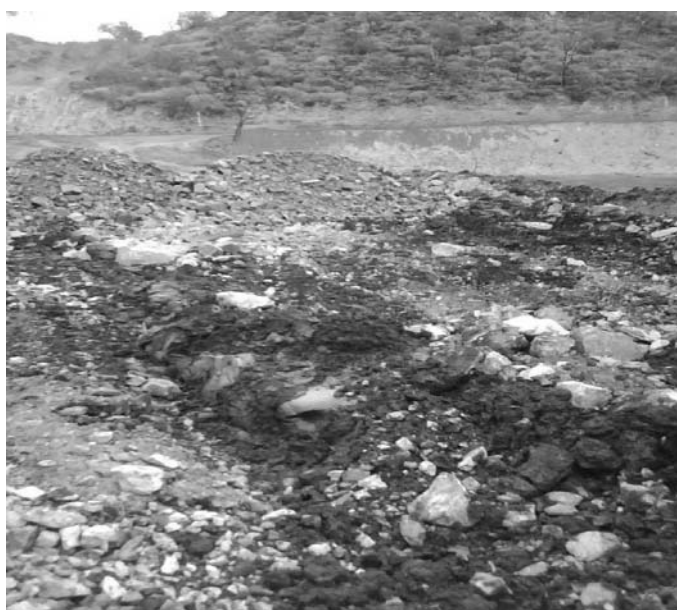
**Figure 13 Typical penetration of tailings – push into tails**

Initially a compacted layer was laid out across the base to form the solid work platform as per the original design (Section 3.1). However, construction issues with this initial tactic became evident immediately. When trying to establish the foundation layer, large penetrations of tails occurred and the stability around these areas was questionable as shown in Figure 13. As a result of internal discussions, a decision was made to construct the groyne using the ‘ice-breaker’ approach to displace and replace the tailings by end-dumping.

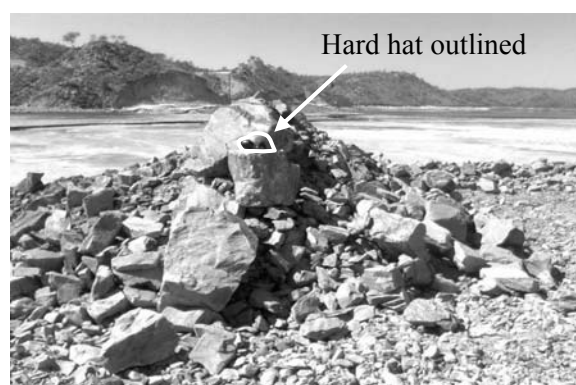
**Figure 14 ROM from BSOC (hard hat for scale)**

The rock used for construction was sourced out of rock waste from the Black Star Open Cut. The rock waste was composed mainly of siltstone and shale. The sourced rock was ROM and the only monitoring was carried out by the operators placing aside rock considered too large to be safely transported by the Caterpillar 740s. A typical load of ROM is pictured in Figure 14 sized against a hard hat. There was a previously sorted pile of rock fines (under 200 mm) that were used to cap the groyne to limit tyre issues on the trucks.

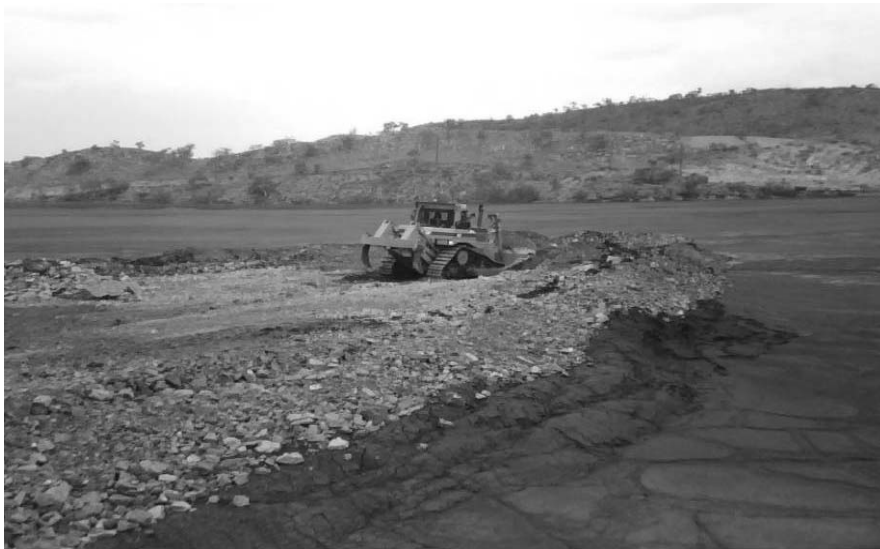
**Figure 16 Mud wave ahead of D10**

Figures 16 and 17 show the mud wave developed in response to the end-dumping method and near completion of the groyne, respectively. Tails penetration can clearly be seen at the end of the groyne in Figure 16.

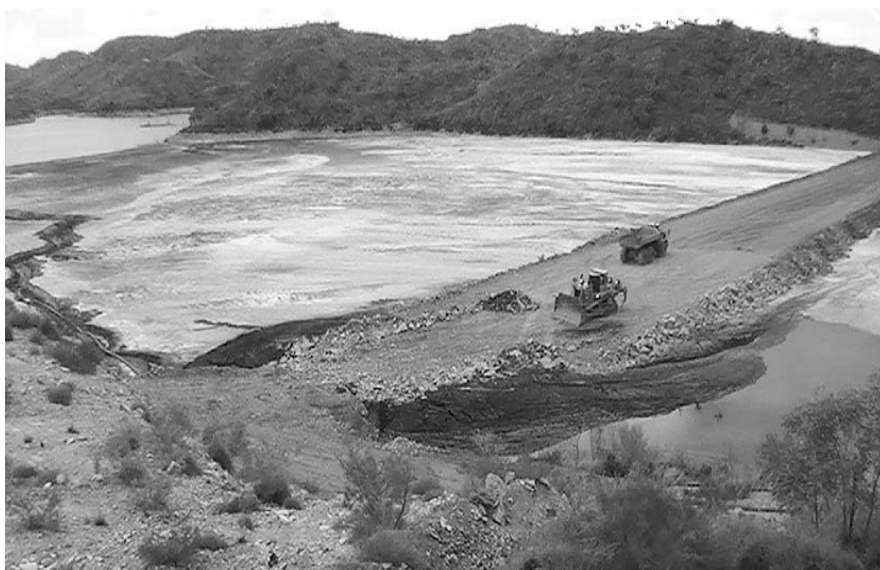
**Figure 17 Groyne No. 9 near completion to full height**
