# Rockfill embankment construction on tailings — realistic, cost-effective and reliable application at Xstrata, Mount Isa, Australia

**G. Reinke** *Xstrata Copper, Australia*

## Abstract

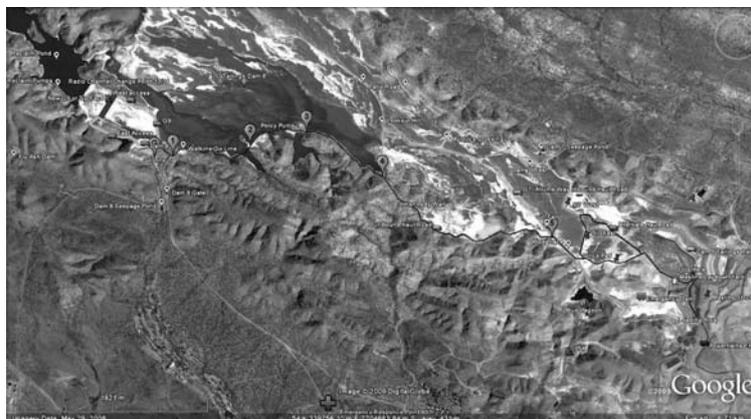
**Figure 1 Tailings storage general layout (north to left border)**

The ‘live’ TSF No. 7 and 8 comprise five external walls with nine internal groyne, the terminology designates the usage of the asset a ‘groyne’ is within the confines of the dam and a ‘wall’ is external part of the dam boundary, covering an estimated area of 1,300 hectares. An aerial photo of the existing tailings facility is shown in Figure 1. Current operational capacity, as of Q2 2009, was approximately 16 million m<sup>3</sup> with more capacity identified in late 2009 with the utilisation of the western and southern evaporation ponds.

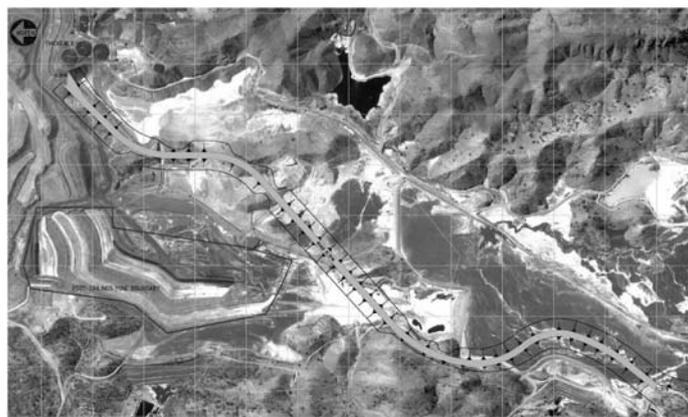
**Figure 2 Proposed outfall groyne tailings TSF No. 5**

The current tailings strategy is to continue depositing wet tailings sub-aerially via a gravity outfall line to the existing tailings dams, and to raise dam walls and groyne as they become necessary. The existing strategy will prove to be usable for two to four years by which time an alternative outfall should be established. A proposed outfall groyne at tailings TSF No. 5 is shown in Figure 2. The northern end of the groyne is approximately 35 m high, and the southern end is approximately 15 m high.

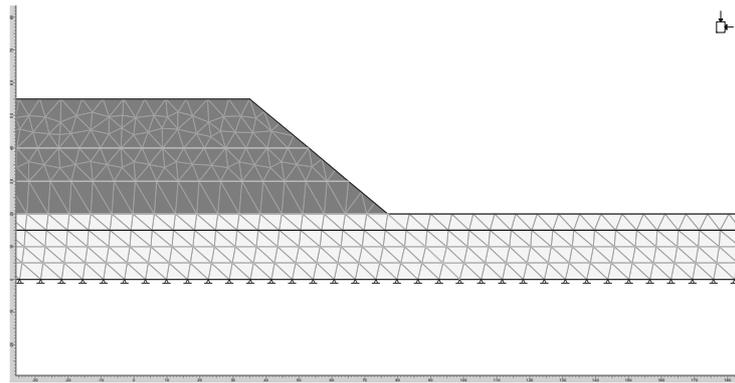
For the purpose of the modelling, the rockfill embankment was constructed on three lifts of uniform thickness. Figure 4 shows the model of the layer-dumped method.

**Figure 4** Layer-dumped model

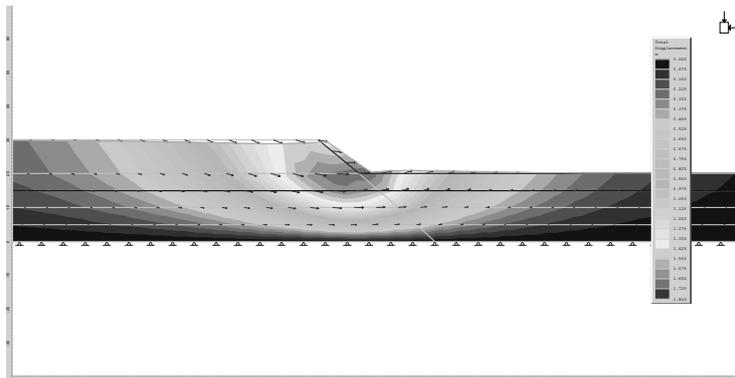
Figures 5 and 6 present the predicted total displacement that will result from placing the first and final rockfill lifts, respectively. It should be noted that the numerical stability of the problem could not be achieved primarily due to the low strength of the tailings (i.e.  $C_u$  of 10 KPa) which indicate definite failure of the rockfill embankment. For the sake of completion of the numerical simulation,  $C_u$  was gradually increased to 100 kPa to achieve numerical stability of the problem to allow visualisation of the deformation and failure mechanism.

**Figure 5** First lift - layer-dumped method – total displacement contour plot

Figures 5 and 6 illustrate that a major failure is imminent as indicated by the large deformation of the rockfill and tailings. The total displacement plots also demonstrate that the failure will most likely be initiated during the placement of the first lift or at some stage during construction of the embankment. The results of the modelling of the layer-dumped indicate that placing the embankment on the surface of the tailings with no allowance for rock penetration (i.e. reality) or additional support such as geotextile is not physically and/or

It should be mentioned that, during placement of the rockfill, ‘mud wave’ will most certain take place as shown in the figures. The ‘mud wave’ or surface heave is an indication of simultaneous tailings displacement and bearing failure due to the load imposed by the rock fill as construction progresses. It is anticipated that the tailings may heave to up to approximately 5 m. The ‘mud wave’ may reach its peak at approximately 20–30 m away from the toe of the rockfill, then diminishing gradually beyond this distance.

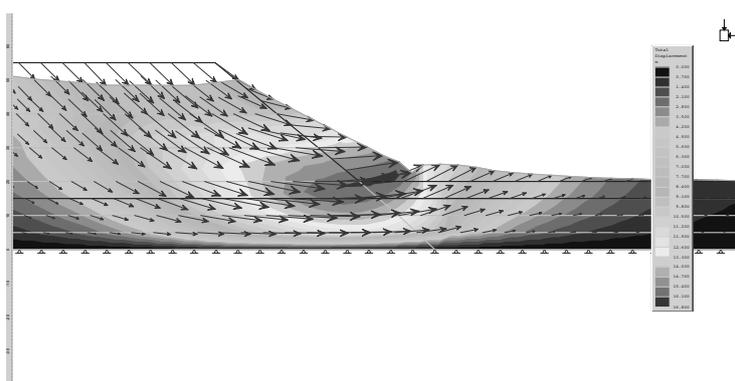
**Figure 6** Third lift - layer-dumped method – total displacement contour plot

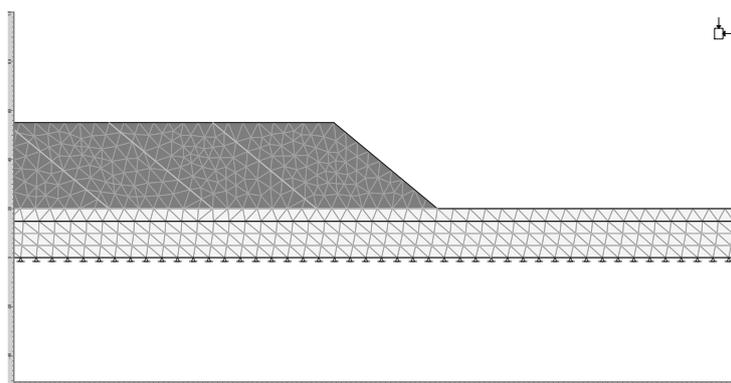
Figure 7 shows the model of the end-dump method. In this method, the dump face advances forward once the full height of the dump has been reached. In the same manner as mentioned in Section 4.1.1,  $C_u$  was increased to 100 kPa to achieve numerical stability of the problem to allow visualisation of the deformation and failure mechanism.

**Figure 7** End-dumping model

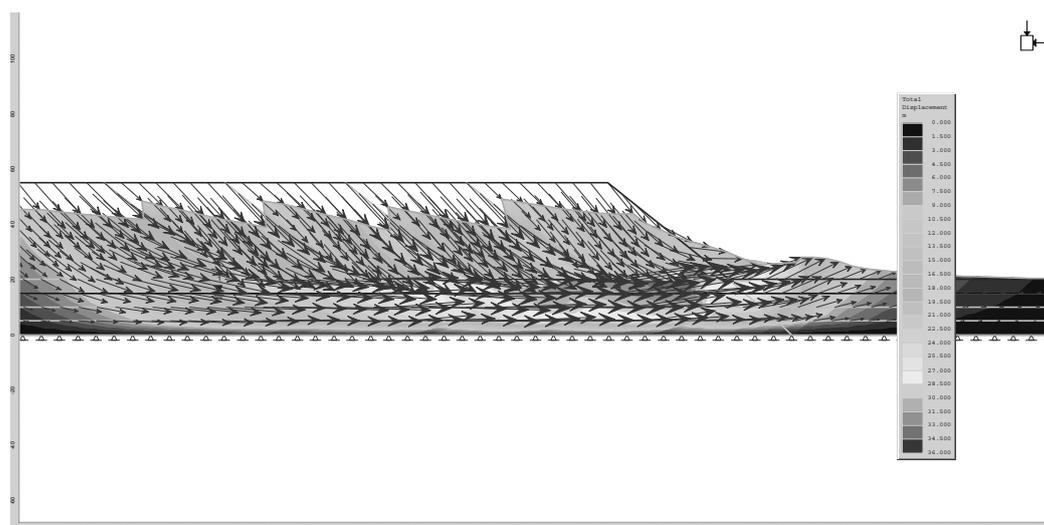
Contour plots of the total displacement for a number of consecutive rock dump faces are shown in Figure 8. The figure indicates that failure of the tailings will occur as the dump face advances. The figure shows also that the ‘mud wave’ moves forward concurrently with the dump face. The dimensions of the ‘mud wave’ appear to be similar to that of the layer-dumped method of approximately 5 m heave at approximately 20–30 m from the toe.

**Figure 8** End-dumping method – total displacement contour plot

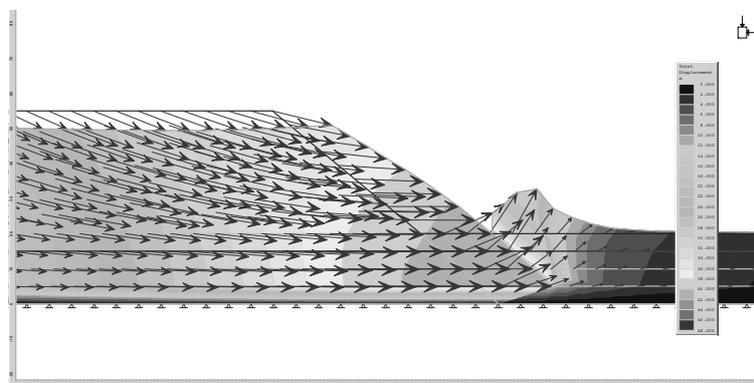
The contour plots of the total displacement are shown in Figures 9 to 10 for the two scenarios respectively. Comparison of the two figures reveals that for the embankment to be built to the full height of 35 m, deep penetration of the rockfill is required. The 15 m rockfill penetration into the tailings appeared not to be adequate to support the embankment load as indicated by the large deformation and potential failure (Figure 9). Scenario 2 is considered the most realistic one, and is likely to occur if a 35 m high rockfill embankment is to be built. It should be noted that the total displacement shown in Figure 10 is the deformation of the embankment itself as it is founded on the in situ rock.

Figure 9 Rockfill: 15 m penetration (3/4 tailings thickness)

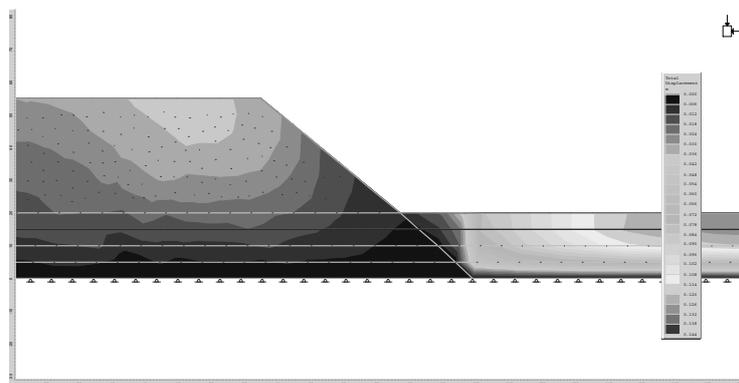
Figure 10 Rockfill: 20 m penetration (full tailings thickness)

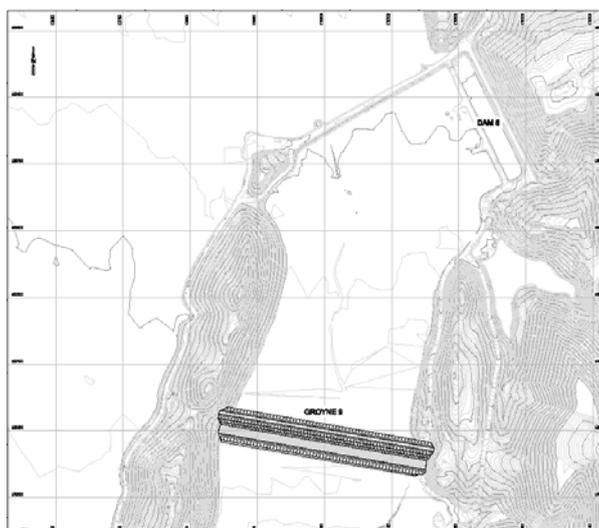
Recently at tailings TSF No. 8, a groyne named No. 9 was constructed using the end-dumping method (i.e. ice breaker). A plan showing the location of the groyne is given in Figure 11. The height of the groyne is approximately 2.3 m above the tailings surface. The tailings TSF No. 8 wall is currently at Stage 3 height (RL 3479) which was designed and completed in the early 1990s. This wall was raised using the Stage 2 wall of the late 1970s as its foundation. An earlier Stage 1 wall was inundated with the construction of Stage 2 as issue with ground water penetration deemed it unsuitable. Tailings TSF No. 8 wall is to be raised further to Stage 4 and Stage 5 RL's using Stage 3 as the foundation.

**Figure 11 Location of groyne No. 9 – tailings TSF No. 8**

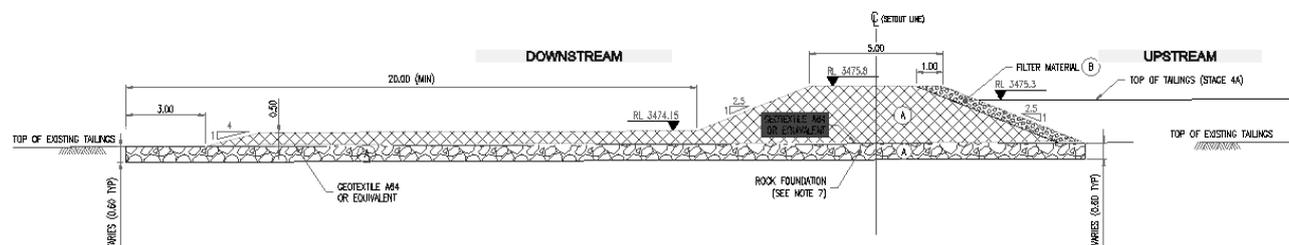
Initially, conventional design was made completed to build and raise the groyne on stages using the upstream construction method. A cross-section of the starter groyne is shown in Figure 12.

**Figure 12 Original cross-section – groyne No. 9**

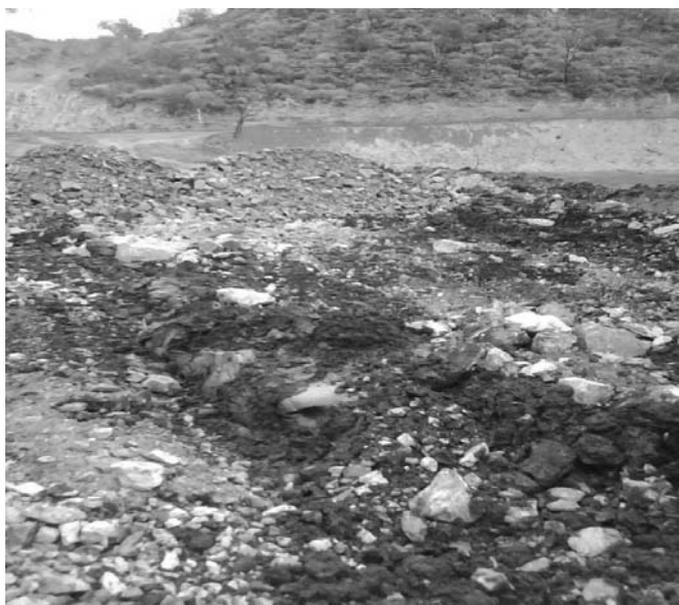
Initially a compacted layer was laid out across the base to form the solid work platform as per the original design (Section 3.1). However, construction issues with this initial tactic became evident immediately. When trying to establish the foundation layer, large penetrations of tails occurred and the stability around these areas was questionable as shown in Figure 13. As a result of internal discussions, a decision was made to construct the groyne using the ‘ice-breaker’ approach to displace and replace the tailings by end-dumping.

**Figure 13 Typical penetration of tailings – push into tails**

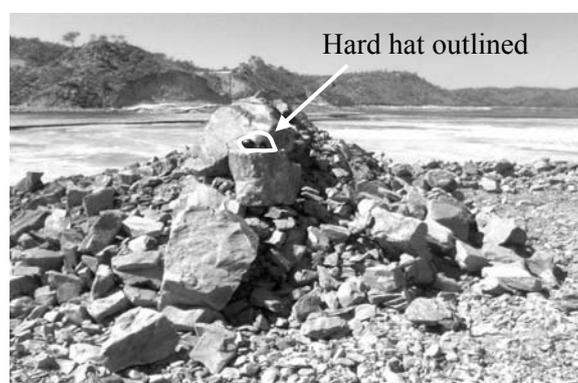
The rock used for construction was sourced out of rock waste from the Black Star Open Cut. The rock waste was composed mainly of siltstone and shale. The sourced rock was ROM and the only monitoring was carried out by the operators placing aside rock considered too large to be safely transported by the Caterpillar 740s. A typical load of ROM is pictured in Figure 14 sized against a hard hat. There was a previously sorted pile of rock fines (under 200 mm) that were used to cap the groyne to limit tyre issues on the trucks.

**Figure 14 ROM from BSOC (hard hat for scale)**

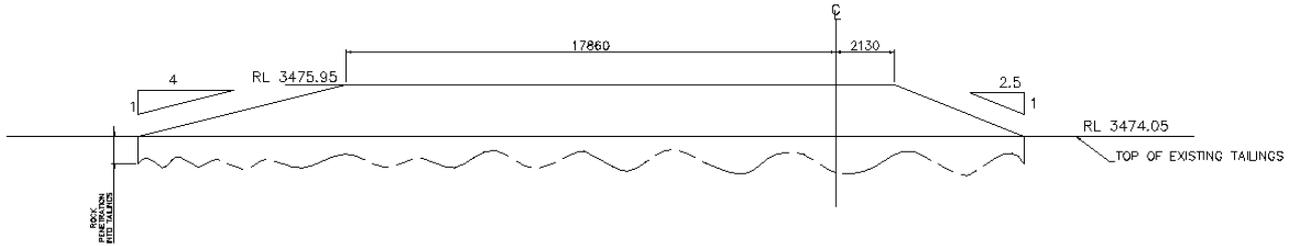
The final cross-section of the groyne is shown in Figure 15. The cross-section does not include the region of the tailings which were displaced by rocks (e.g. subsurface cross-section).

**Figure 15 Final cross-section – groyne No. 9 (tail on the downstream side was not constructed)**

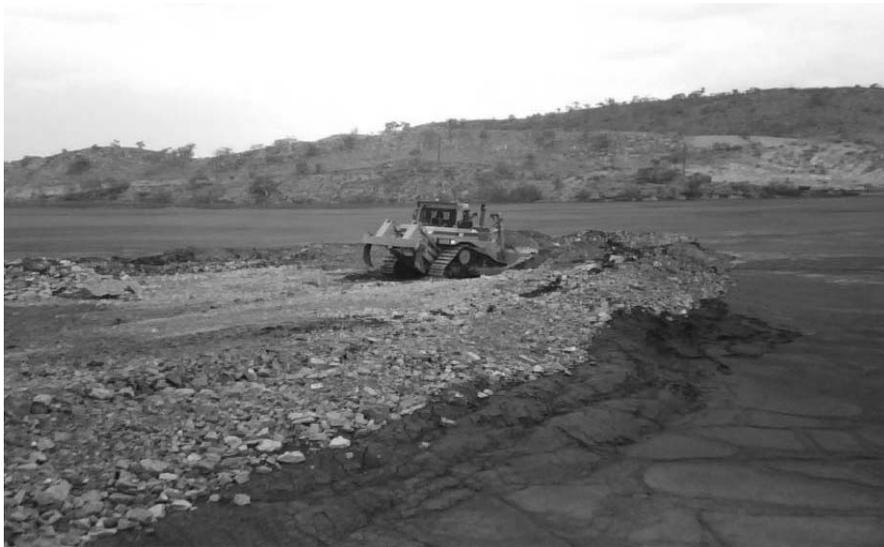
Figures 16 and 17 show the mud wave developed in response to the end-dumping method and near completion of the groyne, respectively. Tails penetration can clearly be seen at the end of the groyne in Figure 16.

**Figure 16 Mud wave ahead of D10**

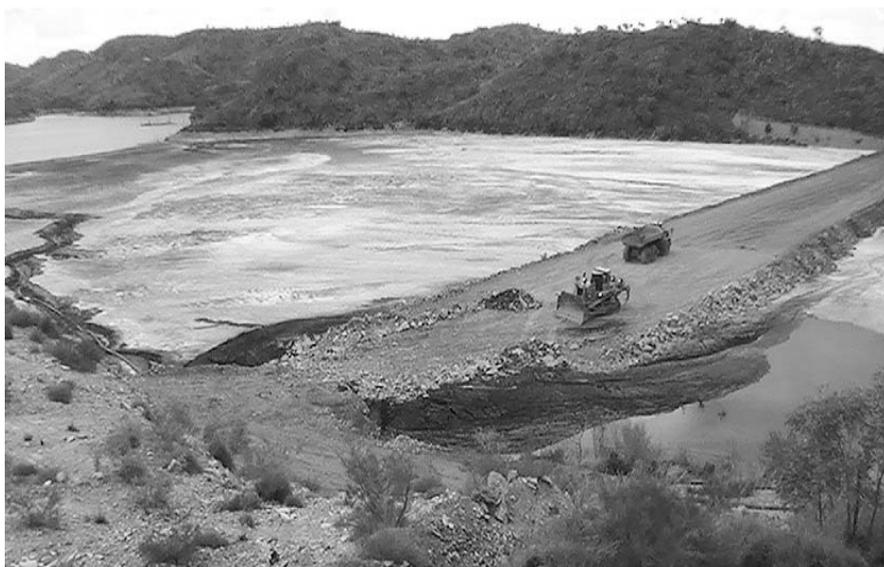
**Figure 17 Groyne No. 9 near completion to full height**

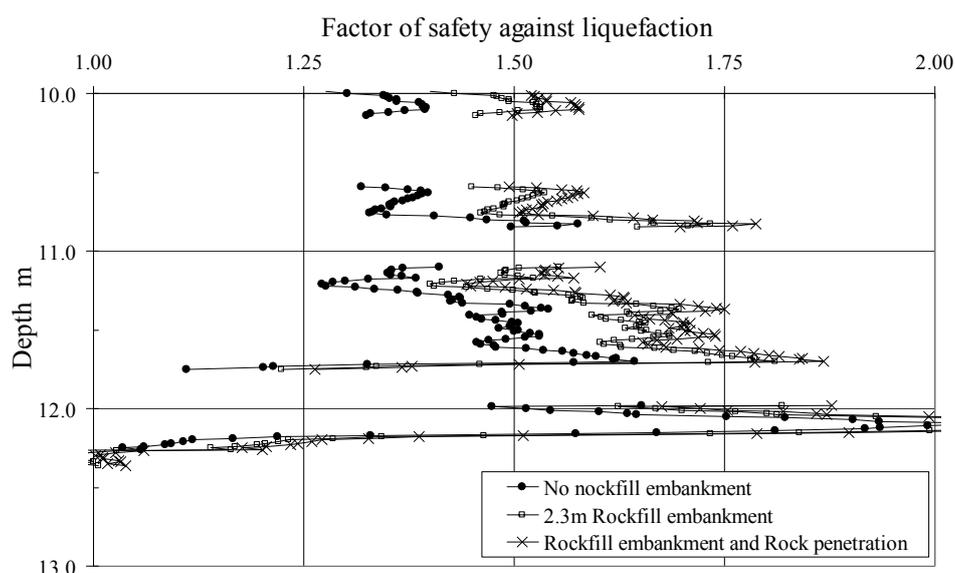
**Figure 18 Illustration factor of safety against liquefaction**

Since the completion of the groyne by the end-dumping method, no evidence of instability was found. It was concluded that the foundation had been improved due to the rock penetration, and hence the stability condition of the groyne was not considered an issue. Therefore, apart from conventional surface monitoring no additional monitoring would be required. It should also be mentioned that improving the foundation reduces the potential of failure due to liquefaction. The liquefaction potential as reported by Soliman (2008) was undertaken based on the method presented by Youd et al. (2001). The method is understood to be considered the best practice. Simply, the method requires calculation of the cyclic stress ratio (CSR) induced by the earthquake and the cyclic resistance ratio (CRR) which is a function of the strength of the material susceptible to liquefaction. In general term, for the liquefaction to occur the CRR should be less than CSR. For illustration purpose, an attempt was made to demonstrate the effect of rock penetration on the factor of safety against liquefaction. Figure 18 shows the calculated factor of safety for three scenarios using one of the cone penetration tests which were previously carried out at tailings TSF No. 5. These scenarios were: no rockfill embankment, groyne No. 9 of 2.3 m with no rock penetration into the tailings and the groyne with 10 m rock penetration. The figure displays the factor of safety with depth below the bottom of the rock penetration zone. The figure illustrates a general trend of further increase of the factor of safety in case of the rock penetration indicating. This is considered a significant risk reduction when compared with the potential risk associated with raising the groyne by the up-stream construction which needs to be managed in both the short and the long term.
