Whitewood Mine closure

D.D. MacKenzie *Navus Environmental Inc, Canada*

D.V. Kuchmak *TransAlta Corporation, Canada*

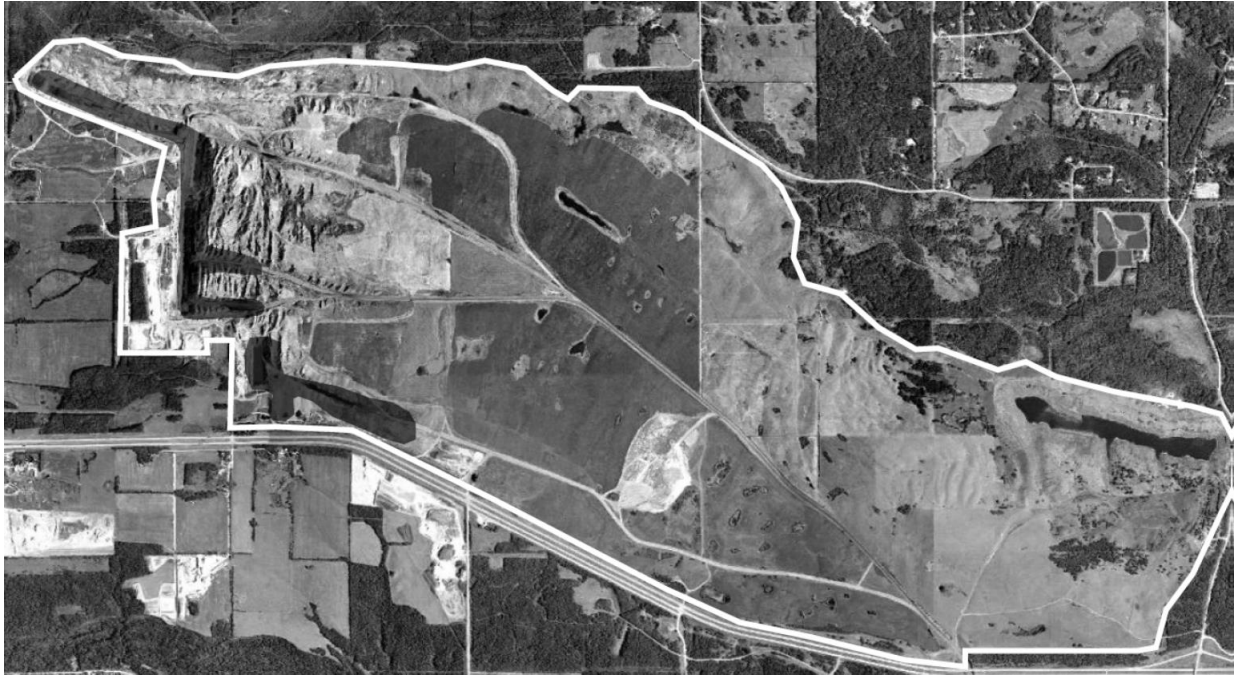
Figure 1 Aerial imagery of Whitewood Mine in 2009. The mined area is outlined in white, two proposed end pit lakes are shaded black on the left side of the image and East Pit Lake is located on the right side of the image
