Mine closure experiences — Bolivia, South America

A Cárdenas *Universidad Mayor de San Andrés, Bolivia*

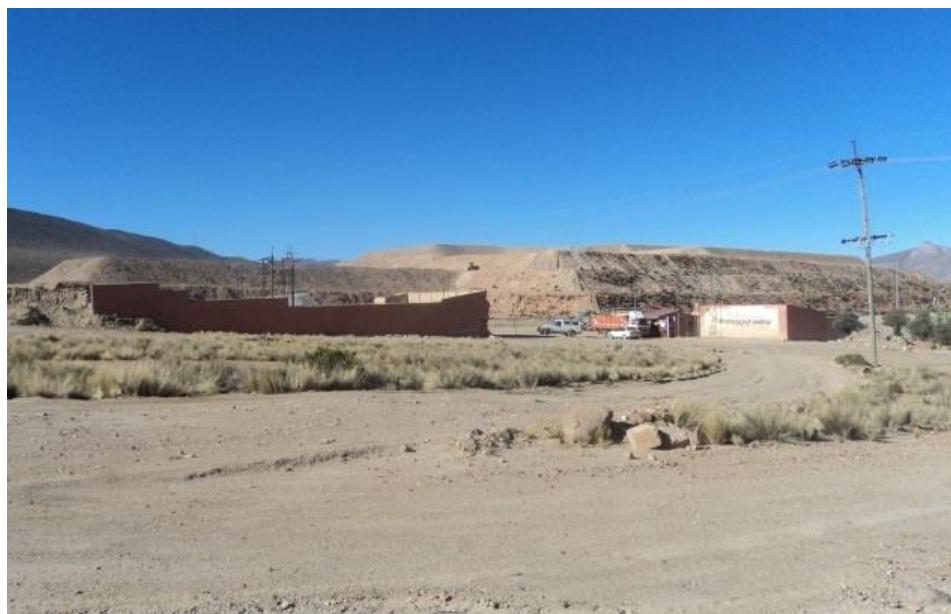
Compañía Minera Concepcion (COMCO) used to be a 2,000 tpd cyanide silver heap leaching plant that operated from 1988 to 2008. Through a cementation process followed by fusion, silver ingot was produced. Compañía Minera Concepcion left in place approximately two million tonnes of heap leaching tailings. No contouring, capping or revegetation of the heap slopes was conducted. Until now even the leaching ponds remain open. This is not a good example of responsible mine closure and is not in compliance with the minimum standards of the national environmental regulations (Figure 1).

Figure 1 Cyanide silver heap leaching facilities at Compañía Minera Concepcion, Potosí, Bolivia

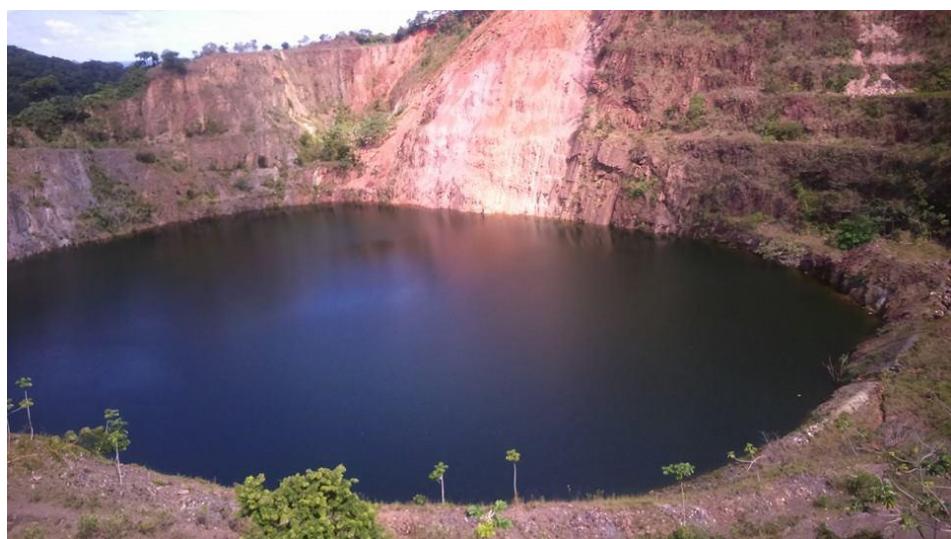
Puquio Norte Mine operated from 1995 to 2001 at 1,500 tpd. It was located in the tropical area of Bolivia, in the San Ramón Gold District, Santa Cruz. The waste dump and the TSF are physically and chemically stable and therefore have been acceptably closed, but this is not the case for the pit. The pit walls are steep and because of the quality of the material, the slopes are eroding and falling into the lake (Figure 2). Moreover, the pH of the water in the pit has turned acidic (pH 2). Apparently there is a non-controlled source of acid rock drainage (ARD) in the vicinity of the pit. This was confirmed during a site visit to the mine in 2014 by students from the Universidad Mayor de San Andrés (UMSA), Metallurgy Career (Yujra 2014).

Figure 2 Open pit left by COMSUR at Puquio Norte Mine. The oxidised gold ore was treated by cyanide agitation leaching, followed by the cementation and fusion process, Santa Cruz, Bolivia
