# Successful transitioning of a conventional slurry tailings storage facility for central thickened discharge

*A copper mine in Australia operated a perimeter discharge tailings storage facility (TSF) for storage of conventional slurried tailings. In response to regional water shortages, the mine installed a high-rate thickener to dewater the tailings. This provided an opportunity to transition the perimeter discharge TSF for central thickened discharge (CTD).*

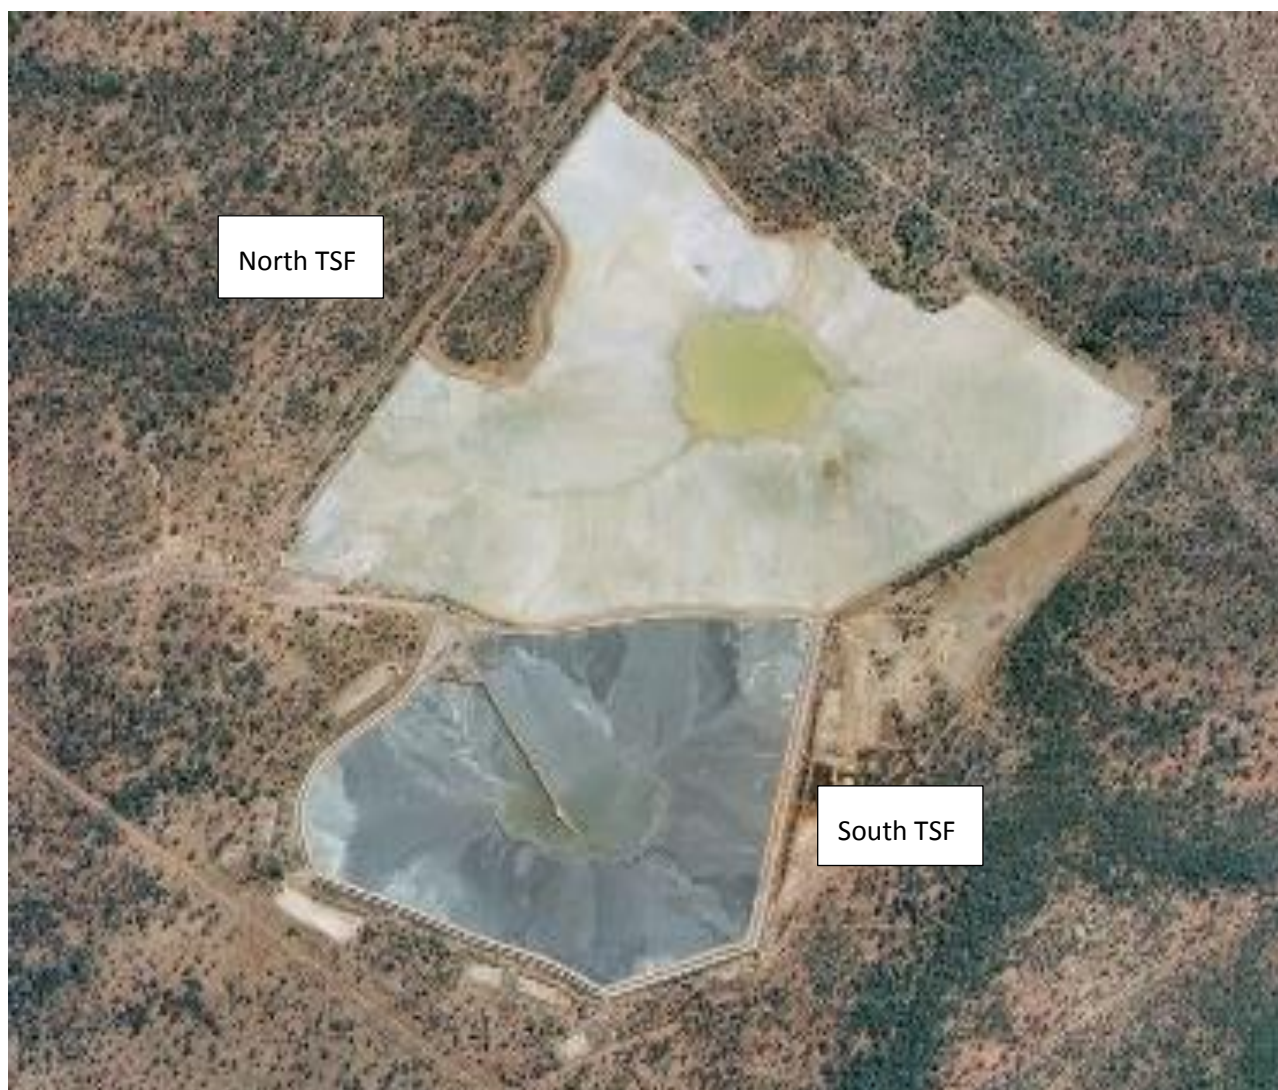
Figure 1 Aerial photograph of the site TSFs, dated August 2004

The site comprises two adjoining tailings storages – the South TSF and the North TSF, covering areas of approximately 80 and 110 ha respectively. The South TSF, the only storage operated by the mine and focus of this case study, abuts the North TSF on its northern side. The perimeter embankment was initially formed with compacted clay and rockfill in the 1960s. The embankment upstream was raised on four occasions with compacted clay and then raised with compacted tailings sourced from the impoundment area. A layout plan of the TSFs, as at 2004, is presented in Figure 1.

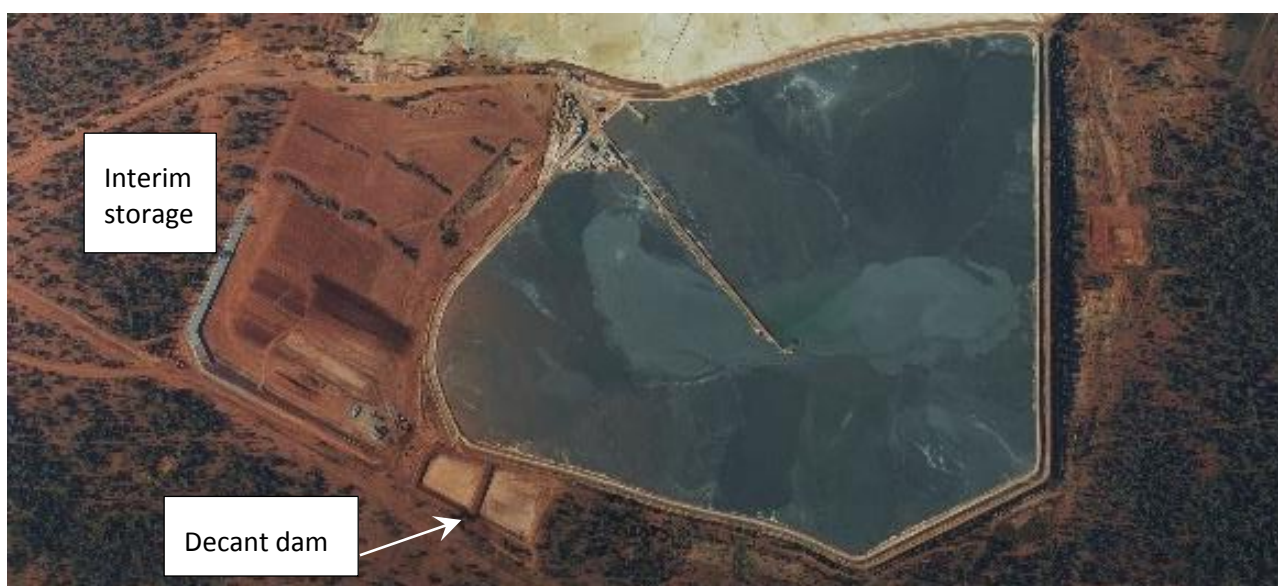
Figure 2 Aerial photograph of the South TSF during construction of the interim storage, September 2006

Deposition of thickened tailings into the interim storage commenced in early 2007, at which time deposition of tailings into the South TSF ceased. The interim storage was initially operated by discharge from its northern side and then later a causeway was constructed into the central area to form a central mound of tailings. Water management efficiency was not optimum for the interim storage due to its approximately rectangular shape but it provided storage capacity for a period of approximately 2.5 years, during which time the tailings beach in the South TSF was given time to dry and desiccate. An aerial photograph showing the clearing works for the interim storage, as well as the shape of the decant dam, is presented in Figure 2.

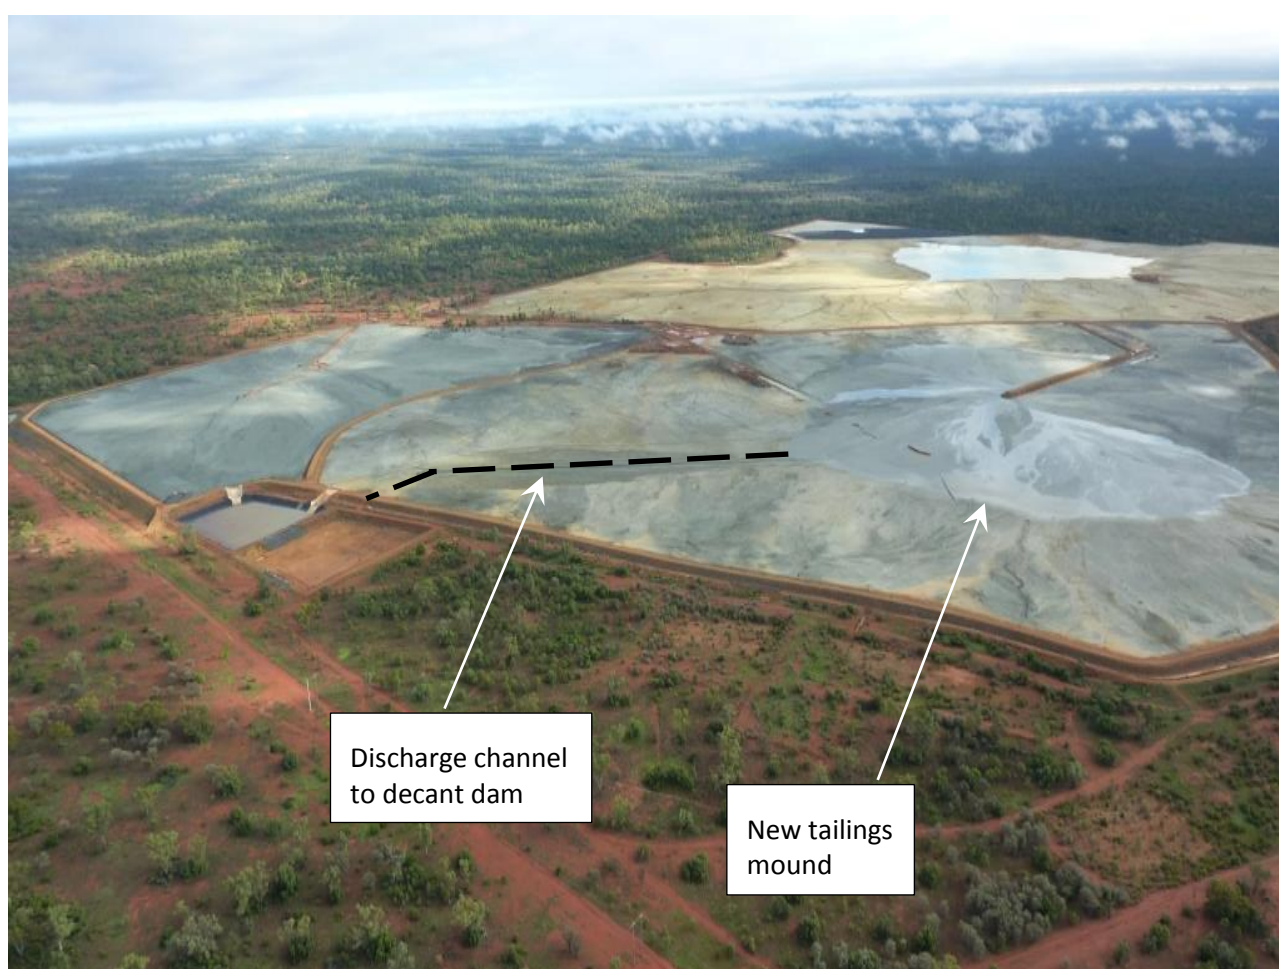
Figure 3 Aerial view of the site TSFs in early 2010, with the South TSF in the foreground

In early 2010, the tailings deposition causeway was constructed, a discharge channel excavated into the tailings beach and an outfall pipe was installed through the perimeter embankment. An aerial view of the South TSF following commencement of central discharge of tailings is shown in Figure 3.

The discharge channel can be seen in Figure 3, located between the new tailings mound and the decant dam. A series of filter berms were installed in the discharge channel to limit tailings from flowing to the outfall pipe located at the old perimeter embankment. A portion of the channel located adjacent to the embankment was lined with a geomembrane liner to limit the risk of seepage from water in the channel. A valve chamber for the outfall pipe, filter curtain and seepage depressurisation system was installed around the pipe where it passes through the embankment.

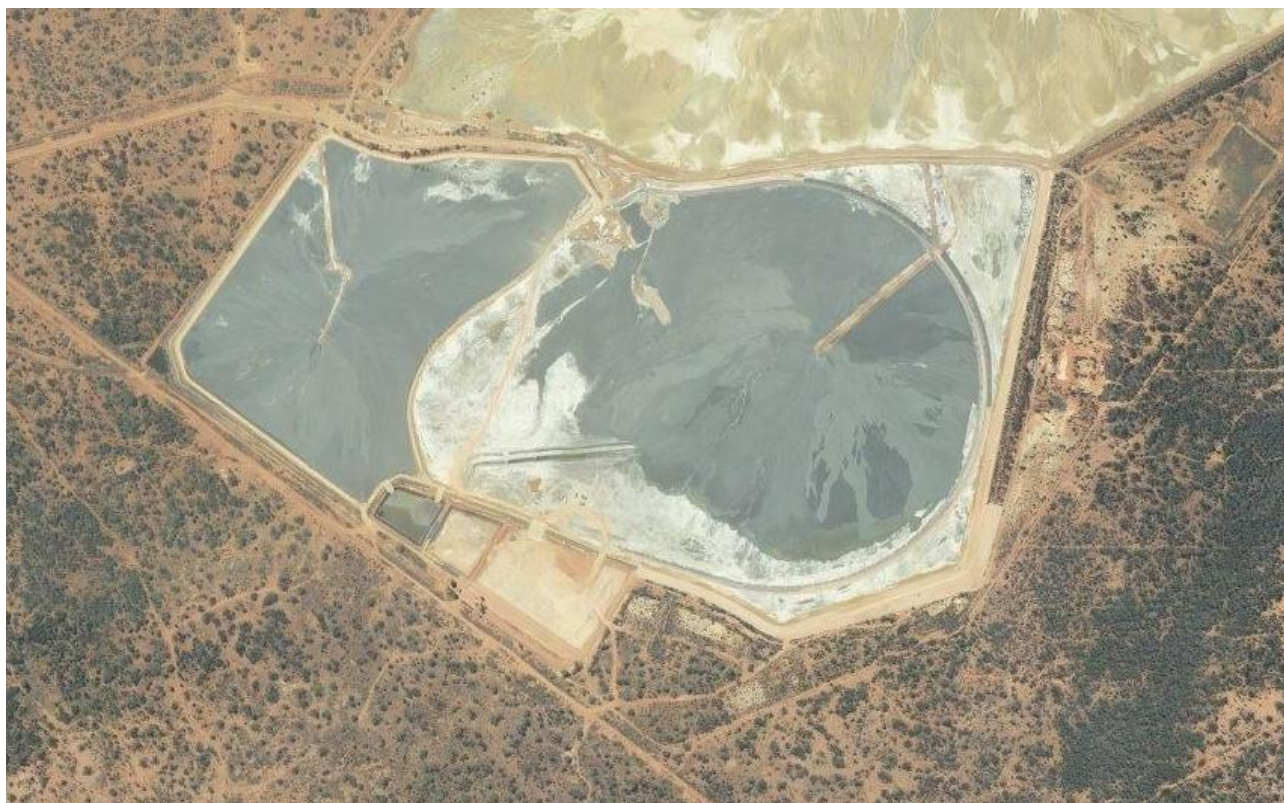
Figure 4 Aerial photograph of the South TSF showing the interim storage and the eastern mound, February 2011

The additional compartment of the decant dam was excavated to the east with new spillways between the compartments. An aerial photograph showing the South TSF layout towards the end of the first phase of construction is presented in Figure 4.

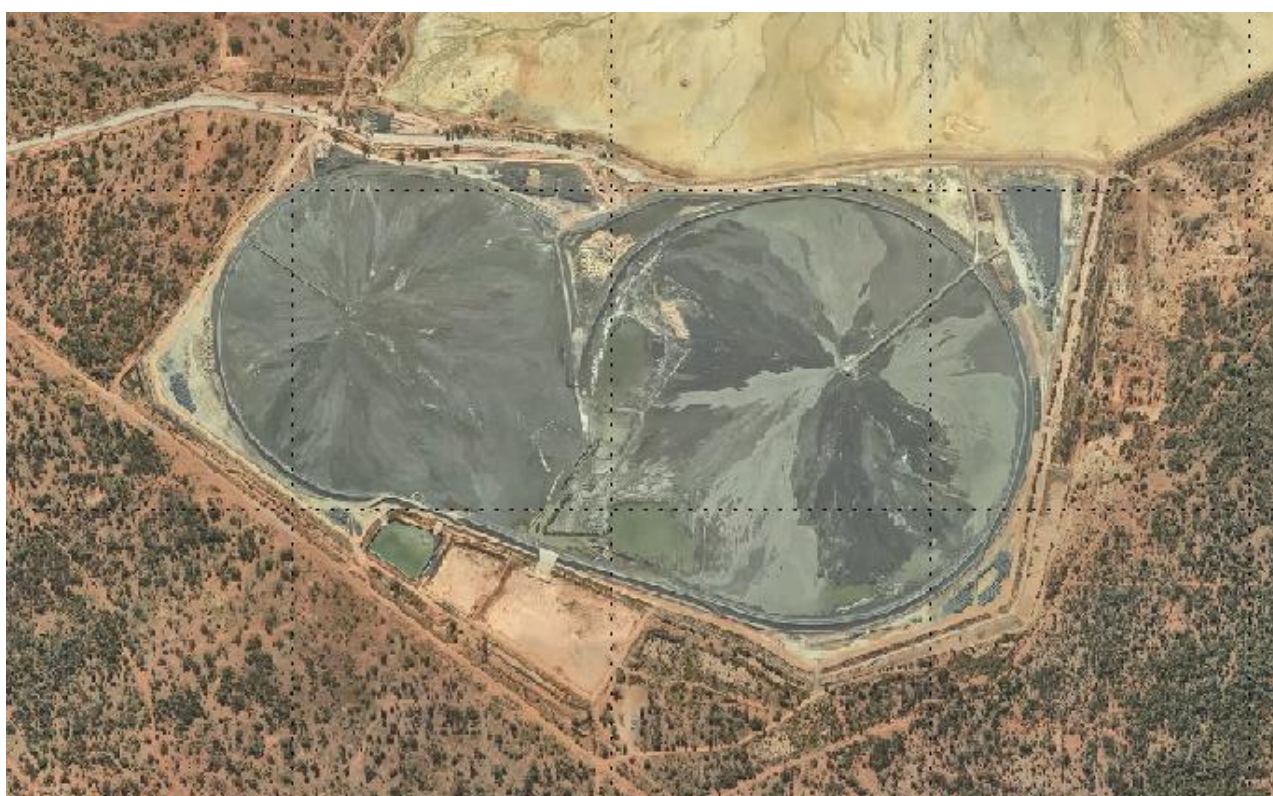
Figure 5 Aerial photograph of the South TSF, August 2015

An aerial photograph of the South TSF, as at mid-2015, is shown in Figure 5. It shows the perimeter embankment around both tailings mounds.
