The effect of hydrothermal alteration of the host rock mass on the slope stability of an open pit mine at Tujuh Bukit, East Java

GP Koriawan *PT Merdeka Copper Gold, and Hasanuddin University, Indonesia*

Abstract

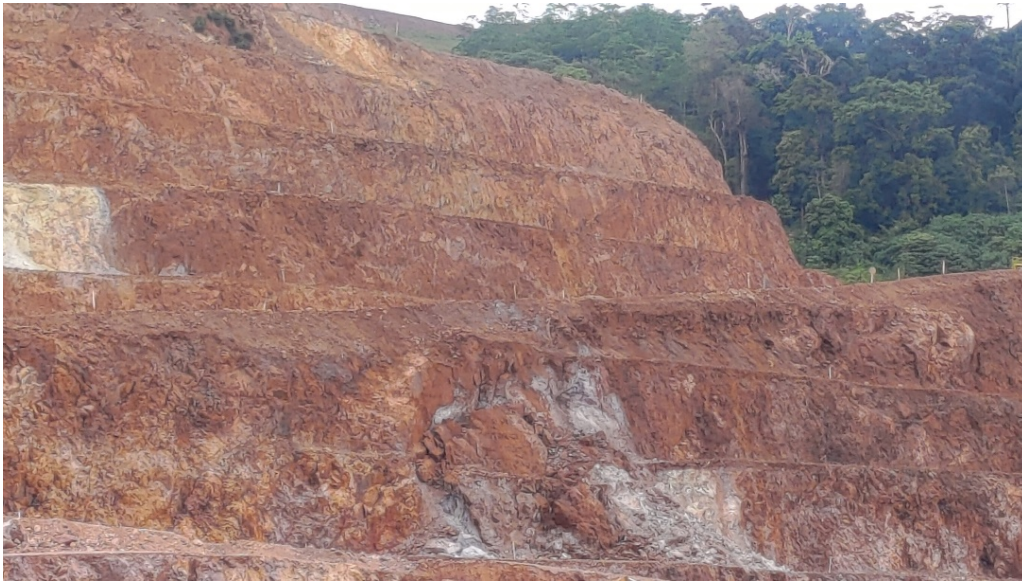
Geological processes that occurred during and after rock formation also appear to influence the rock mass engineering properties. The Tujuh Bukit mine operational area experienced historical failure of the pit slopes (Figure 2). These unstable areas all exhibit different igneous rock mass characteristics and appear to have

Figure 2 Historical failure of the pit slope
