# Integrating community participation in mine rehabilitation in the West Rand, South Africa

<sup>a</sup> Asset Transition and Closure, SLR Consulting, South Africa

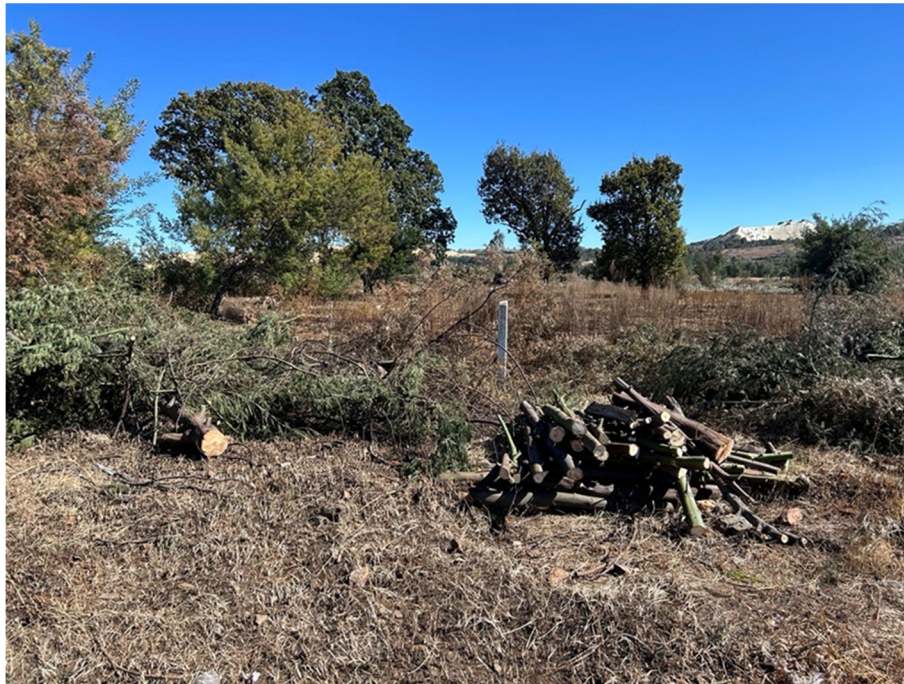
**Figure 1** Cleared biomass made available to contractors and surrounding communities

While rehabilitation projects are typically implemented using established and experienced contractors, the mine elected to pursue an alternative delivery model that prioritised community participation. A key component of the rehabilitation activities was executed by community contractors, who focused primarily on invasive alien plant clearing and follow-up maintenance. Mechanical clearing was supplemented by controlled chemical treatment where required. However, herbicide use was avoided upstream of wetland areas in accordance with the national legislation. Clearing activities comprised the removal of gum (*Eucalyptus camaldulensis*), pampass grass (*Cortaderia selloana*) and various wattle (*Acacia* spp.) trees which are prevalent on site. Cleared biomass was made available to contractors and communities surrounding the project area (Figure 1) as timber or fuelwood, providing an additional socio-economic benefit.

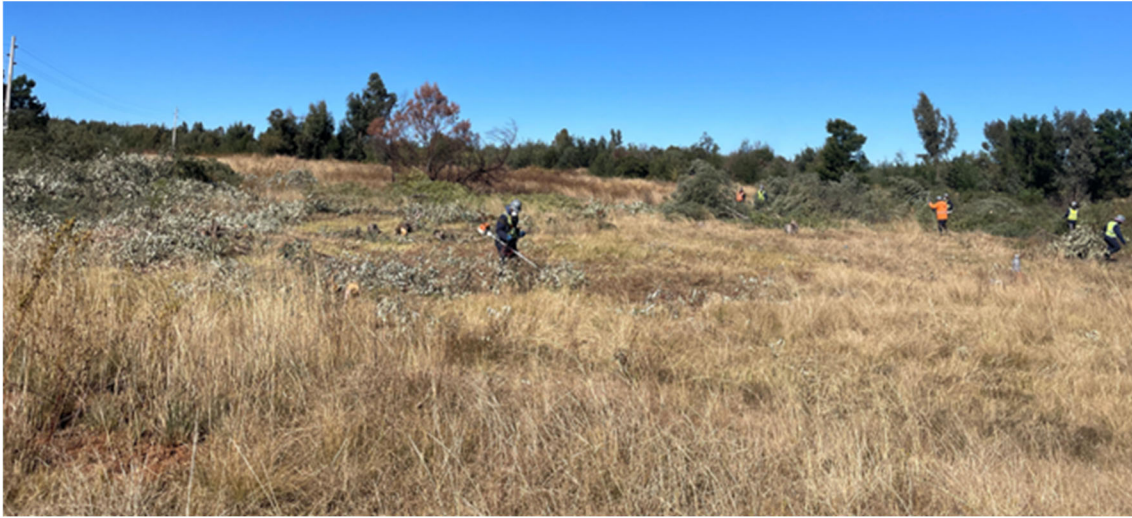
**Figure 2** Site conditions in parts of the project area during the initial alien plant clearing and herbicide application

- Alien and invasive plant species identification and mechanical management
- Accredited course in hand tools use such as chainsaw operation
- Brush cutting operation
- Herbicide application for weeds and invasive plants management (Figure 2)
- Personal protective equipment requirements for each activity.

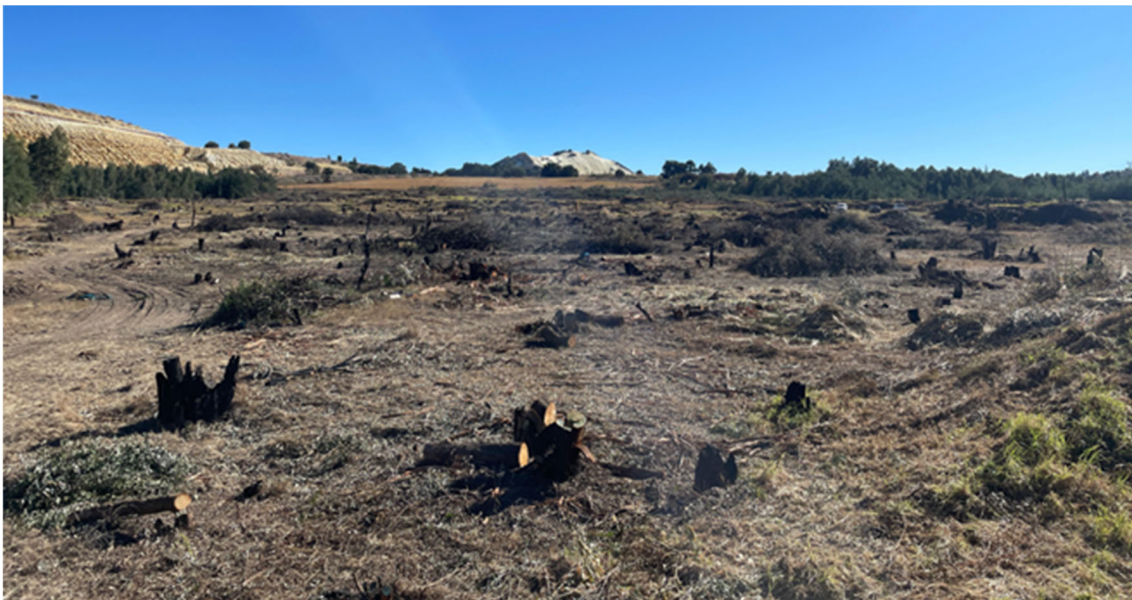
**Figure 3** Site conditions in parts of the project area during the initial alien plant clearing by various contracting teams

Rehabilitated areas demonstrate improved surface stability, reduced invasive plant species density (Figure 3), and increased ground cover of indigenous vegetation. The concurrent rehabilitation of the project areas has reduced the extent of disturbed land. Furthermore, concurrent rehabilitation continuously contributes to
